THE CHRISTIAN BASILICA NEAR THE CENCHREAN GATE AT CORINTH

INTRODUCTION AND GENERAL DESCRIPTION ¹

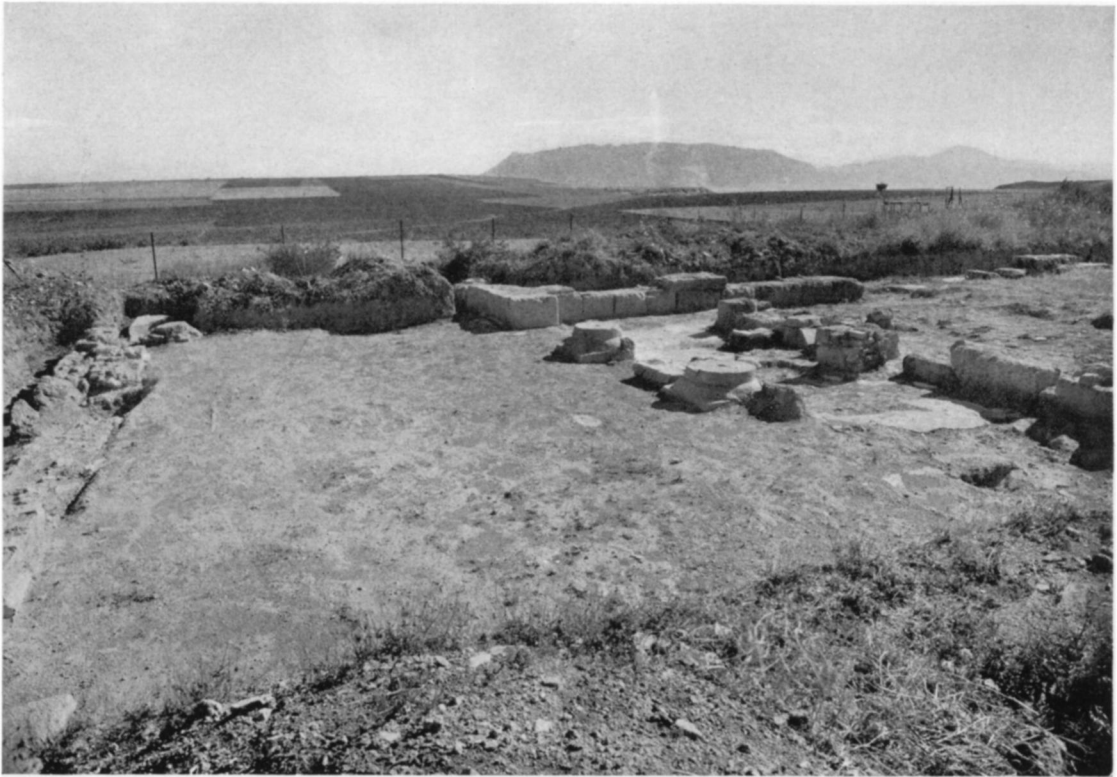
Fig. 1. Christian Basilica at Corinth, 1935. Narthex and West End of Nave Looking North

WESTERN END. As stated above, the original church was entered from a narthex⁴ about 6 m. broad, extending the full width of the church, although not quite at right angles to the length, as can be seen from the plan (Pl. XII) and Figure 1. While the exterior wall is not very well preserved, the position of the two outside doorways is

marked by portions of the marble thresholds still in place. That there can have been no central door is shown by fragments of wall revetment still in their original bedding where such a door would have to come. While the wall itself is destroyed at this point, there is a sort of bench of rubble on the western side of the wall, which would have blocked a central doorway.

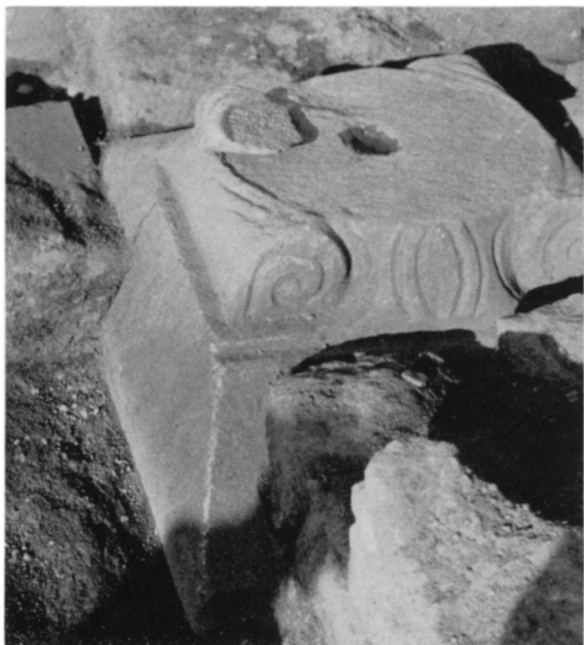
Fig. 2. Ionic Impost Capital in Late Wall

slabs, together with a long foundation wall almost paralleling that of the narthex, probably indicates a portico on the west end of the church rather than an atrium. Perhaps the Ionic impost capital of Proconnesian marble⁵ built into the later wall just inside the nave (Fig. 2) came from this colonnade.

After a lapse of time sufficient to fill the church with 30 or 40 cm. of earth, possibly corresponding to the Avar occupation of Corinth (A.D. 588 to 805),²⁰ enough of the ancient structure still remained to make repairs worth while, testifying to the solidity of the original building. The portico and narthex had evidently been destroyed, however, since a new narthex was created by walling off the westernmost bay of the nave and closing up the nave arches. This roughly laid rubble wall included such fragments as the boldly modelled Ionic impost capital mentioned above (Fig. 2).

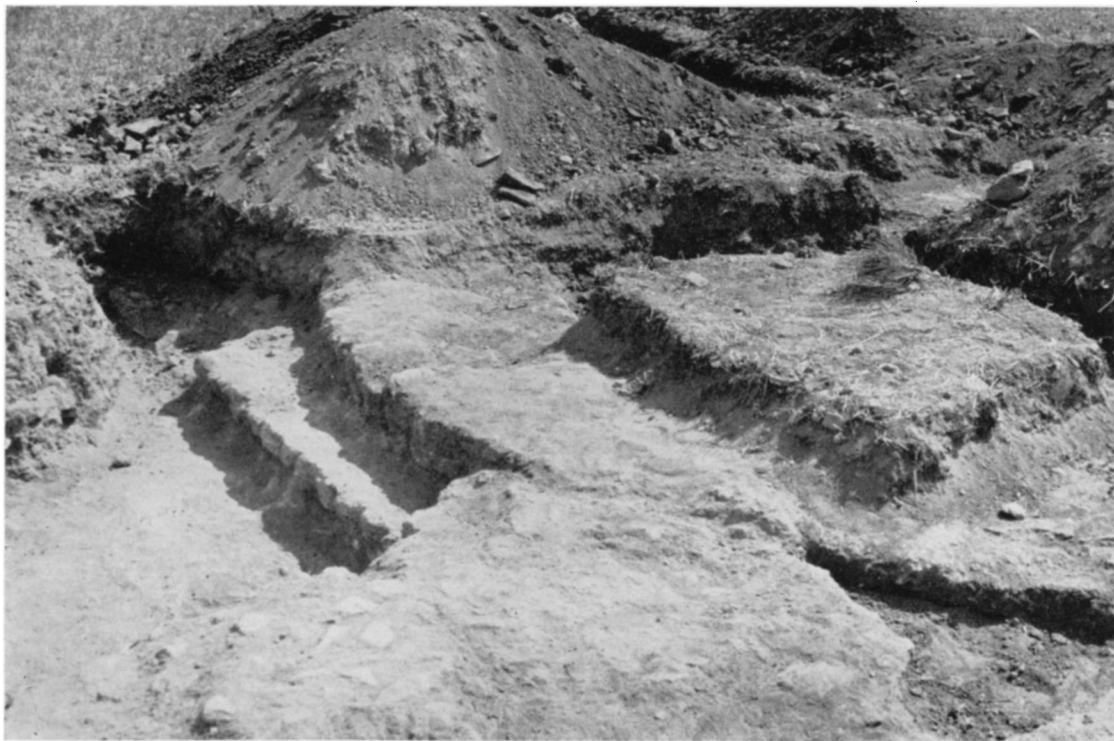
Fig. 3. Apse of Side Chamber from Southwest

The interesting apsidal building at the north end of the portico is preserved only to the level of the rough cement floor bedding, which is about two steps above that of the narthex, with the apse a step higher. The apse is turned towards the west, and like that of the triconch was enclosed in a rectangular wall outside (Fig. 3). This

is a common location for a baptistry, but until this chamber is fully cleared, its form and purpose cannot be definitely determined. It remains to be seen also if there may be a similar room off the south aisle as in Basilica A at Nea Anchialos.⁶

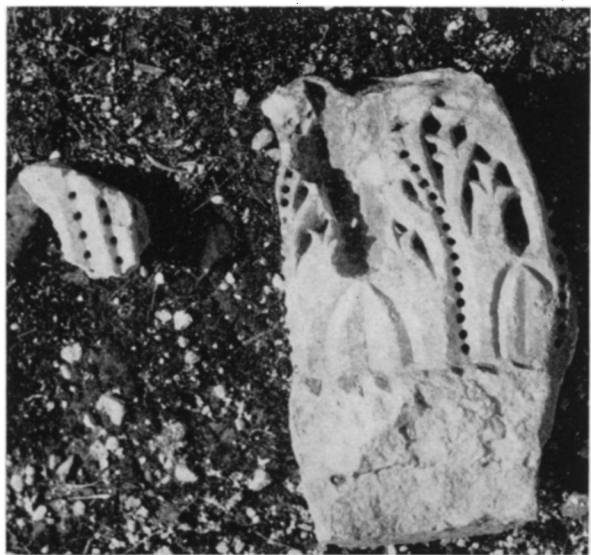
Fig. 4. Fragments of "Theodosian" Capitals
Found in the Narthex

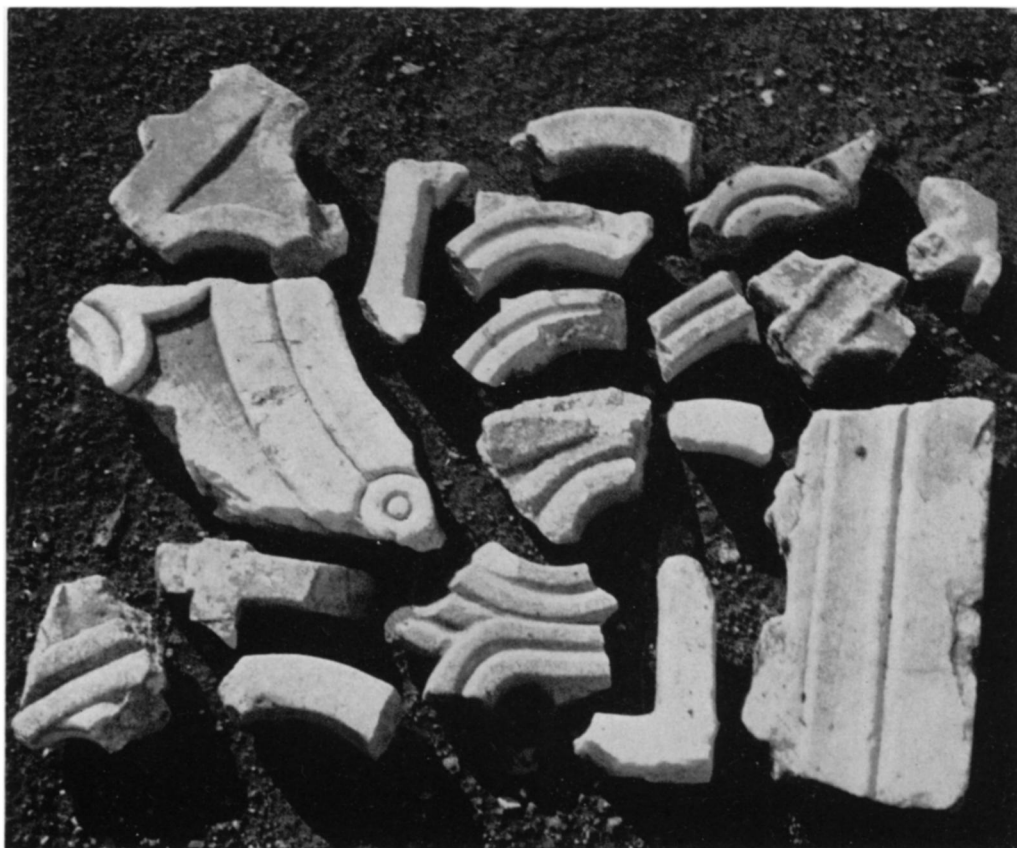
Fig. 5. Fragments of Pierced Screens

of this step, but unhappily it is precisely at this point that the evidence is most thoroughly destroyed, and so far no fragments which might belong to such a feature have been found. There are, however, many fragments of the pierced slabs (Fig. 5) and some of the square marble posts which formed the low parapet enclosing the bema.

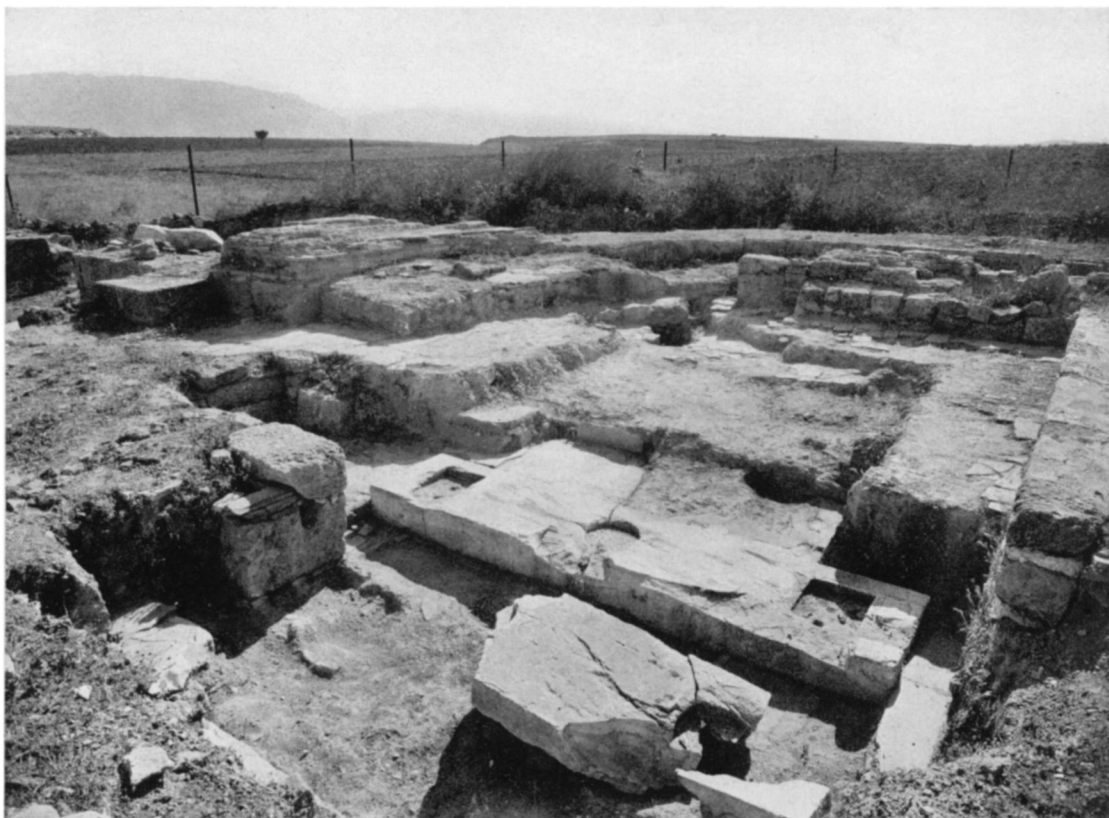
Fig. 6. Foundations of Holy Table, 1935

In front of the apse, on the axis of the church is the foundation for the Holy Table (Fig. 6), consisting of two parallel marble blocks cut from Roman architraves, one of them in place, part of the other found near by. Each of these blocks had two sets of three shallow cuttings: one set of two square cuttings at the ends with a round

one in the center, the other set of three round cuttings, partly obliterated by the former. These clearly show that the Holy Table was of a common type: a marble slab supported on six colonnettes.¹³ A small fragment which may belong to one of these colonnettes was found in the excavations (Fig. 7).

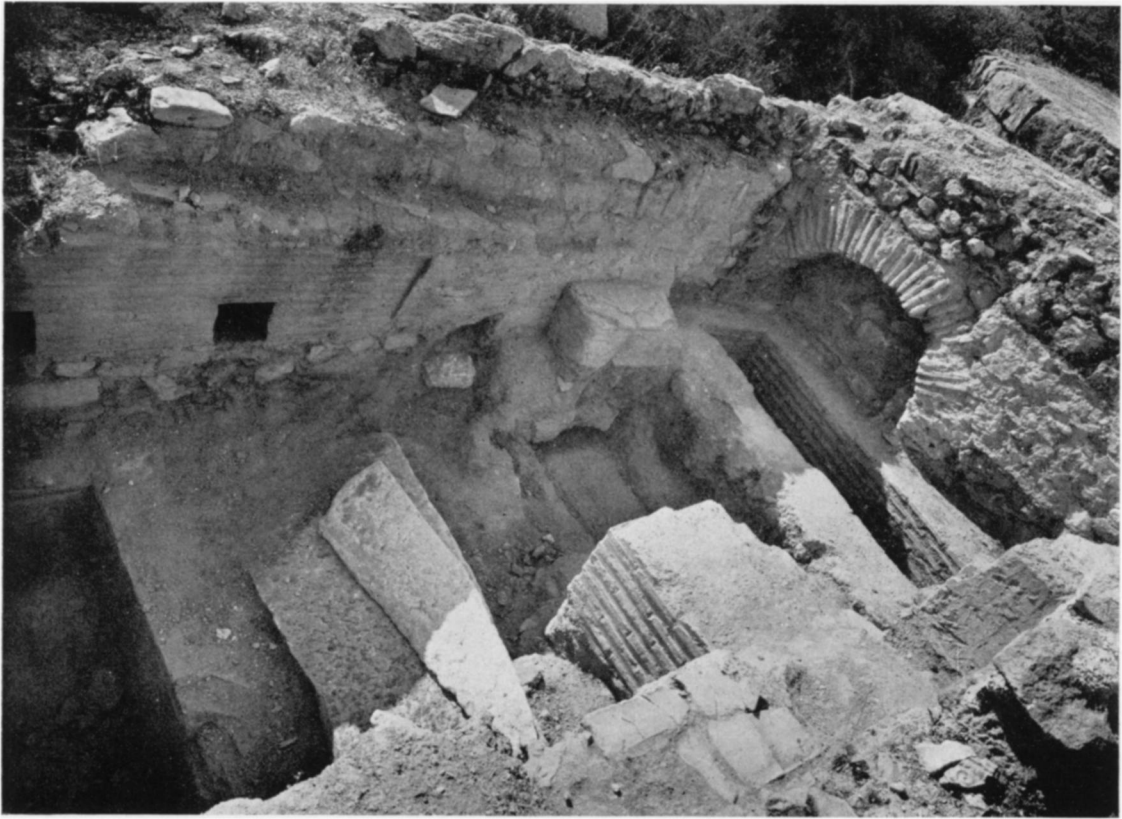
Fig. 9. Chamber A, Looking Southeast, 1935

This vault (Figs. 9 & 10) is well made of flat bricks in heavy mortar similar to the construction of the church, resting on a rubble foundation. The side walls had

niches for lamps, while the south wall contained the entrance opening. Within the vault was one grave, desecrated as usual, built of tiles and stuccoed inside, with a marble cover. All of this obviously antedated the church, if one may judge from the manner in which the church foundation cuts into the brickwork, and from the orientation.

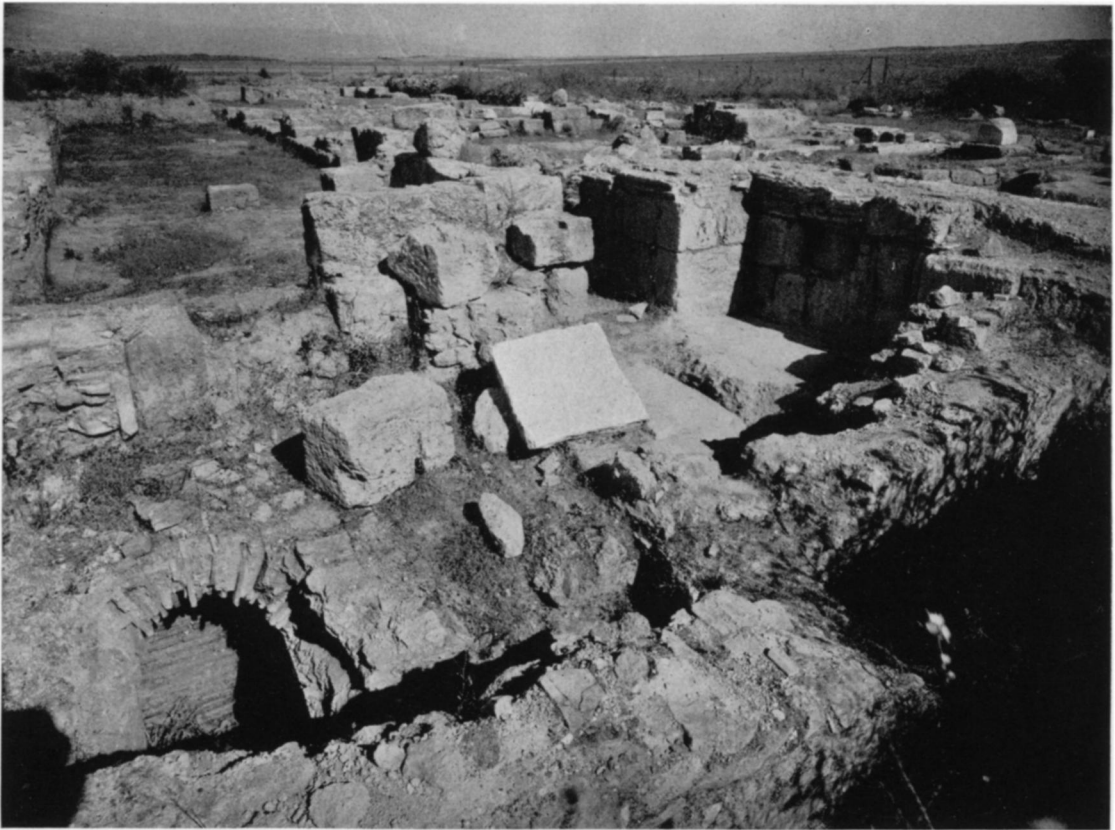
Fig. 11. Chambers C and B, Looking Northwest, 1935

The next tomb chamber is B, just south of the apse. After the late grave found in the first campaign had been removed it was found that the original floor of slate and marble, rather calcined by a fire, extended well into the corner (Fig. 11). A nicely

Chamber B probably originally extended to the south side of the doorway in chamber C, which formed its original entrance until chamber C was added, when this door was walled up and the present one cut into chamber B.

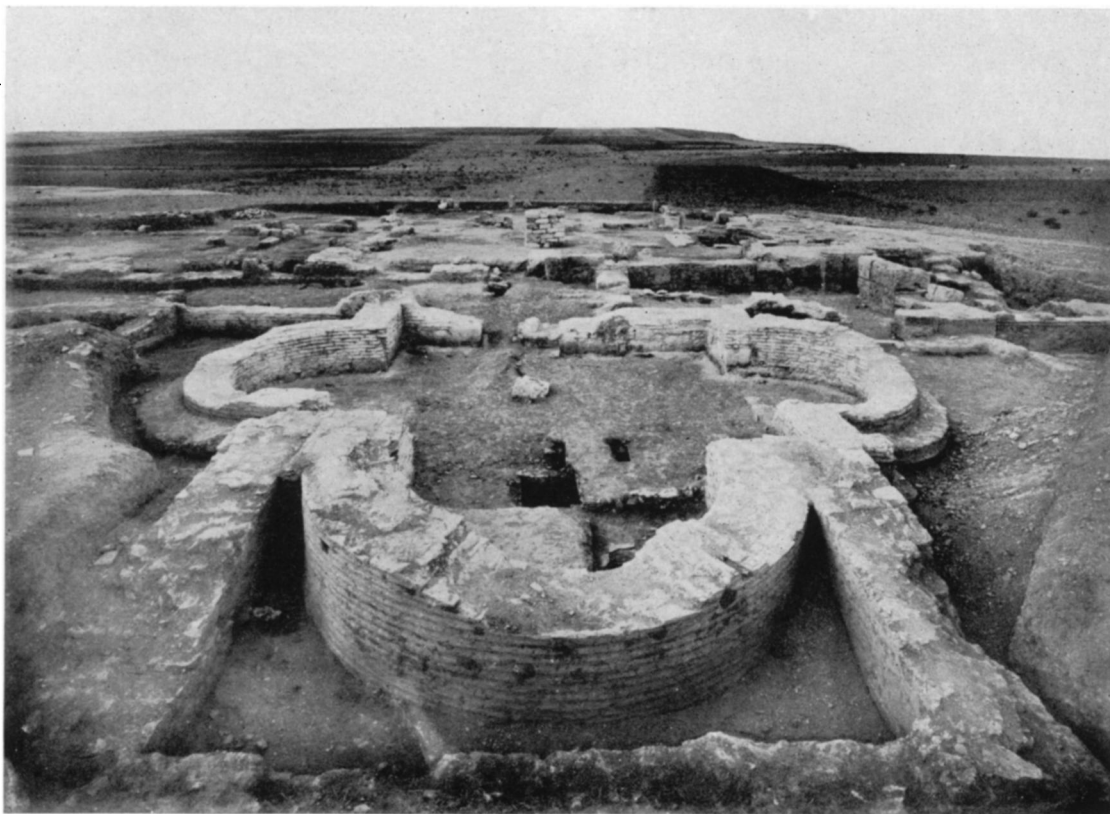
Fig. 12. Triconch, Looking North

The most interesting feature of the entire church is the imposing funerary chapel off the south aisle (Figs. 12 and 13). It has a trefoil shape (triconch) or rather that of a square room with three projecting apses.¹⁶ The apse walls are built of brick, the

others of brick and cut stone. Outside the foundations of the lateral apses are water tables of rubble with sloping cemented top to shed the water away from the foundations. Between the eastern apse and the church wall and next to the doorway into the south aisle is the small rainwater cistern E (plan, Plate XII, and Fig. 14), which was lined with tiles and stuccoed to catch the drip from the intersecting roofs of the aisle and triconch. No good reason can be given for the rectangular wall which encloses

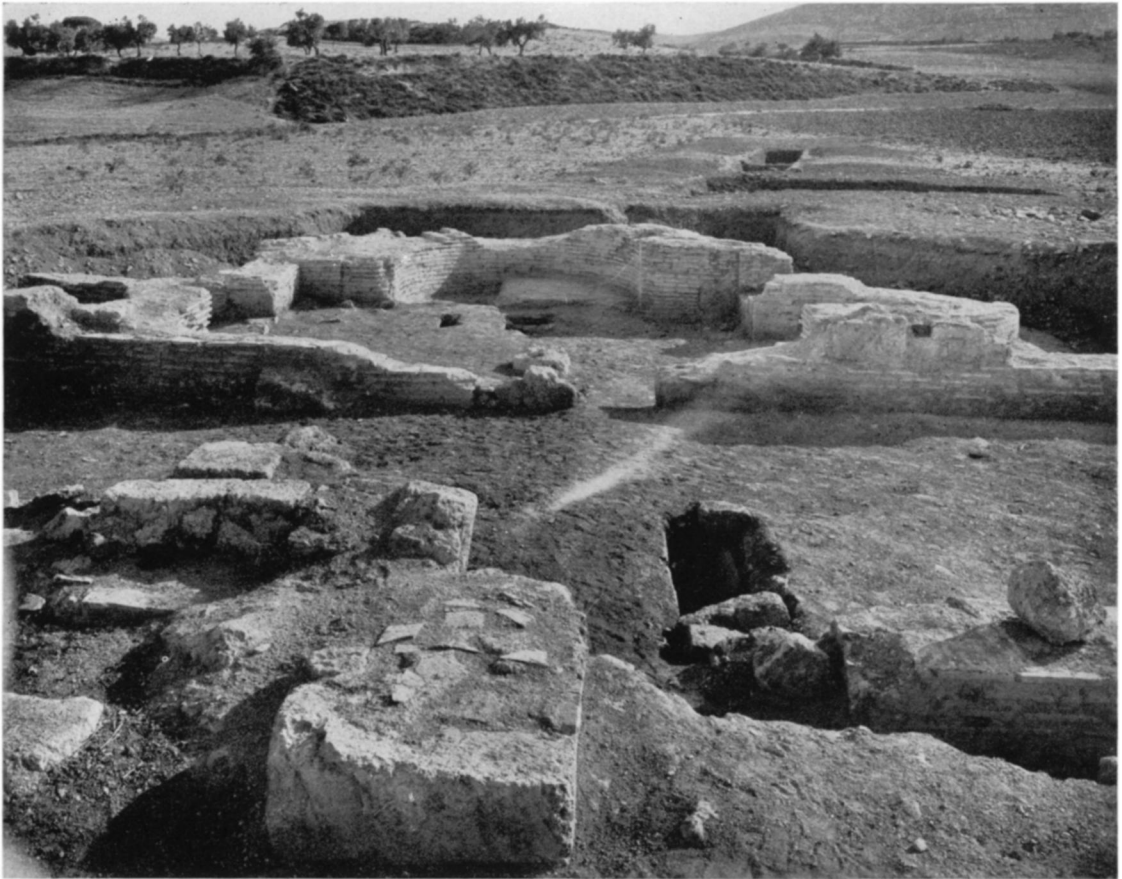
Fig. 13. Triconch, Looking South

It is the large southern apse which provides the reason for this elaborate chapel in the form of an unusually large vaulted tomb constructed of flat brick arched over and stuccoed inside. The apse floor above the tomb is raised. The east end of the tomb has an opening covered with a stone slab which was removable, and access was further assisted by footholds formed in the sides of the tomb under the opening. Since

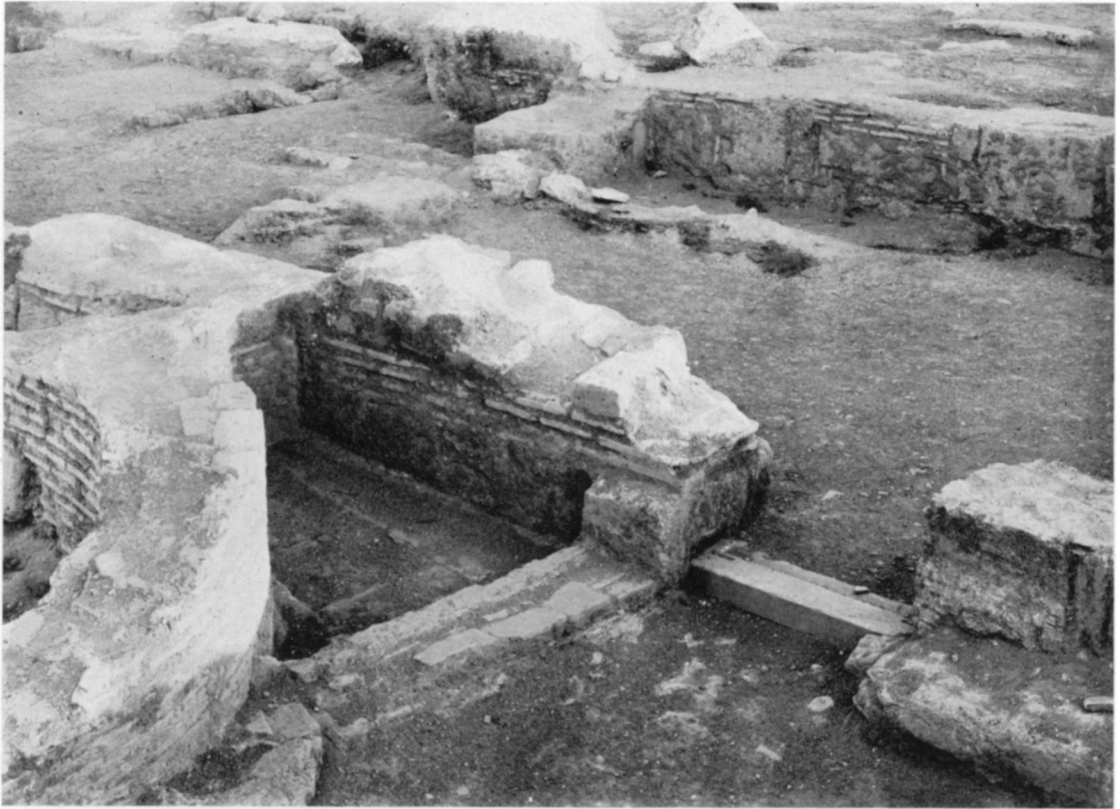
Fig. 14. Rain-Water Cistern E

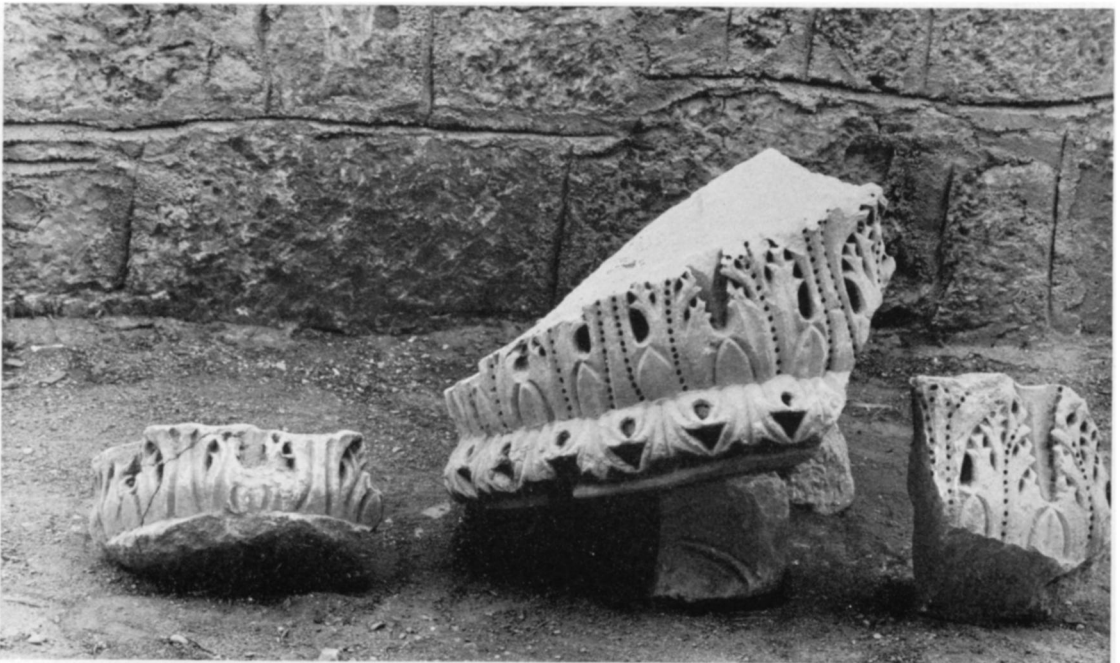
Fig. 15. Fragments of Theodosian Capitals from Triconch

A door in the south aisle opposite the first arch of the nave arcade gives access to the triconch, the floor of which was at the same level as that of the aisle, and of similar material and design as shown by the existing portion. The eastern apse was raised a step above this, but whether the western one was also raised is not clear. However, the walls at the sides of the western apse show vertical cuttings as though for a rail or low screen about 95 cm. high to enclose it. In the triconch also were found several more fragments of "Theodosian" capitals shown in Figure 15.

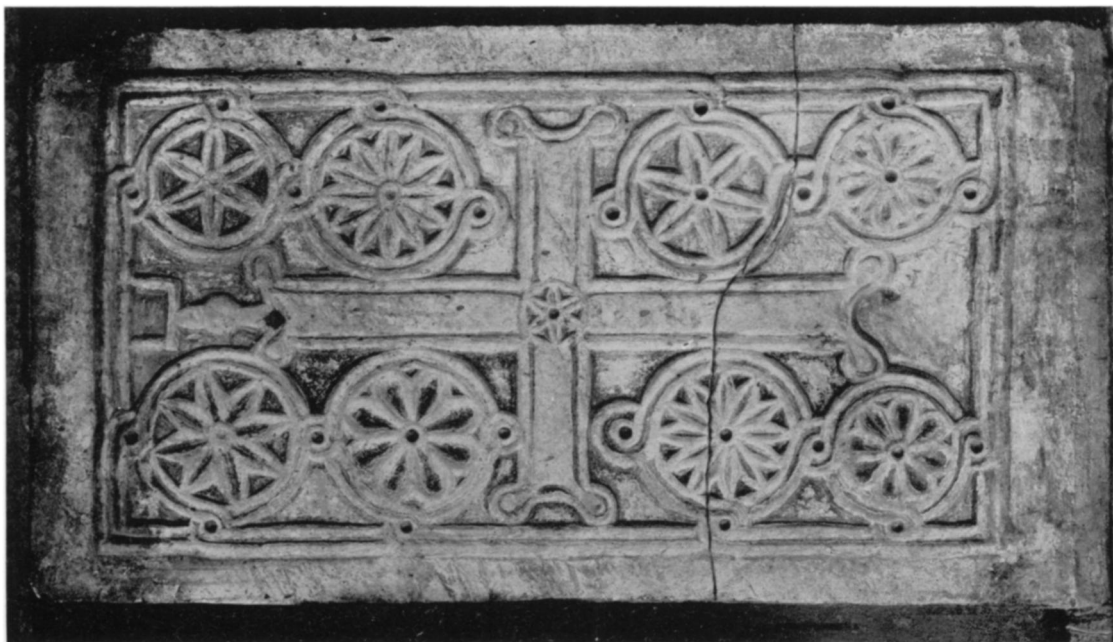
Fig. 16. Marble Plaque from Church II

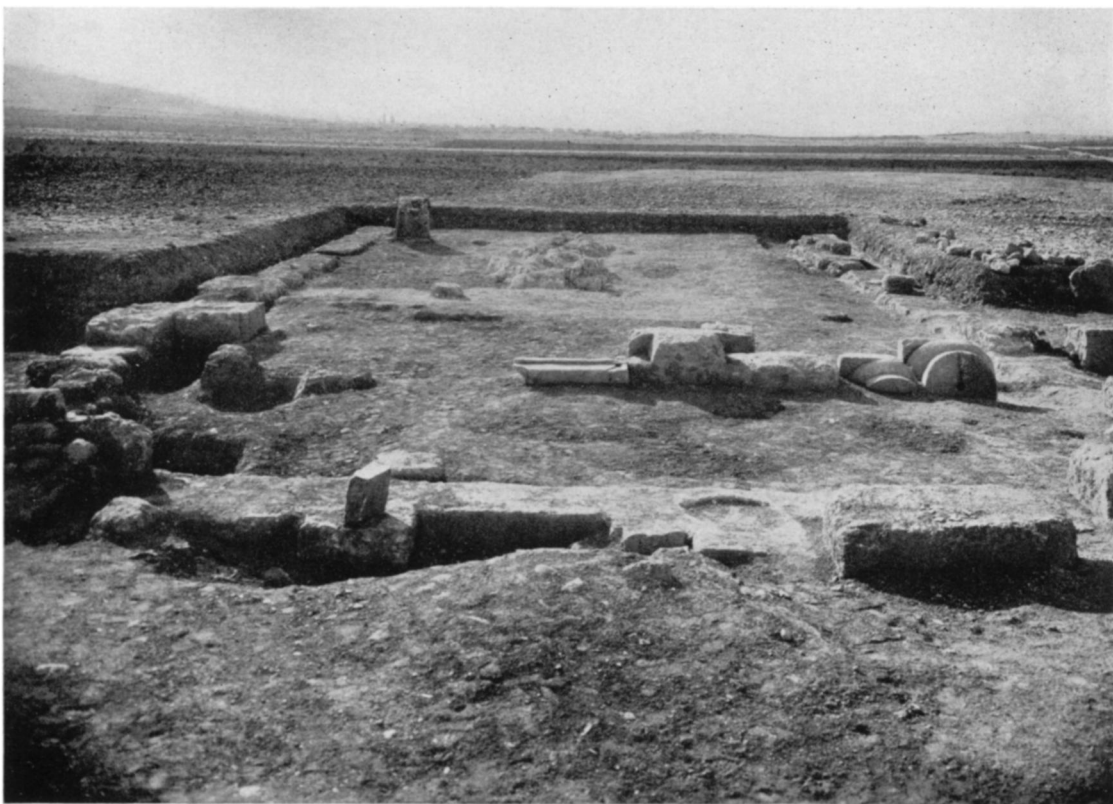
Fig. 17. West Wall and Narthex of Church III. Fallen Wall of Church II Seen above the Marble Threshold in the Center of the Picture

At any rate, this phase was ended by a disastrous fire which damaged the structure very badly. Indeed, a portion of the clerestory wall of the north side of the nave which fell in is still lying in the center of the church (Fig. 17).

Even with this, enough of the east end remained to make a third rebuilding worth the trouble. Heavy abutments were built against pier 3 and a heavy wall thrown across the nave at pier 5. At pier 6 another lighter wall with the marble column bases of the same type as those at the nave entrance, shown in Figure 17, enclosed a narthex,

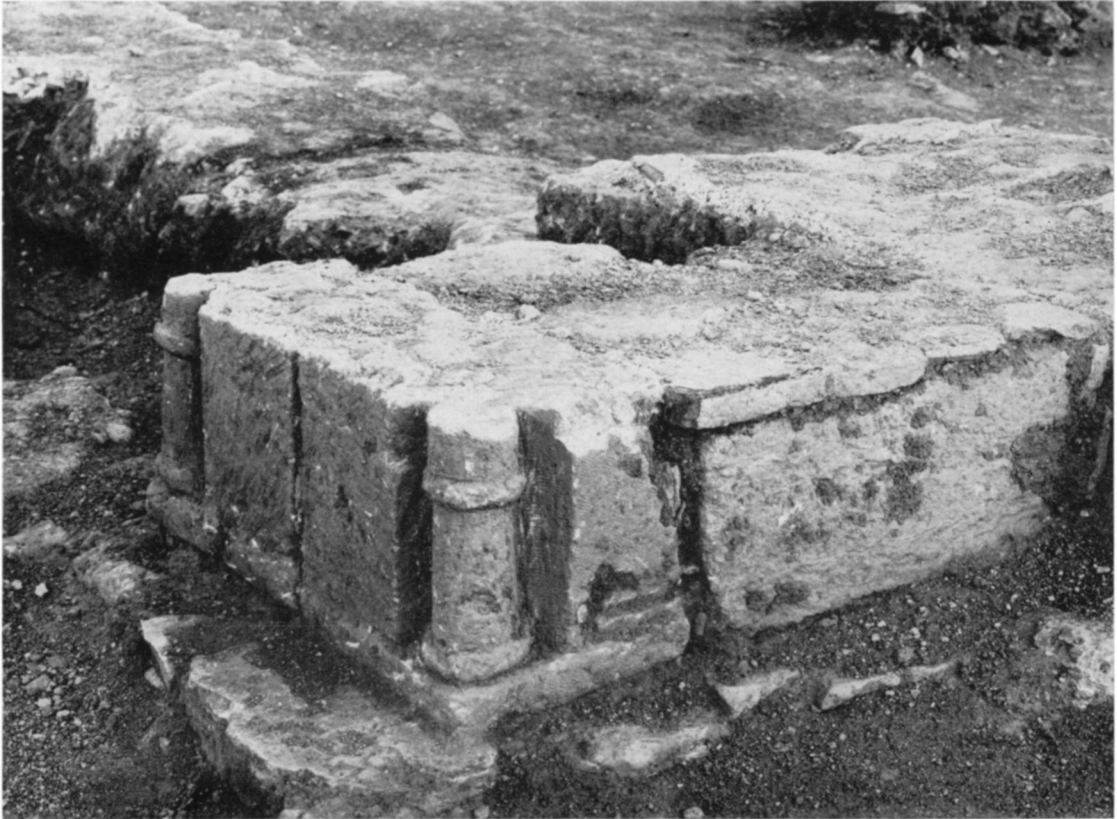
Fig. 18. Base of Porch Pier, Church III

while at pier 7 is the remaining jamb with bases of engaged colonnettes (Fig. 18) of what appears to be an arcaded porch in the Western style.²² The masonry is characteristic of eleventh and twelfth century work in Greece, of squared stones with tiles in both the horizontal and vertical joints. The heavy abutments would indicate vaults of some sort to replace the original wooden roof.

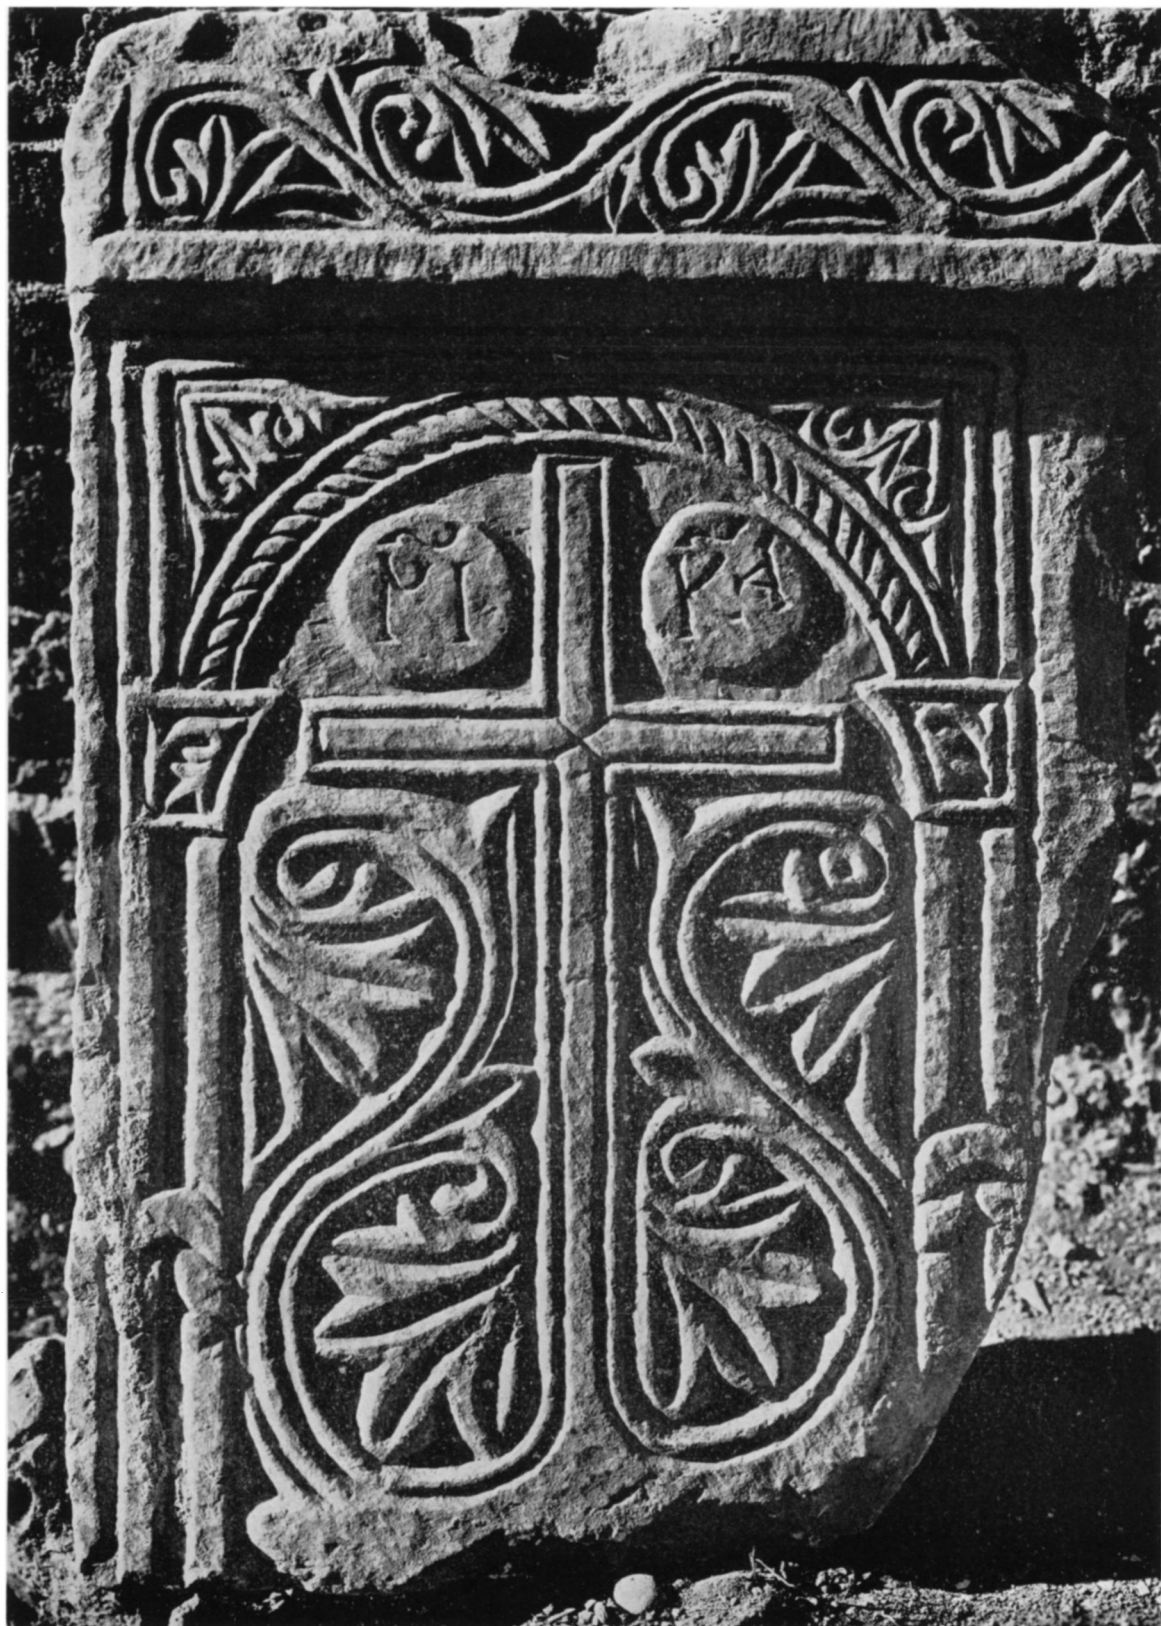
Fig. 19. Plaque

Ancient columns and other fragments have been re-worked into a basis for the iconostasis (see above), from which may also come some of the plaques now in the Museum (Figs. 19, 20).

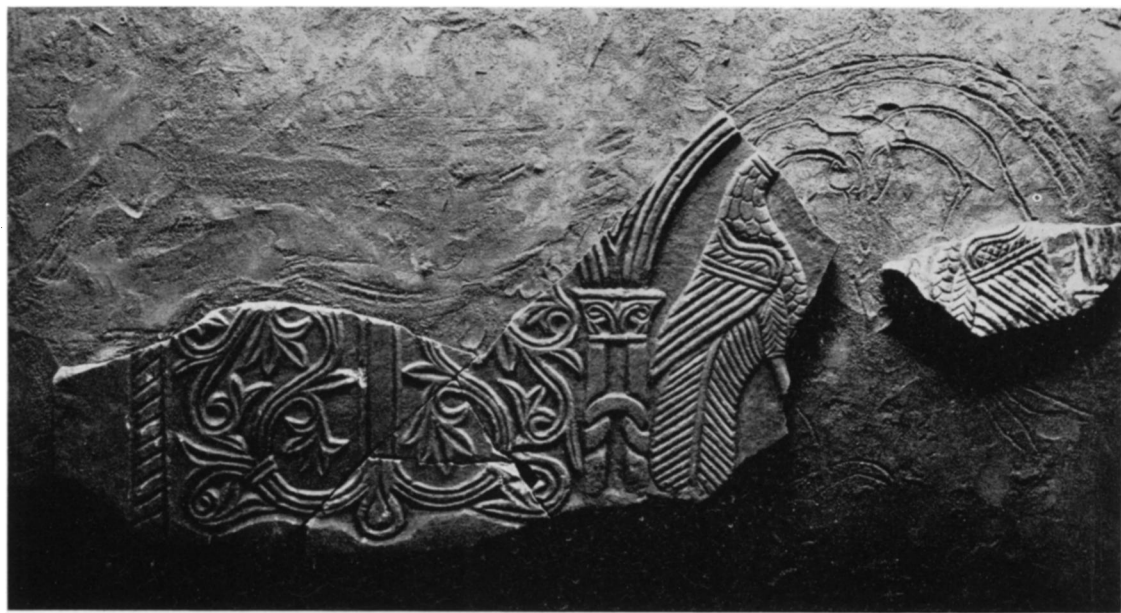
Fig. 20. Fragments of Marble Plaque

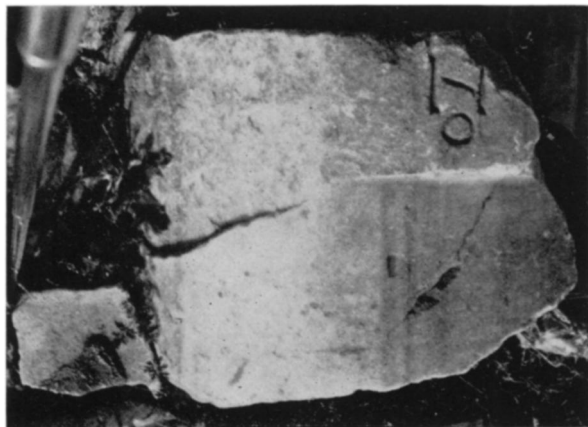
Fig. 21. Column with Monogram

fragments have been mentioned in connection with the structure, but very little was found in any case. One column fragment bears the monogram shown in the accompanying photograph (Fig. 21), but this scanty clue as to the identity of the structure has not been of much help. Small finds were almost non-existent; the most important have been mentioned.
