THE ATHENIAN AGORA

RESULTS OF EXCAVATIONS

VOLUME XX

THE CHURCH OF THE HOLY APOSTLES

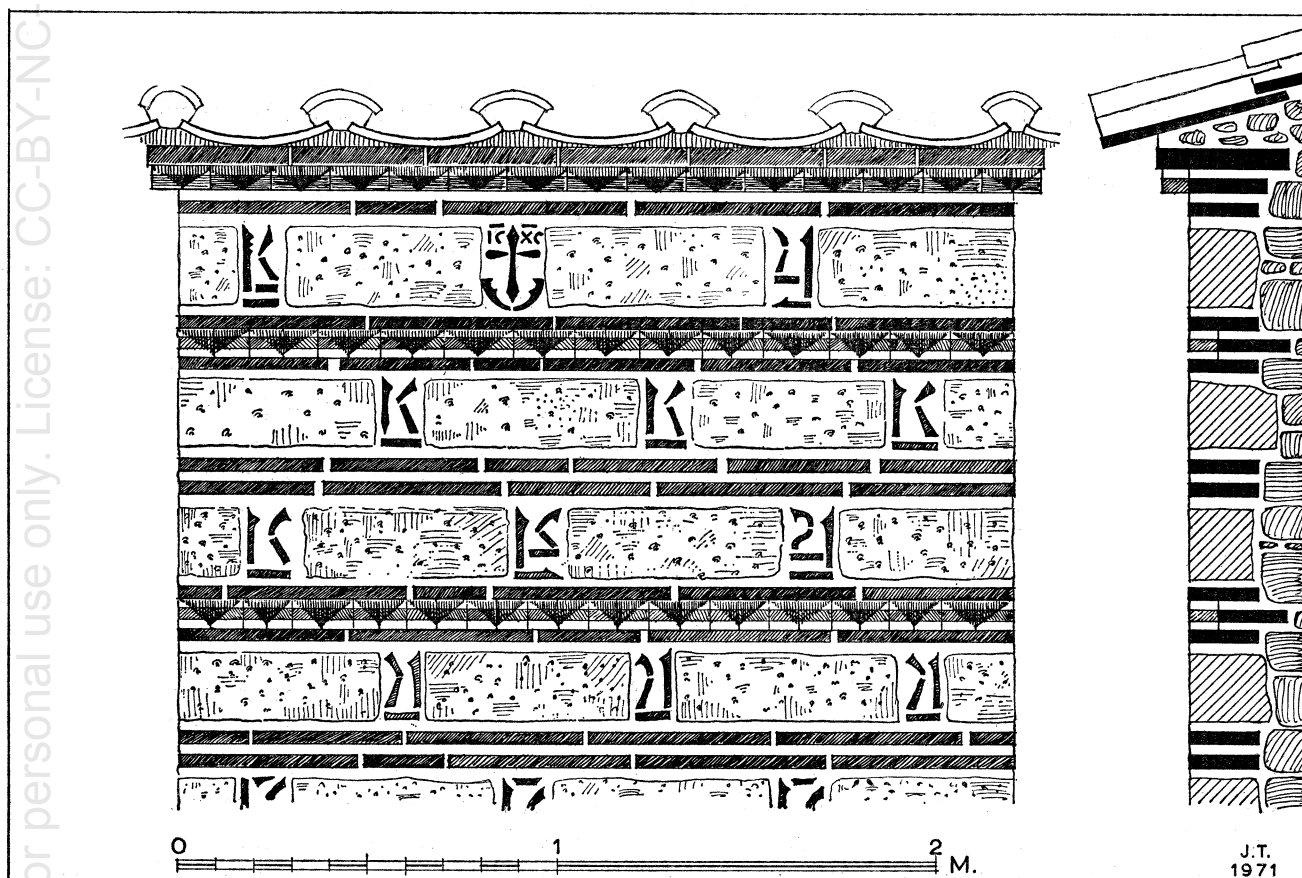
Fig. 1. Masonry on East Side of East Apse

Above eye level almost all of the vertical joints are filled with bricks set in ornamental patterns (Fig. 1; Pls. 8, 9, d).⁷ In the lower courses the simplest cloisonné masonry was used.

Large ancient blocks were set on end at all key points of the building, in the lowest course: at the outer corners of all the apses and the narthex, and flanking the three doorways in the west wall. In addition, two others were placed at irregular intervals in the south wall of the narthex and at least one, and probably two, in the north (Pls. 4, c, 32, 33).⁸ Behind the cloisonné facing the thickness of the wall was filled out with a core of rubble masonry, giving the walls a total thickness of 0.70–0.80 m.

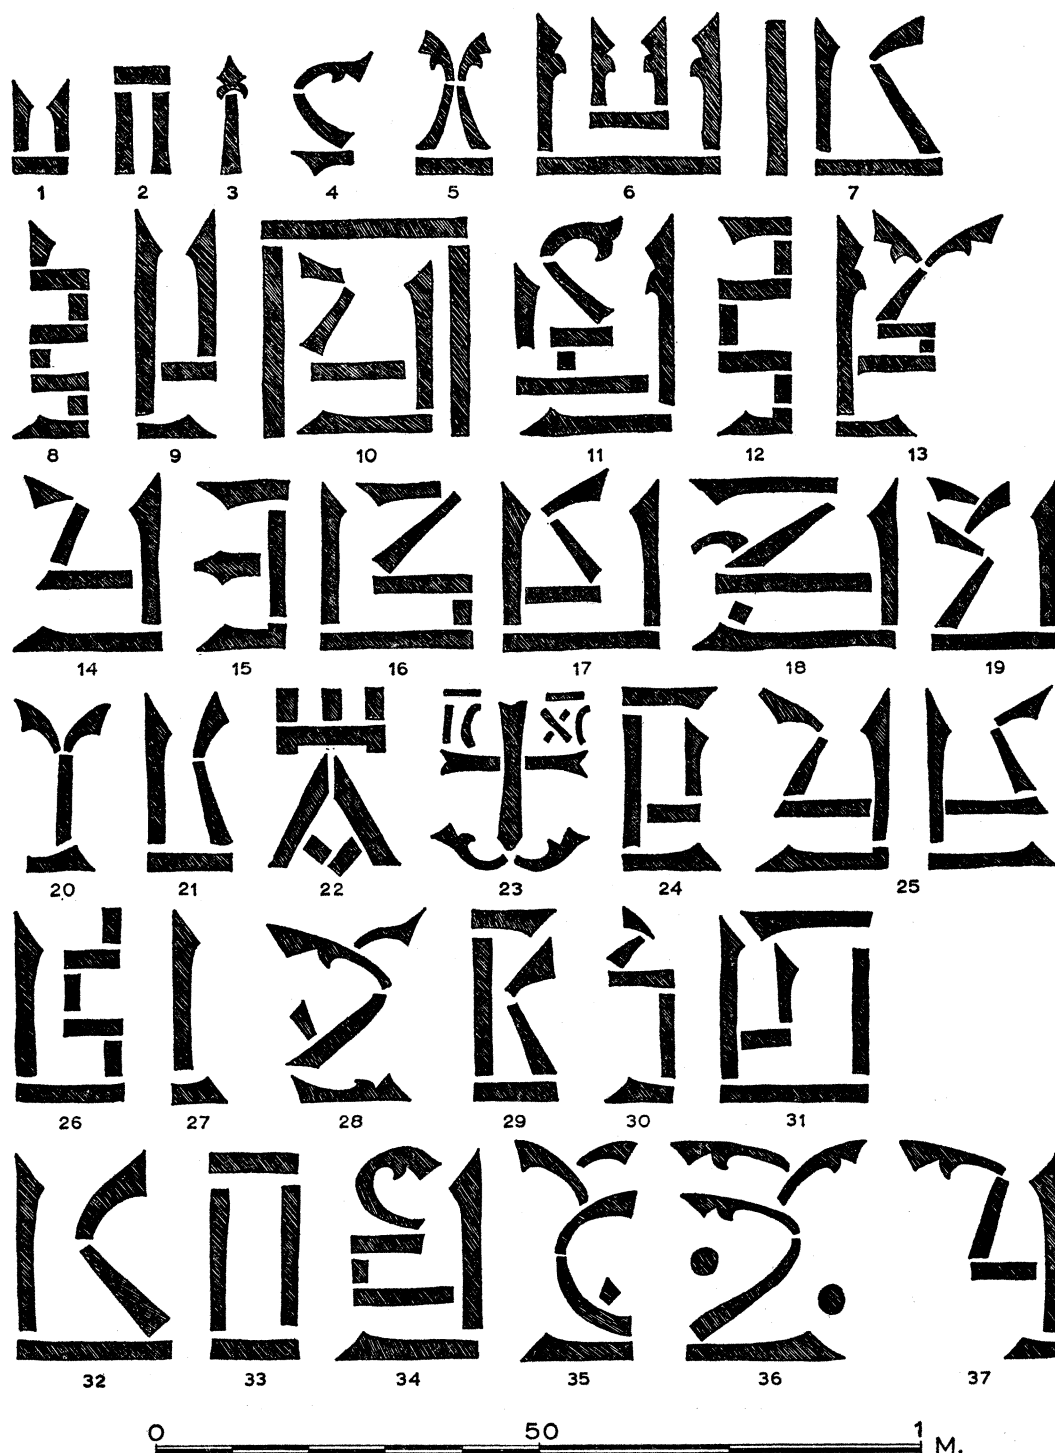
Fig. 2. Kufesque Designs in Masonry

An interesting example of how the architect handed on his ideas to the mason is provided by a half brick with a Kufesque design drawn in black on its uneven surface (Pl. 5, b).¹² It was found in the rubble core of the south wall of the south apse during conservation operations, having apparently been discarded after serving its purpose as a model and picked up on the spot to be used as building material. It cannot be matched exactly on the church but Megaw's No. 6 (Fig. 2) is a close approximation.¹³

⁹ The brick patterns of the Holy Apostles form an important part of Megaw's analytical study of brick patterns in general (*Chronology*, pp. 102-115). Special thanks are here expressed to Mr. Megaw for permission to reproduce his drawings, which include all the decorative elements found on the church; our Figure 2 was prepared by Helen Besi from Mr. Megaw's drawings.

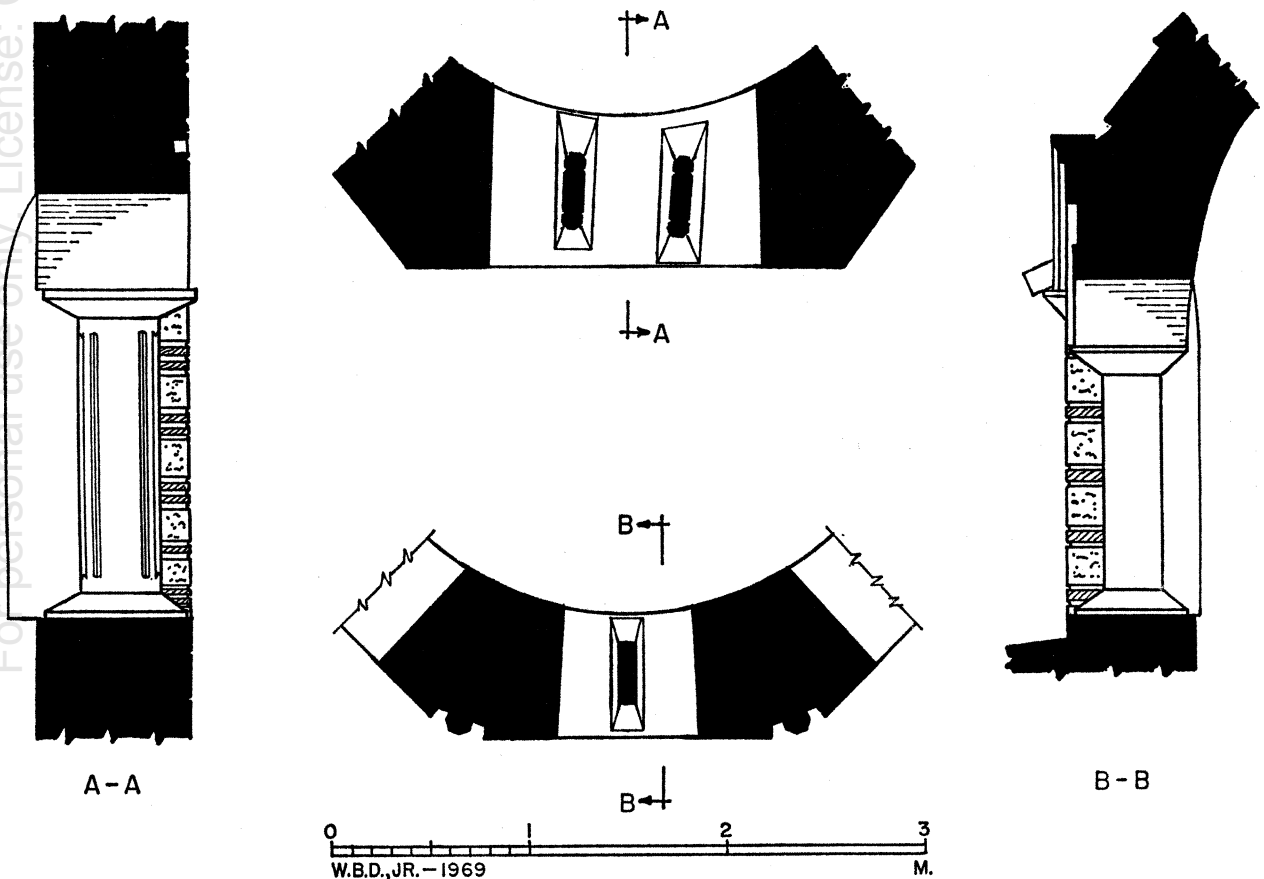
Fig. 3. Window Details. A. East Apse. B. Dome, Southeast Face

The removal of the stucco which covered all the masonry of the dome revealed the tops of the original window frames still in place. They were in varying states of preservation and in all cases the mortar had crumbled beyond all usefulness, but the scheme could be recovered with certainty (Figs. 3, B, 4, d; Pl. 6, b, c).

and south apses and the dome are double (Figs. 3, 4; Pl. 9, e).¹⁸ The mullions are elongated in section, on flaring bases and with flaring capitals decorated with incised crosses or rosettes.

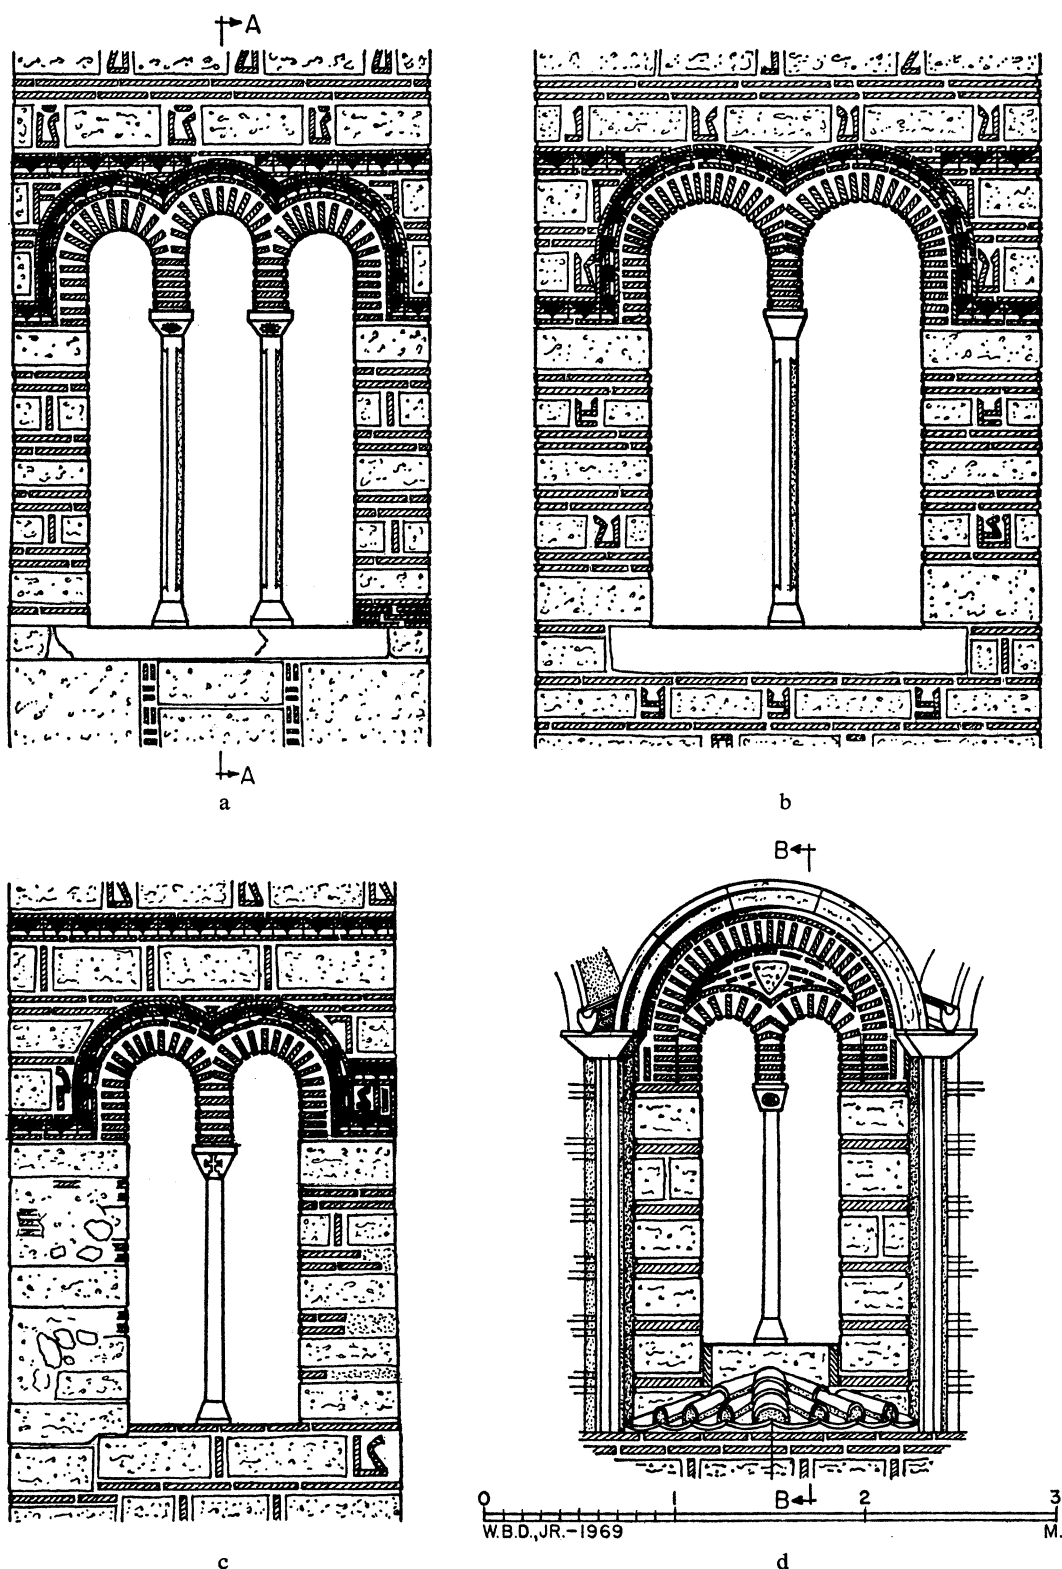
Fig. 4. Windows. a. East Apse. b. North Apse. c. Diaconicon. d. Dome, Southeast Face

The decorative scheme in the tympanum of the arches (Fig. 4, d; Pl. 8) was composed of a fairly large block of poros limestone, roughly triangular, in the center, its lower edge chiseled to a point to fit in the spandrel between the two small arches. The remaining space was filled with a simple pattern of brickwork laid in a heavy bedding of mortar. Even where the original scheme had completely disappeared on the outside face, as in the south window, the arches were found to be preserved halfway through the thickness of the wall, including even the facing of the soffit, which was a coating of creamy white plaster, 0.01–0.02 m. thick, with much straw (Pl. 6, b, c).

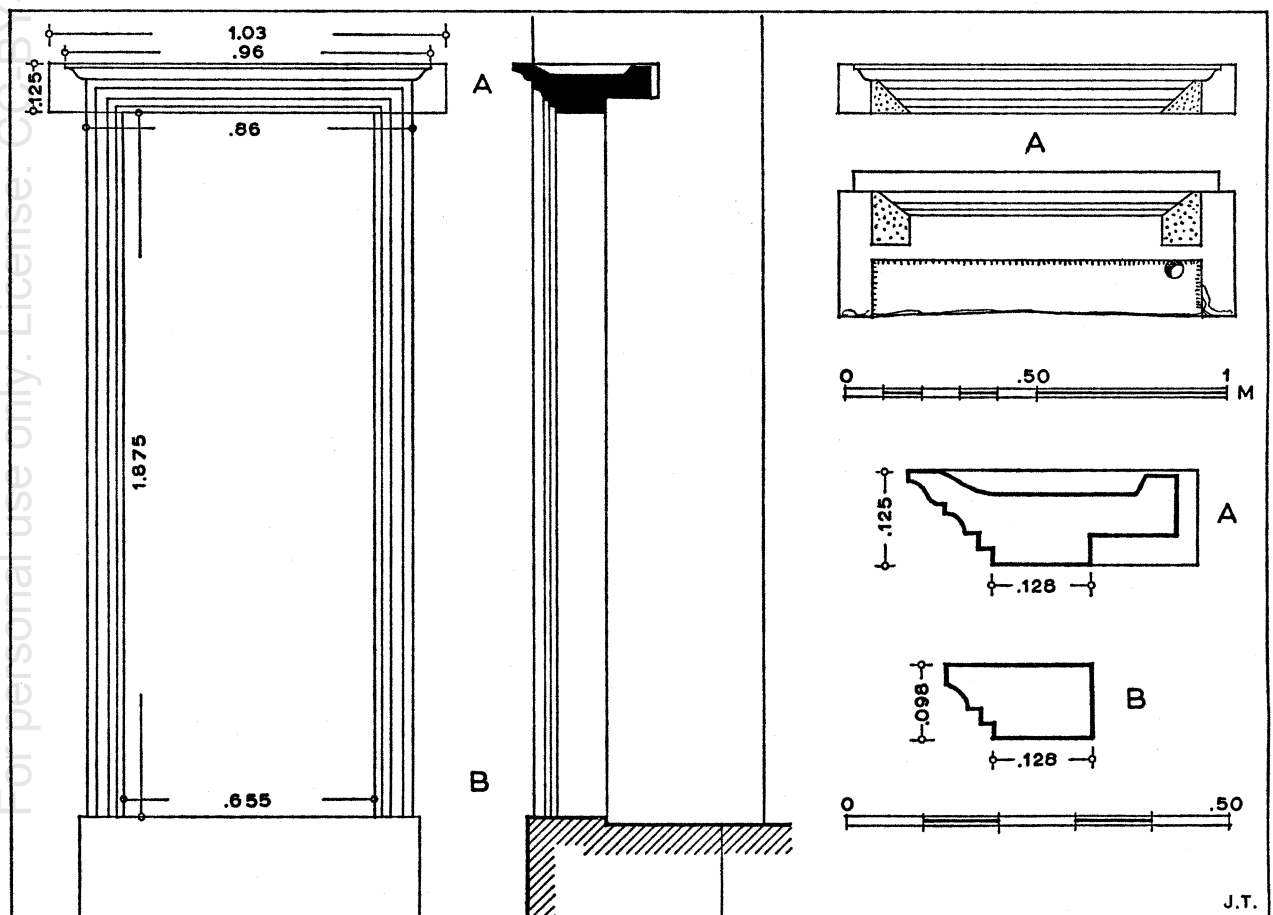
Fig. 5. Door Frame of Period I

The doors were framed by moulded jambs and lintels of Pentelic marble, of which many fragments were found in and about the church. A lintel, found intact, built into the later masonry, corresponded in size to the indications of openings in the foundations and could be assigned to one of the smaller doorways (Pl. 15,f). Several fragments joined to make one complete jamb, chiselled at the upper end to fit the cuttings in the underside of the lintel. It was thus possible to establish the height of the small doorways at 1.875 m. and their width as 0.655 m. (Fig. 5). The width of the central doorway was fixed by the threshold at 1.30 m. In the absence of definite evidence its height was restored by analogy at 2.10 m.

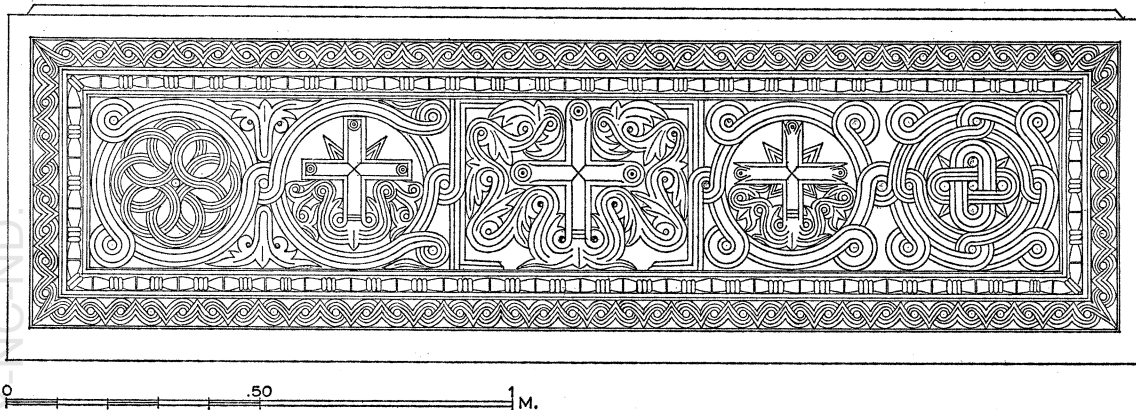
Fig. 6. Sarcophagus Front, Restored Drawing

An elaborately worked sarcophagus front of the Middle Byzantine period (Fig. 6; Pl. 10,e) which was found not far from the church has now been placed in the position of the arcosolium.²³ It is well known

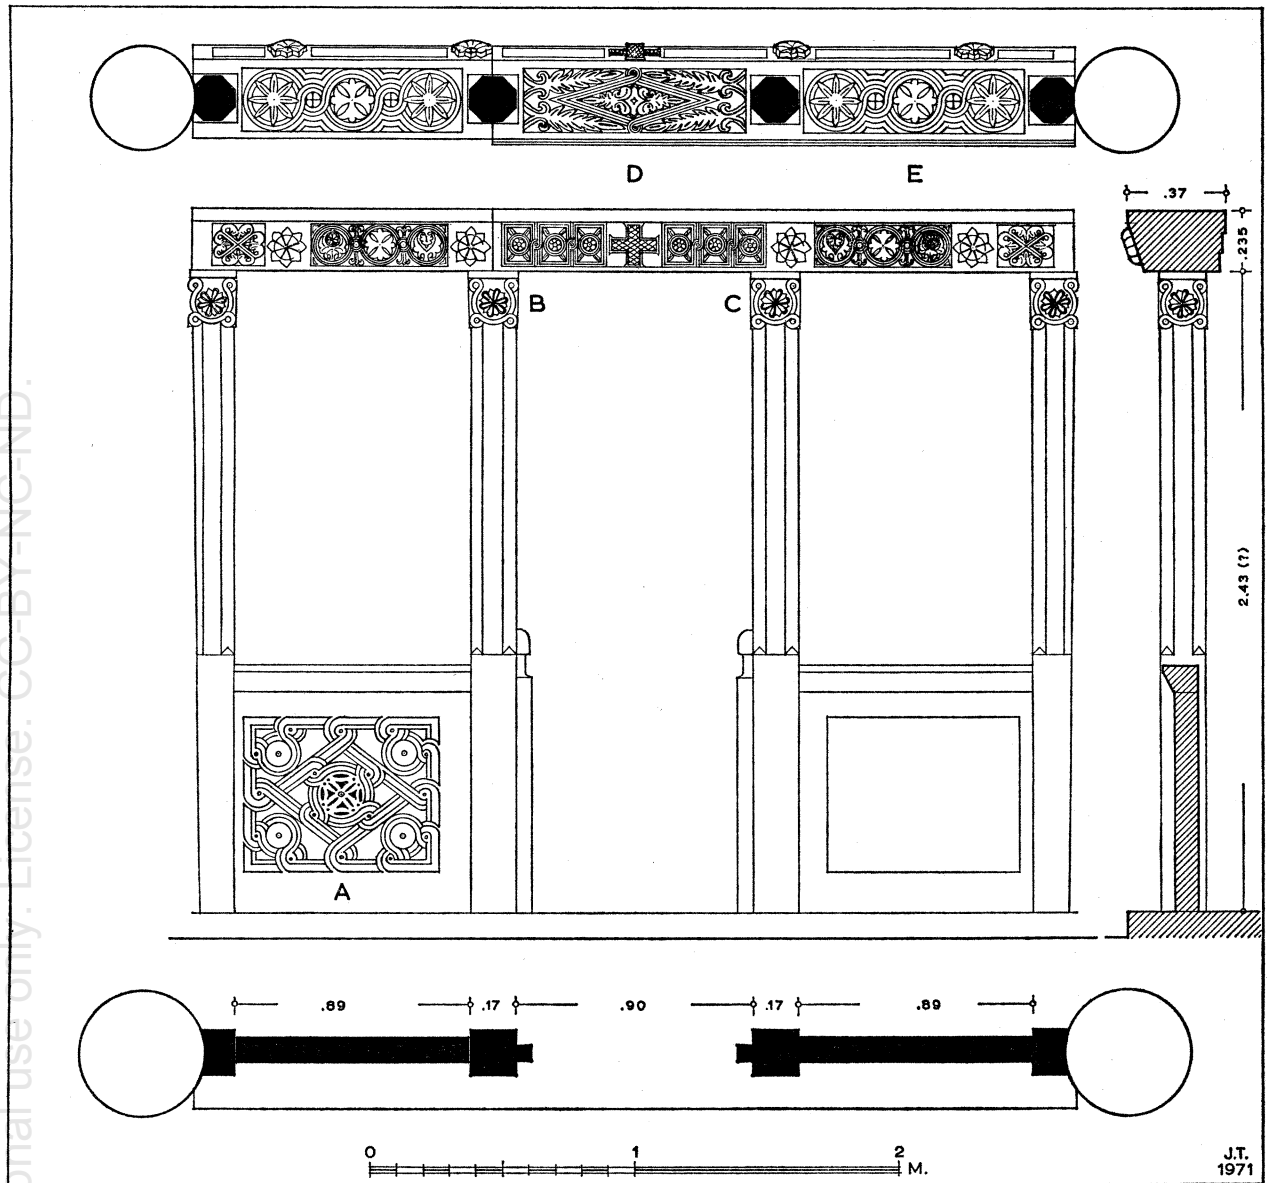
Fig. 7. Iconostasis, Restored Drawing

Part of the foundation for the iconostasis was found between the two east columns. It consisted of a limestone block on a rubble bedding, on which was a narrower marble block, badly broken. Many fragments of all the members of the iconostasis itself: columns, epistyle blocks, and closure panels, were found built into the masonry of the two latest periods, in the loose fill in and around the church and in the building material taken from the demolition of modern houses in the vicinity. The screen apparently survived up to Period III, when the fragments first appear in the masonry of the church. The largest piece, the greater part of the closure panel (A; Pl. 11,e), was built into the northwest corner of the foundations of Period IV together with a piece of the epistyle (E; Pl. 11,c,d); a piece of the epistyle (D, 1) was built into the later phase of the northwest pier (Period III) and a large joining piece was used as part of the cover of Tomb 2 (D, 3). Another came from debris inside the church (D, 2) and a small fragment of the braided cross (D, 4) was found in the earth just behind the iconostasis where it fell as it splintered off when the rest was dismantled (Pl. 11,a). The largest piece of one of the columns (B) was built into the foundations of the modern iconostasis (Pl. 11,f) while a smaller piece of a column (C) came from the demolition of neighboring houses. Both pieces of the epistyle (Pl. 11,a-d) were made from an Ionic architrave of the Roman period, at least 2.20 m. long. The three fasciae were visible from inside the sanctuary. All of the pieces have been built into the restored iconostasis (Fig. 7; Pl. 26).

The general scheme of the decoration of the iconostasis is typical of the Middle Byzantine period. Panels with a combination of interlaced rectangle, rhomboid, and circles have been found in many places²⁵ and of varying degrees of complexity, but these variations are apparently without regional significance and they have not been sufficiently studied to afford precise chronological criteria. In the simpler forms the rhomboid is connected to the enclosing rectangular frame only at its corners, where it meets the frame at mid point in each of the four sides. The circles filling the corners are linked to the rhomboid but not to the frame, and the center of the rhomboid is occupied by an unconnected rosette, as, e.g., in a panel from the Moni Petraki in Athens (Pl. 11, i)²⁶ and some of the panels in the windows and gallery of the

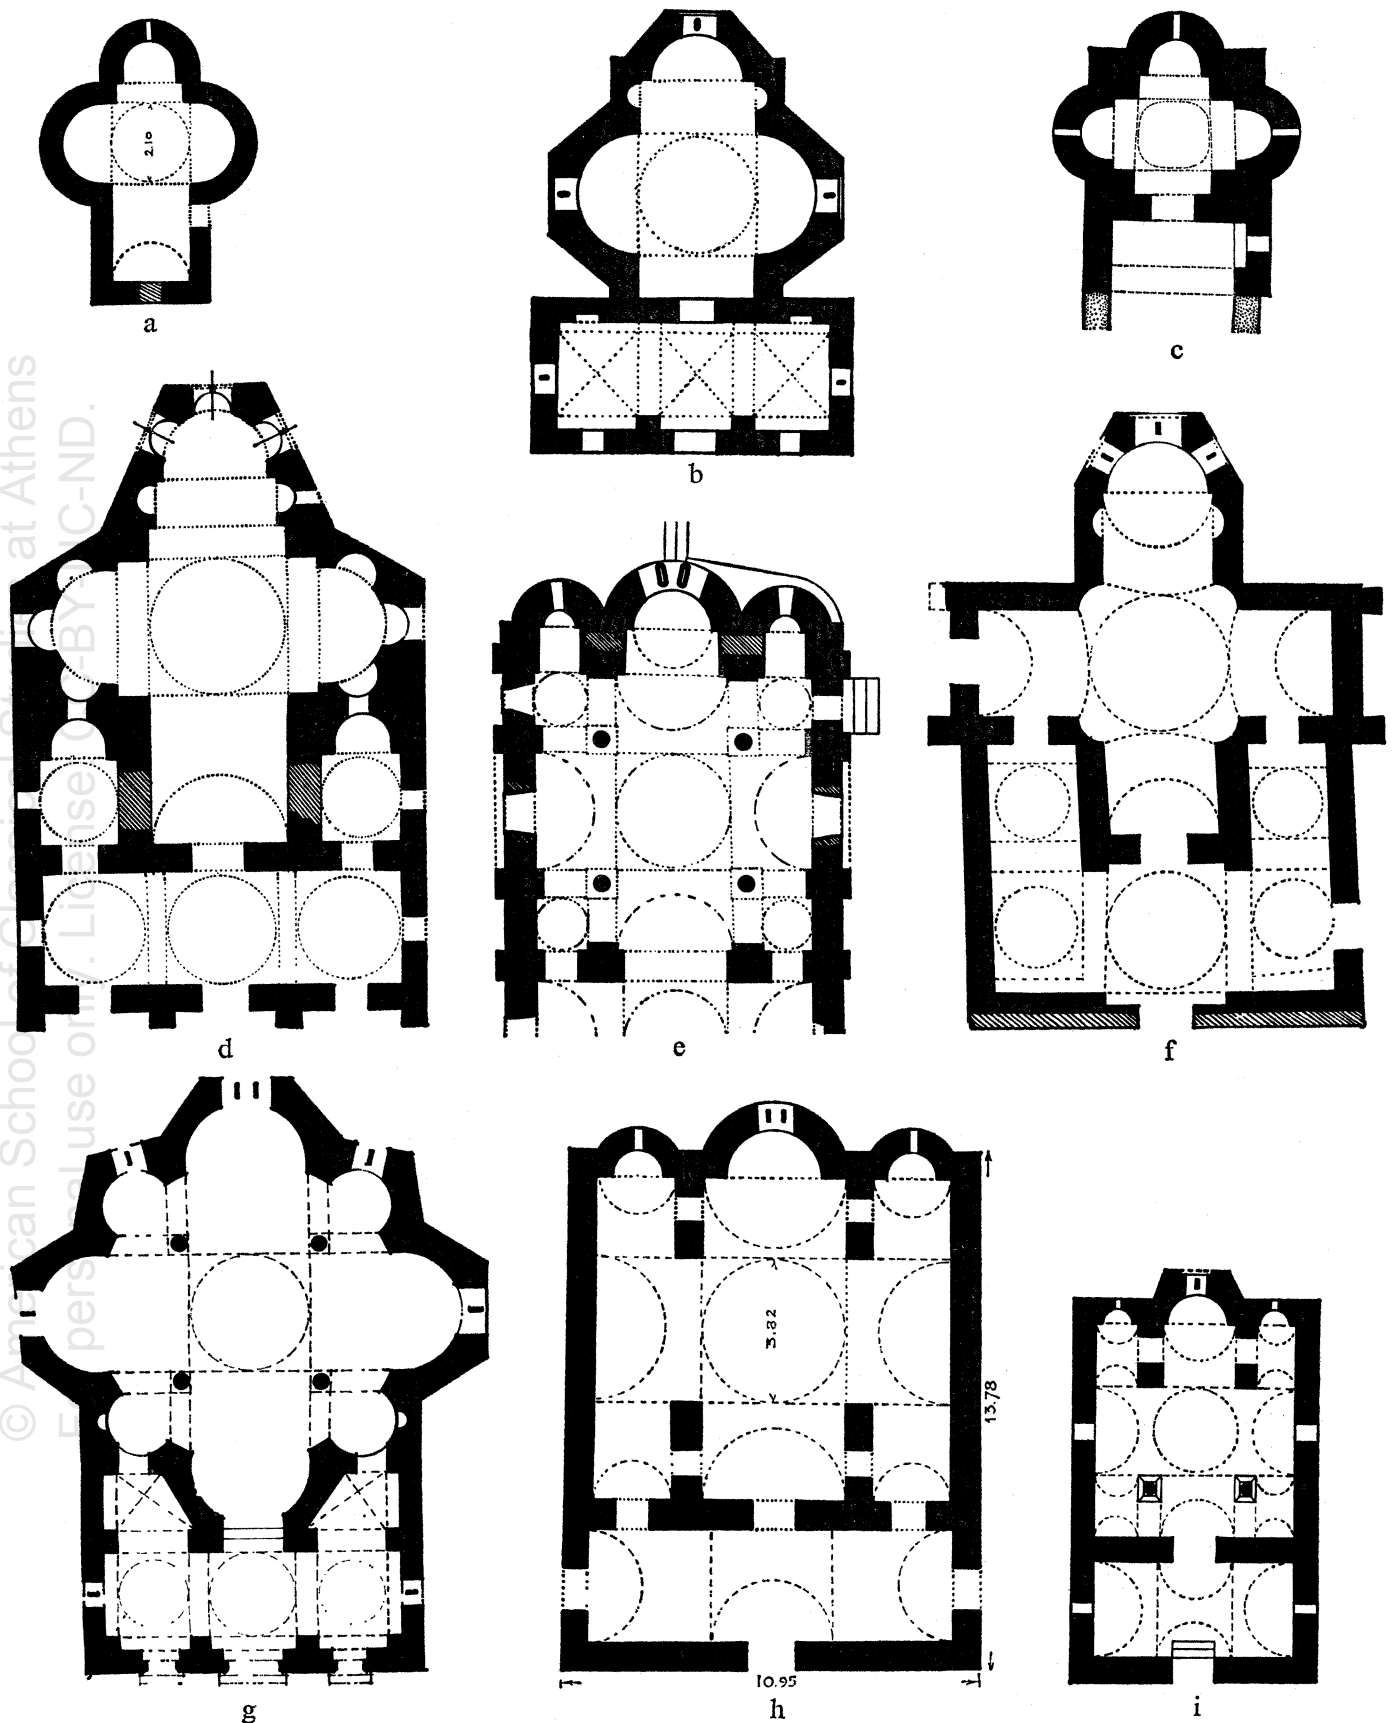
Fig. 8. Churches in Greece. a. Methana, St. Nicholas. b. Platani, St. Nicholas. c. Kastoria, Koumbelidiki. d. Varasova, St. Demetrios. e. Athens, Moni Petraki. f. Manolada, Palaiopanagia. g. Athens, Holy Apostles. h. Gavrolimni, Panaxiotissa. i. Arta, St. Nicholas 'Ροδιῆς. (1:200)

A more successful approach was taken by the architect of the now ruined church of St. Demetrios at Varasova, on the Gulf of Corinth,⁷ a much larger building (*ca.* 16.50 × 11 m.; Fig. 8, d). As at St. Nicholas at Platani, a narthex was added against the western vault, but here its connection was made less tenuous by continuing the north and south walls eastward to merge with those of the north and south apses, thus avoiding the creation of awkward open spaces such as are found at Platani. The western vault of the church proper was longer than that at Platani and the larger spaces enclosed to either side were made into small rectangular chambers entered from the narthex, each having a small semicircular niche on the east side. The niches looked into the north and south apses through small arched windows.

Although the general effect of the church at Varasova was more harmonious than that offered by St. Nicholas, circulation between the narthex and the rest of the church was improved not at all, for there was no communication between the small lateral chambers, which perhaps served as chapels, and the church proper.⁸

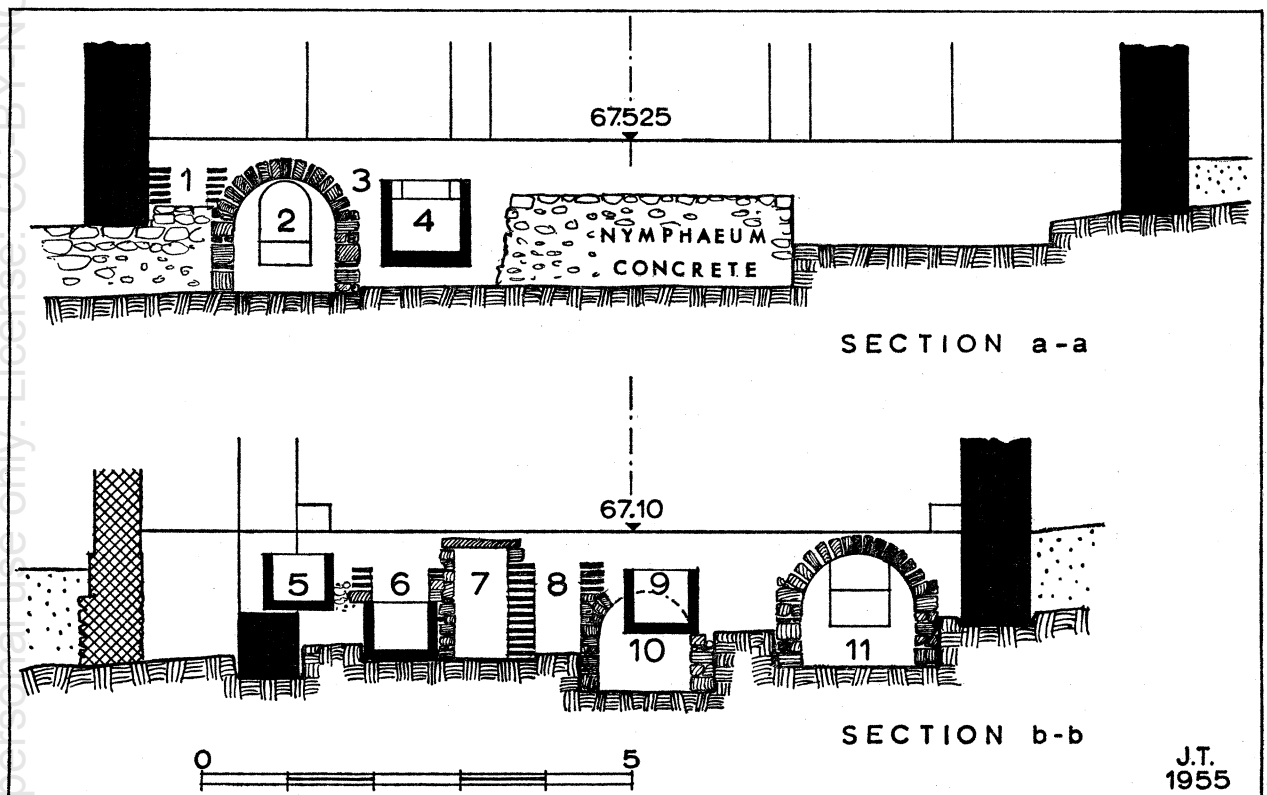
Fig. 9. Sections through Church Proper and Narthex, showing Tombs

A considerable part of the interior of the church was occupied by tombs and burials, i.e. the central part of the church proper and the western bays of the narthex (Fig. 9; Pls. 15, 16, 28). In addition, two vaulted osteothekai were constructed immediately to the west of the narthex, in the space later enclosed by the exonarthex, and another to the north, just outside the later addition. With one possible

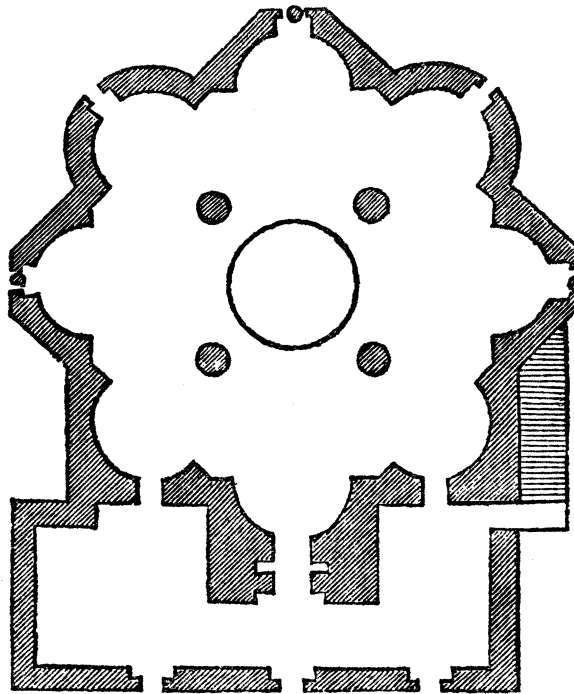
Fig. 10. The Holy Apostles. Plan by A. Lenoir (1836).

The next phase can be reconstructed from internal evidence, aided by the plan published by Lenoir (Fig. 10).² A cannon ball found in a tomb in front of the western apse³ indicated gunfire as the probable

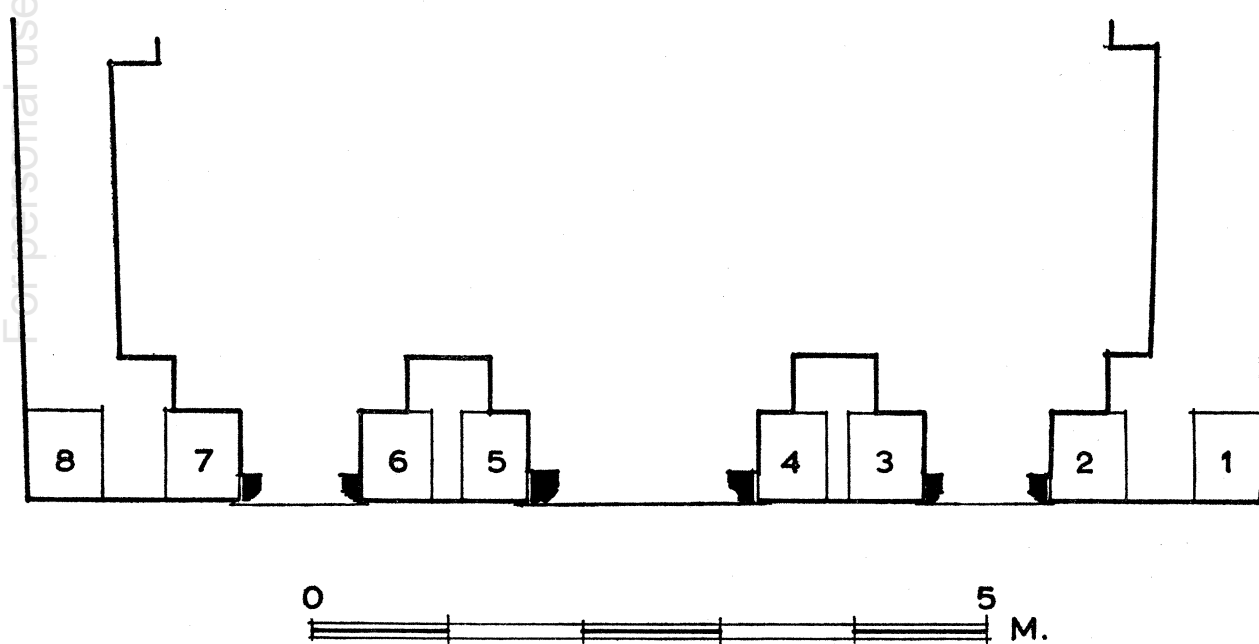
Fig. 12. Position of Orthostates in West Wall.

To learn what happened to the original west wall during the successive periods of rebuilding it will be most convenient to begin with the state in which it was uncovered and track its history backward. As discovered, almost immediately under the tiled floor of the latest period, the top course consisted of two large ancient blocks (Nos. 7 and 3) which had stood as orthostates in the wall¹⁶ and had been carefully tipped over from their positions at the north sides of the north and south doorways respectively (Fig. 12). Their

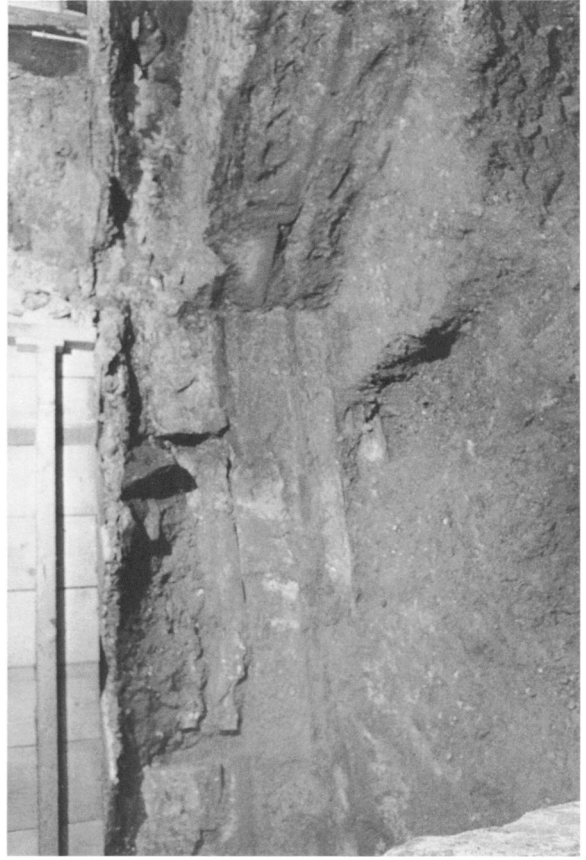
c. Junction of West Apse and Adjoining Wall.

The problem of the ground plan was quickly solved by excavation (Pls. 28, 29), which proved both of the opposing schools of thought right in some degree. Not far below the paving were uncovered the foundations of a fourth apse corresponding to the three already visible, but provided with a doorway (Pl. 3, a). At the same time it was clear that the western apse had always been surrounded by a narthex, the extent of which was fixed by the foundation for a crosswall connecting the north and south walls, which came to light 2.65 m. west of the west face of the apse (Pl. 3, b). Two courses of masonry were preserved above the ground level of the apse; they were of cloisonné, but simpler and rougher than that used elsewhere in the building. The foundations were well bonded into the adjacent walls (Pl. 3, c).

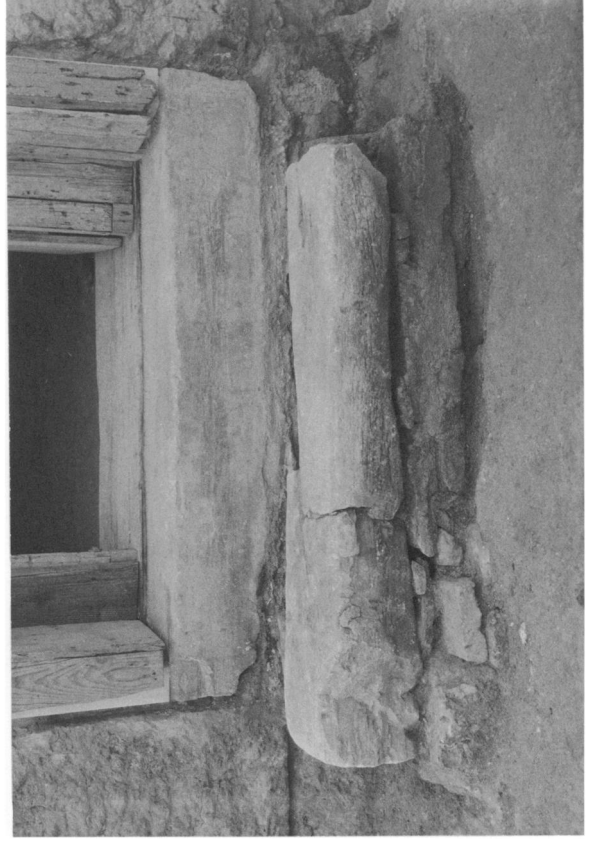
d. Original Step Block in Place.

In the interior all apses and angle chambers are semicircular, and a semicircular niche, subsequently blocked up, was sunk into the opposing wall of each of the western angle chambers. Entrance to the church was provided by a large central doorway in the west wall of the narthex, flanked by two narrower openings. The original step block was found in place in front of the middle door (Pl. 3, d).

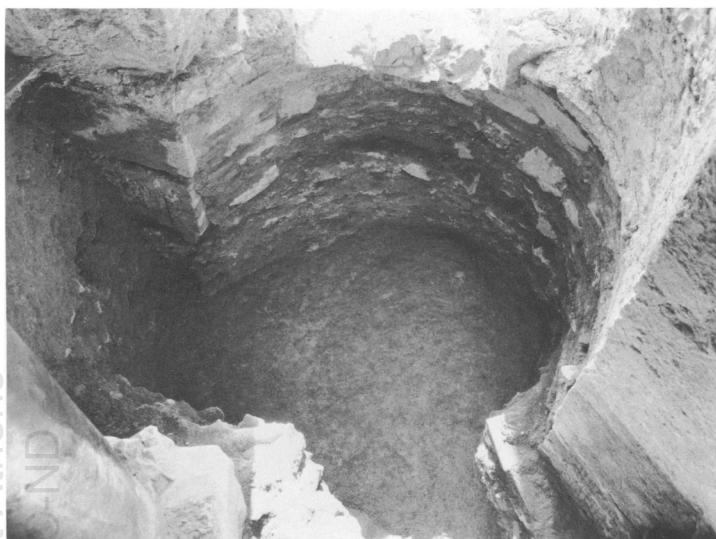
a. Foundations of Northwest Angle Chamber, from Southeast.

The foundations consist of rubble masonry set in firm lime mortar (Pl. 5, a) and vary in depth from 0.75 to 1.10 m., the highest point being at the east. This is accounted for by the gradually rising ground level in this direction which prevailed at the time of the construction of the church and was adhered to in the junction of the foundations with the cloisonné masonry, whereas the bottom line was dictated by the level surfaces of the ancient monuments on which the building was bedded (Pls. 32, 33). The foundations were laid exactly on the lines to be followed by the walls, with both inner and outer surfaces already clearly defined, and with no extraneous connecting lines in the interior. The eastern half of the building, as noted above, was built over the foundations of the Nymphaeum, on the underpinning of its massive semicircular wall and on the heavy concrete bedding for its marble floor slabs, which had been plundered in antiquity (Pl. 2, a). This circumstance may account in part for the better ability of this section of the building to withstand the damage which resulted in the destruction of the west end.
