ARCHITECTURAL STUDIES

I. THE ROYAL STOA

IV. THE ZEUS STOA

VI. THE ALTAR

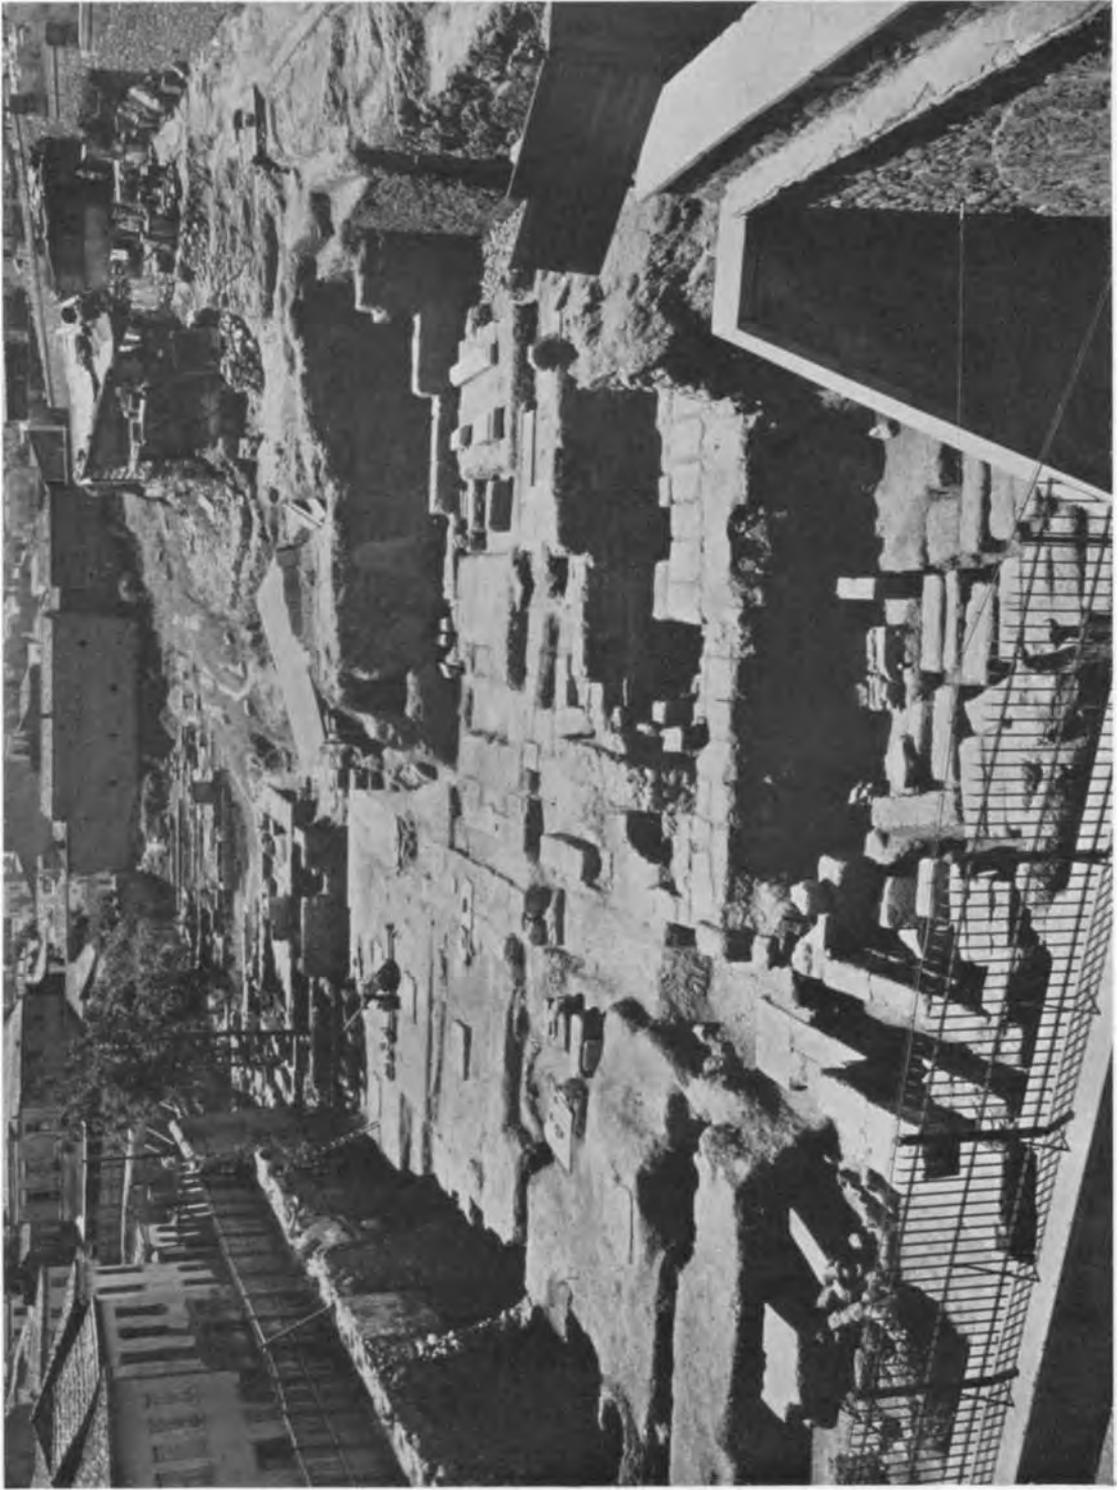
Fig. 1. View of the Royal Stoa from the North

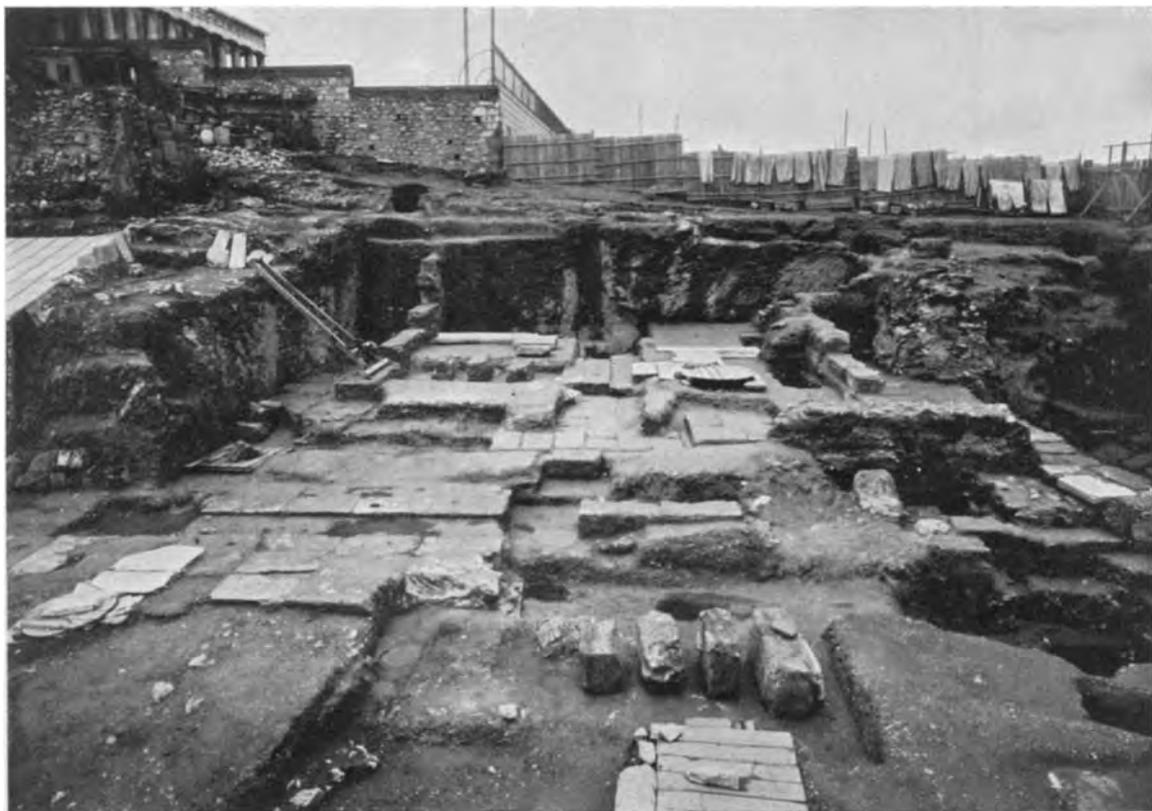
Fig. 2. Hellenistic Building behind Royal Stoa. View from the East

The building behind the stoa, dating from the third century before Christ, is a rectangle measuring 12.50 m. by 16.50 m., divided into two equal parts by an east-west wall. It is clearly an addition to the stoa, and apparently communicated with it, for there is no possible approach to the lower level of the smaller building save through the larger.

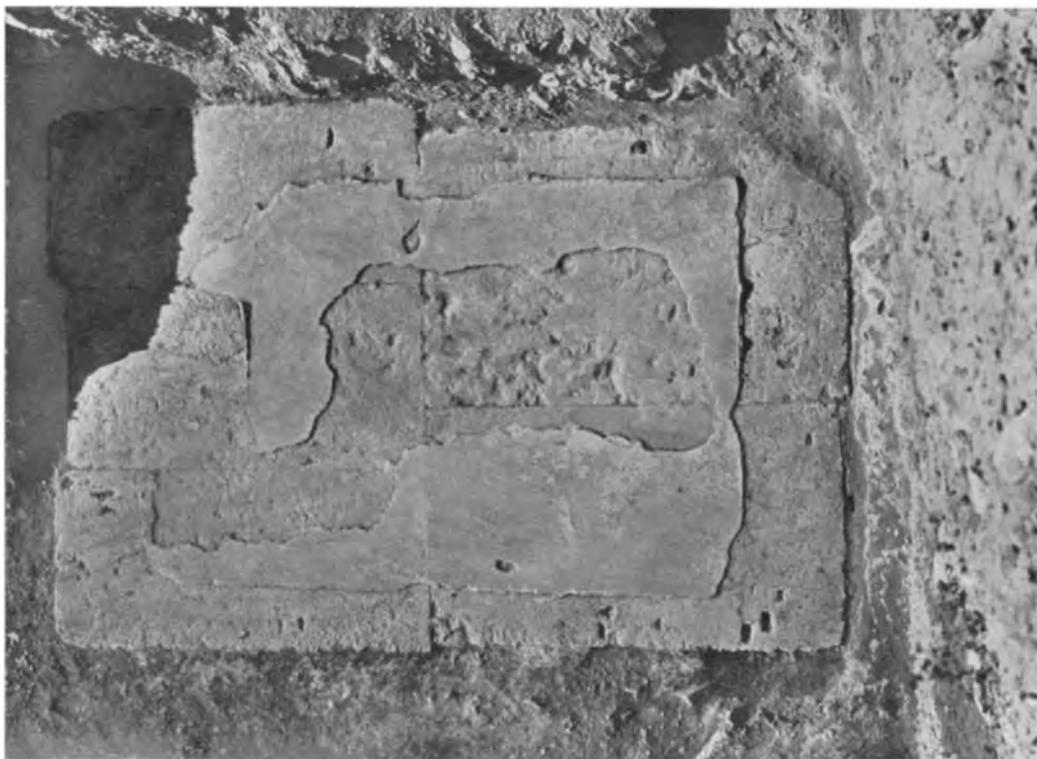
Fig. 3. Water Basin at South End of Royal Stoa

A large water basin (Fig. 3) measuring 1.80 m. \times 2.70 m. on the inside stood at one time immediately within the southern limit of the building. At present there are five large poros slabs on which the outlines of the basin may be traced by the presence of the hard waterproof stucco that originally lined it. At the west end of the basin the stucco turns up in such a way as to show the presence of a small pier against the centre of the end wall. This presumably was for a fountain. The floor of the tank is some 0.60 m. below the supposed floor level of the stoa, and if the tank remained open it would have been sunk in the floor. The line of the south stylobate cuts very close to the corner, and the orientation of the tank is not that of the stoa but is some degrees removed from it. It seems clear from the plan that the basin and the stoa were not contemporary,

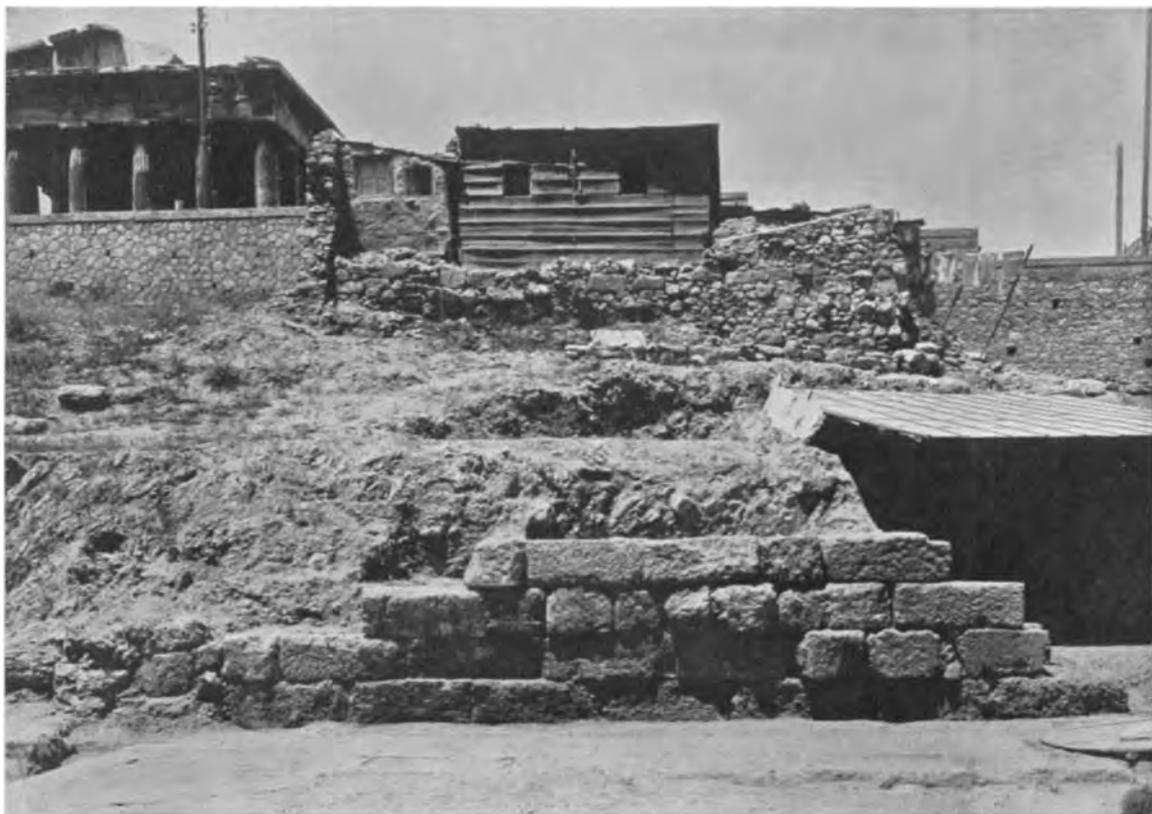
Fig. 4. Retaining Wall at South End of Royal Stoa

Parallel with the rear wall of the stoa, and about a metre further west, runs a retaining wall of squared but not faced poros and conglomerate blocks (Fig. 4). The wall begins just north of the south corner of the stoa, and is the continuation of a lighter wall, built of uncoursed pieces of Acropolis limestone. The conglomerate retaining wall is preserved four courses high at the south end, and breaks down as it extends north. For a distance of twenty-five metres it consisted of courses of headers and double stretchers, but the alternation of these in succeeding courses was not observed, that is, the same course will contain headers and stretchers, all save the lowest course which consists solely of stretchers. Where the wall crosses the front of the Hellenistic building some of the blocks have been removed, five from the west face of the wall, and one from the east. The two remaining blocks on the west side of the wall seem to have been left for some purpose in connection with the Hellenistic building, and it may not be purely a coincidence that they would serve to give foundations for an opening made from the stoa into the southern chamber of the addition. The northern part of the retaining wall has been much overbuilt by later construction. A section, four blocks long and two high, remains where the wall passes beyond the line of the Hellenistic structure. The west face of the upper stones has been cut down leaving a projecting lip at the bottom, and the blocks retain traces of red stucco. A cutting in a block that forms a corner indicates that at some time a small, very poor building was made here.

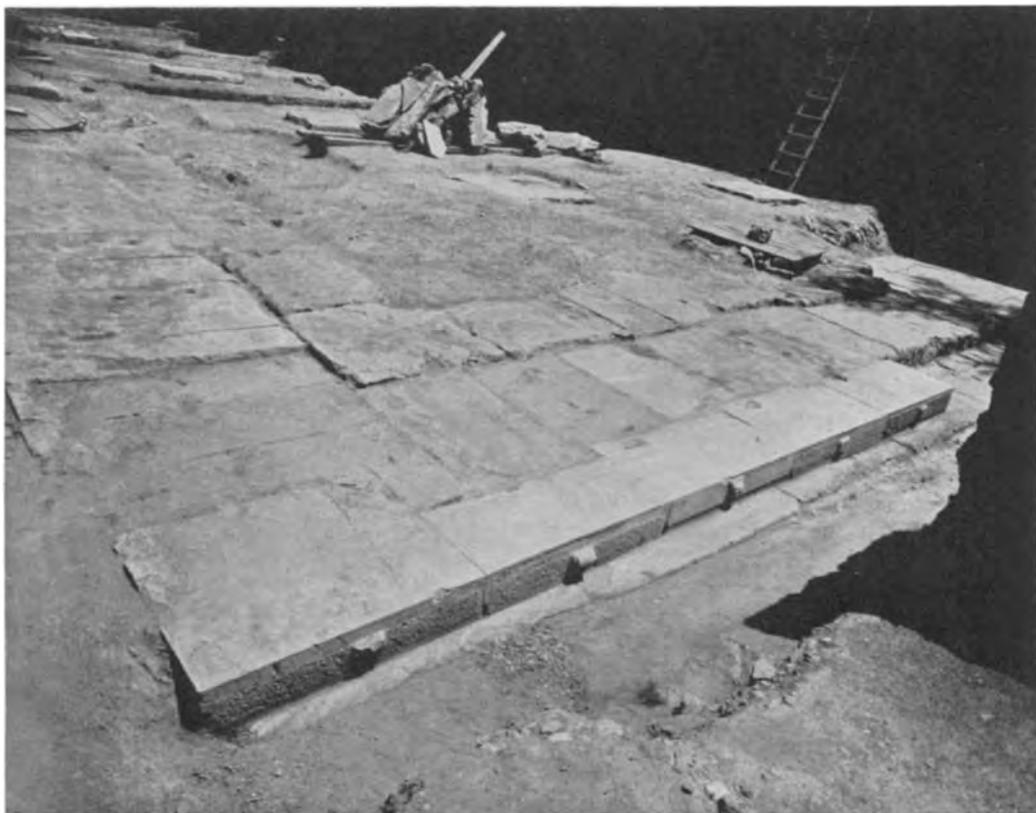
Fig. 5. View of Step at South End of Royal Stoa

At the south end of the building (Fig. 5) the poros foundation blocks, coursing with the marble step-euthynteria, were originally laid 1.25 m. wide. A rabbet 0.20 m. wide was then hacked in their upper front face, and an additional course of poros, 0.50 m. in width, was laid south of the main course so as to provide a foundation for the marble step. This rather haphazard form of construction is a little startling in a building of the date to which we must assign the Royal Stoa. The marble step was then laid, the first four blocks counting from the west being of blue Hymettus marble, and the fifth of white Pentelic. Again the discrepancy is disturbing. The steps were not dowelled to their foundation, nor clamped against it, but evidently it was thought that the double dowelling of the next marble course would afford sufficient bond. One dowel of the next course occurs in the marble step and is matched by another in the poros foundation. The faces of the steps were never finished. They still retain their lifting bosses, and all but one of the steps show merely a roughly picked protecting surface, with a slight smoothing around the edges done with the chisel. The remaining block, the third from the west, is better finished and shows a drafting on its lower edge, 0.055 m. high and 0.005 m. deep. The lower corners of several of the blocks are chipped in such a way as to make a satisfactory finish impossible, but inasmuch as it seems to have been the intention to cover the face of this course, it presumably did not matter. That this course

was never entirely covered, but that the ground level came up very nearly to the upper edge of the blocks, is shown by the wear that can be distinctly seen on the upper surface, and the rounding down of the actual front edge of the course. The fill which was densely packed against the face of the blocks contained pottery that could not date later than the second half of the fifth century B.C.

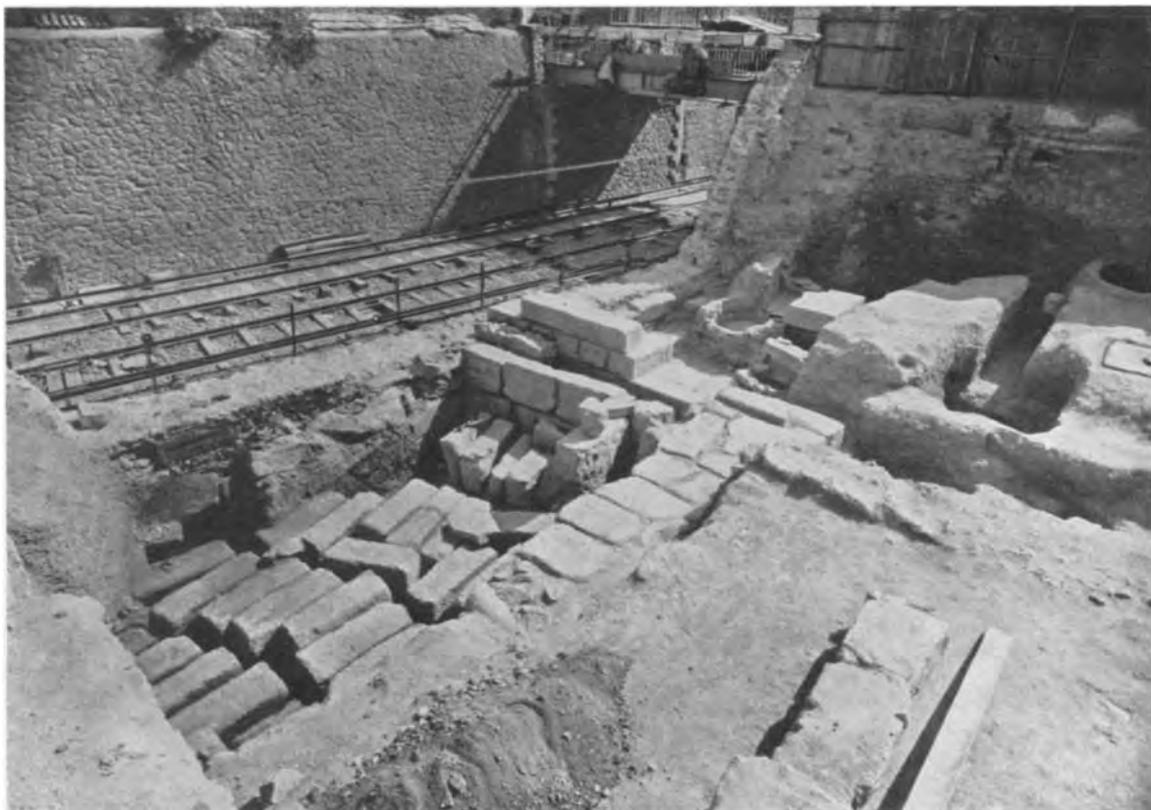
Fig. 6. The Rear Wall of the Royal Stoa near the North End of the Area

Behind the fifth interior column the foundation becomes deeper (Fig. 6). From two courses it changes to four, and later to five, and it is bedded on the friable rock that underlies this area. Two blocks which belong to the upper course of the foundation remain in place at the north end of the area. The level is maintained very accurately, there being a difference of less than one centimetre in the whole length. As might be expected, the underlying courses are laid alternately as headers and stretchers and show anathyrosis throughout. No clamps or dowels occur save in the top course. The close fitting joints of courses three and four below the top are distinguished by being roughly bevelled, generally on one side of the joint only, and the faces of the blocks have been picked roughly to a plane surface, not always perpendicular. The top of course III (counting down) shows a setting line less than five centimetres behind the average face of the blocks. To this line are set the headers of course II, the southern corner of whose blocks has been drafted so as to give a surface for alignment. The upper and lower edges of this course have been worked so as to produce an approximately straight line 0.02 m. outside of the setting line. This is not a drafting but rather a bevelled cut, done with a chisel.

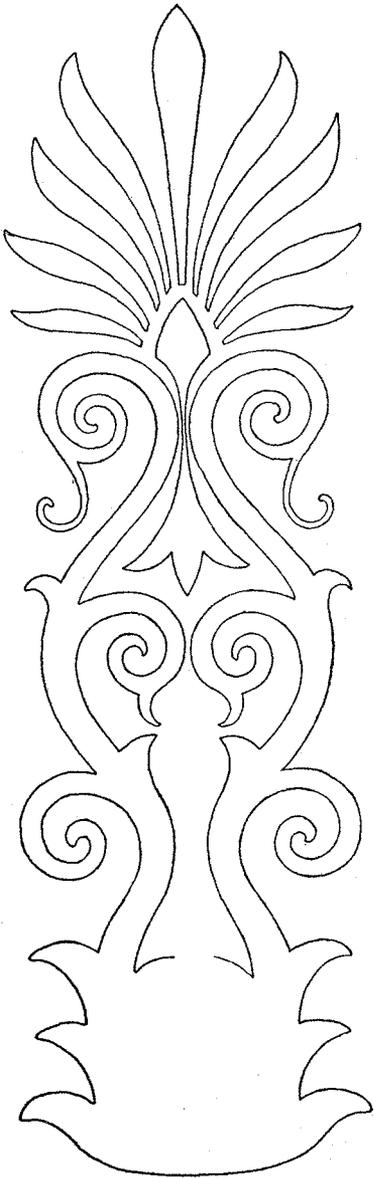
Fig. 8. Palmette from Via

fragments, were probably of terracotta. The most interesting feature in the way of decoration is the painting of the viae, which are adorned with palmettes of the flame

type, issuing from scrolls which in turn spring from an acanthus leaf. The design, somewhat restored on the basis of other fragments found nearby and belonging to the same order, is illustrated in Fig. 8. These palmettes were scratched in outline on the marble and the background was painted red. Whether the ornament itself was colored does not appear. It is clear that the design was applied before the block was hoisted into place, for the via on one side of the block has been worked down nearly a centimetre in order to make the block fit, and the anathyrosis has been recut. This entailed the slicing off of the sides of the scrolls. The band behind the viae was painted red, the mutules show traces of blue color, and the bedmold¹ is decorated with a leaf and tongue done in red, green, and presumably gold. Although no trace of the actual gilt remains, the marble where it was applied has been stained a blackish color, not to be confused with the traces left by black paint. The character of the stain is that which would be left by metal. The soffit of the bedmold where it projected slightly over the metopes was red. The guttae were probably also colored, for each gutta bears an incised circle on its lower face, some three millimetres from the edge. What color was applied here does not appear.

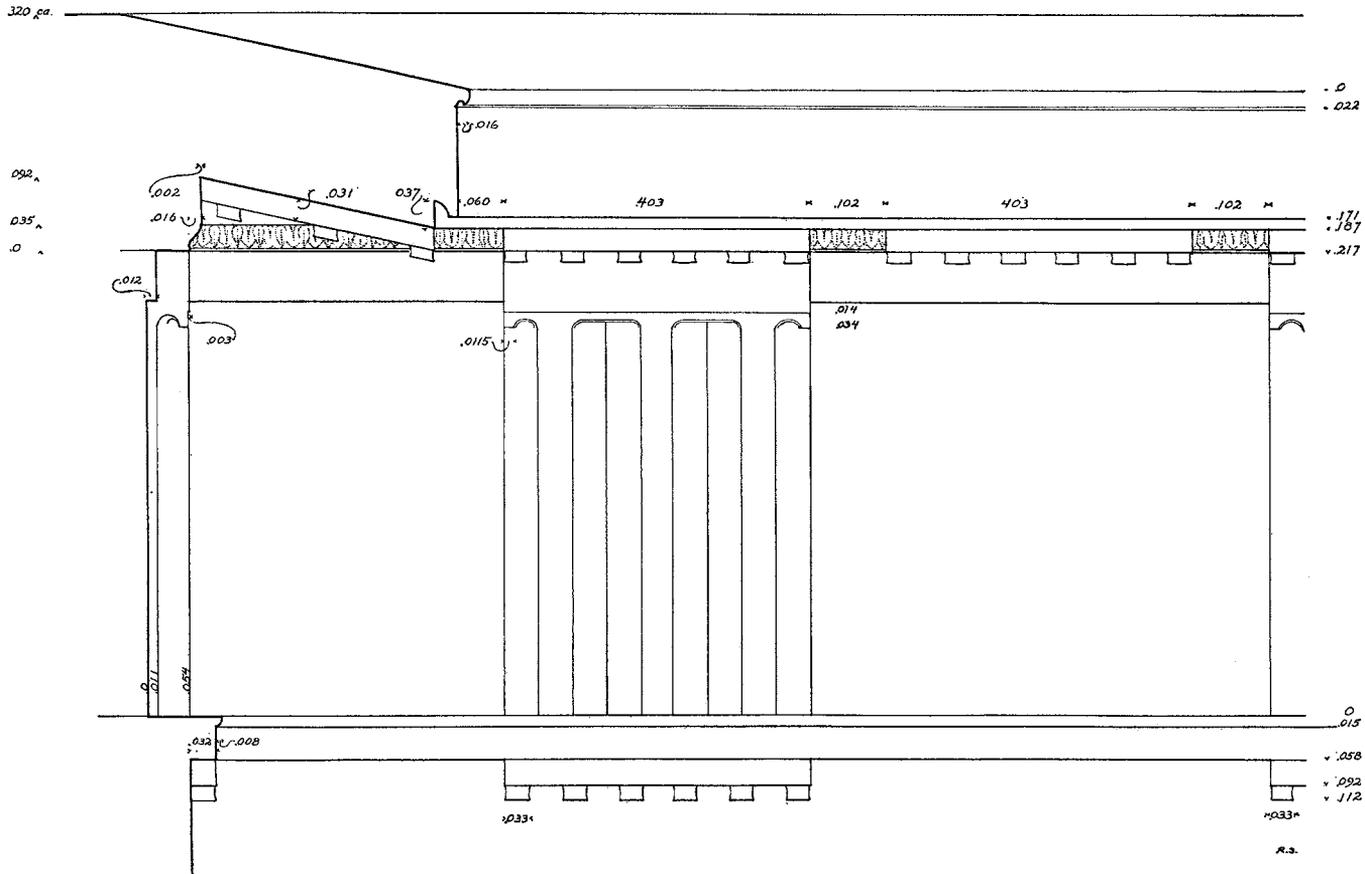
Fig. 9. Restoration of Entablature

Frieze (Fig. 9)

the building. The stone is the typical granular Aiginetan poros. These can be restored to make a triglyph ca. 0.40 m. wide, which corresponds to the width of the mutule. The treatment of the corner bevel of the triglyphs is shown in the cut, as are the details of the cutting for the metope slabs. It is not possible at present to recover the height of the frieze.

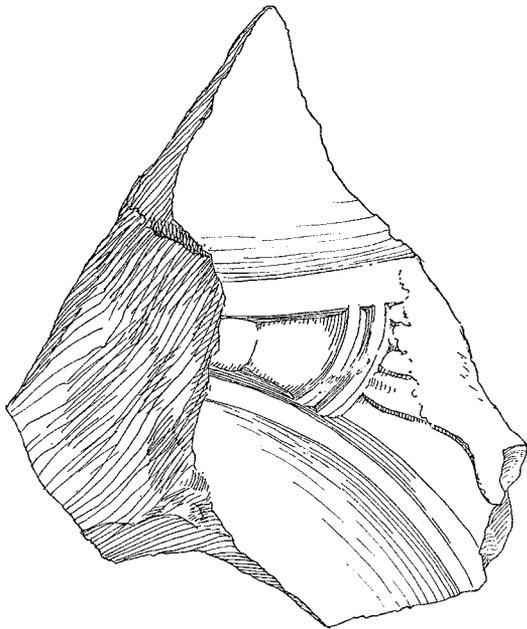
Fig. 10. Fragment of Volute

It might be presumed that the interior order of this stoa was Ionic, and the finding of three chips of an Ionic capital and some bits of fluted column with flat arrisses confirms this supposition. The first piece (Fig. 10) is from the angle formed by the horizontal part of the volute band and the curve of the volute. Here is a delicately carved palmette springing from a calyx with a double rim. The height of the capital is not obtainable. The echinus, where a small corner shows, seems to have been plain and not carved. This is borne out by the second fragment (Fig. 11) that clearly comes from the echinus, and has painted on it a tongue-shaped leaf with a double border and a central spine. The leaf has a double border, the inner one plain, and the outer painted

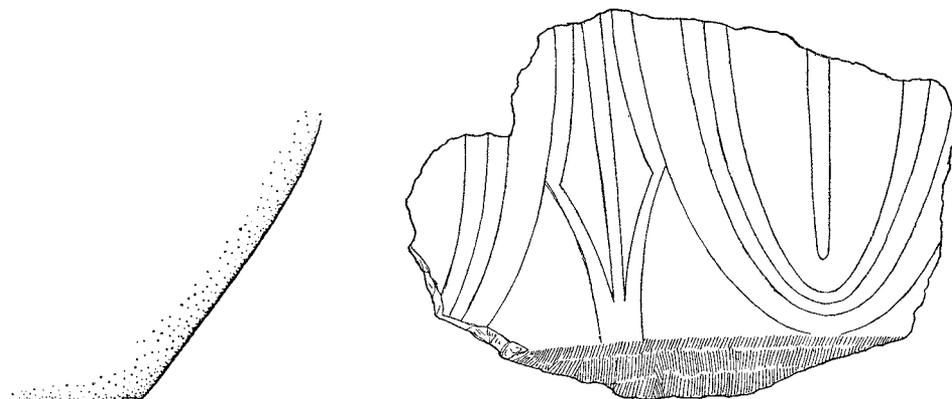
Fig. 11. Fragment of Echinus of interior Order

the rather bad weathering of the piece it is difficult to tell. This gives us the information that the columns were fluted, at least in part, and that the astragal measured 0.02 m. and the fillet below it 0.013 m. in height. The upper diameter, exclusive of the fillet and astragal, would be about 0.60 m.

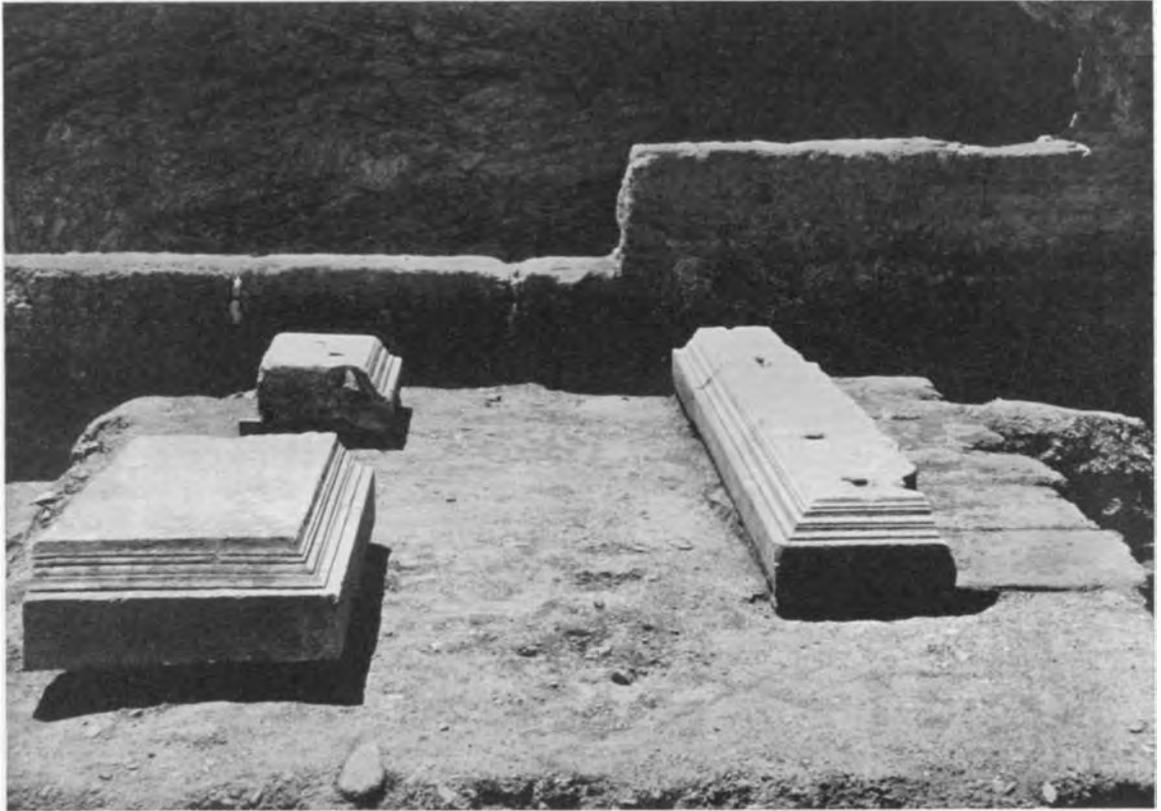
Fig. 12. Marble Base Blocks in Hellenistic Building

fully laid, with their tops nearly at the same level. They rest partly on earth, partly on the projection of the broad foundation. A cutting on one of them may indicate a step to a sill in a door between the two chambers. On the north of the median wall five blocks remain, also resting partly on the foundation and partly on dirt. These are much better joined, and are brought to a level surface some 0.06 m. below the top of the

central course. Presumably these two flanking rows of blocks represent the foundations of seats that ran around, or at least partly around, the two chambers. From the eastern wall of the northern chamber two poros blocks 0.70 m. wide project one metre into the room. They course with the euthynteria of the building and are only 0.27 m. high. Like the blocks that flank the median wall they rest partly on the foundation and partly on earth or rock. From their position, spaced centrally on the end of the chamber and 2.15 m. apart, they may be supposed to be foundations for some objects set against the wall, though the nature of the objects is not revealed by any cutting on the upper surface of the stones. They could hardly have been very heavy, or the blocks would have had more of a foundation than they were given. Possibly a narrow gallery or balcony ran

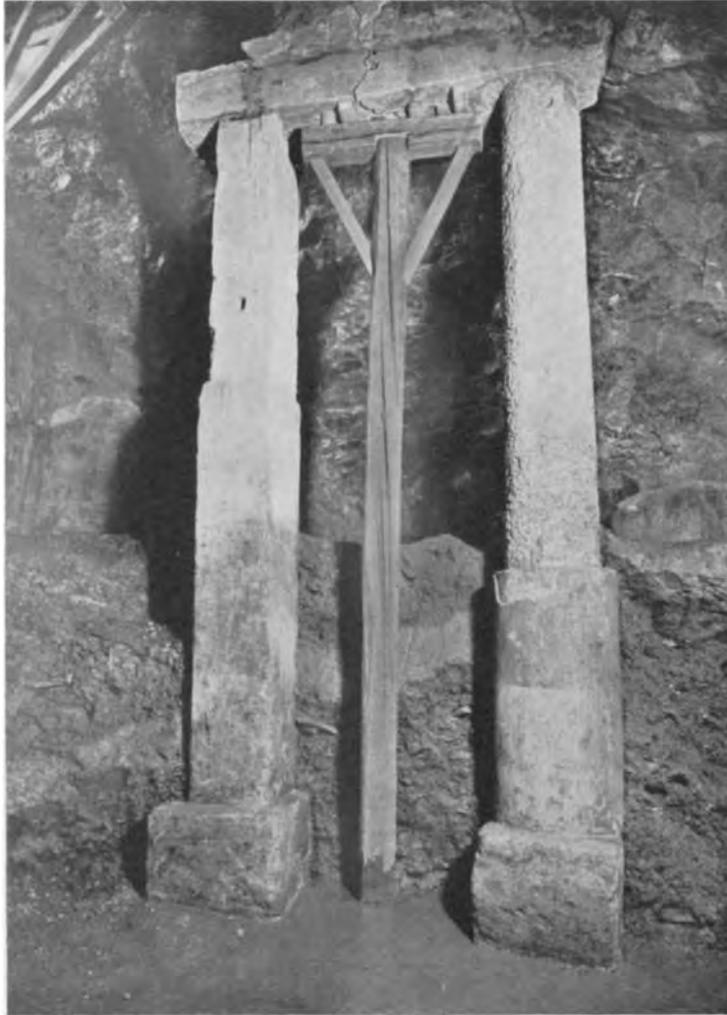
Fig. 13. Cistern in Sector A. View of the Interior

One of these double cisterns lies in the angle between the back wall of the stoa and the south wall of its late annex. Of the two chambers the southern is the larger, having a maximum depth of 6.37 m. and a lower diameter of ca. 5.34 m. This chamber was too large to be safe because of the faulty nature of the rock, and, therefore, it was found necessary to strengthen the ceiling by a lintel carried on a round column and a square

pier, built up, in part, of re-used materials (Fig. 13). Notwithstanding these precautions, a great mass of the eastern wall, facing towards the stoa, has fallen in. A short surviving section of a *poros* water channel leading into the cistern's mouth from the direction of

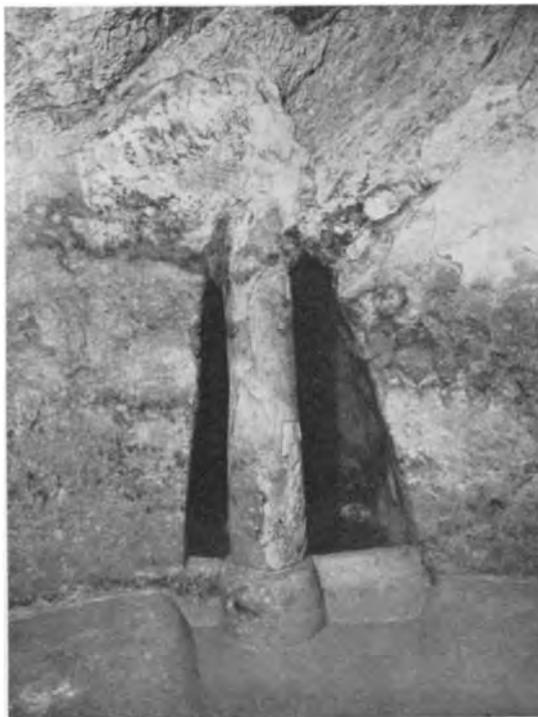
Fig. 14. Cistern in Sector A. Entrance to Side Passage

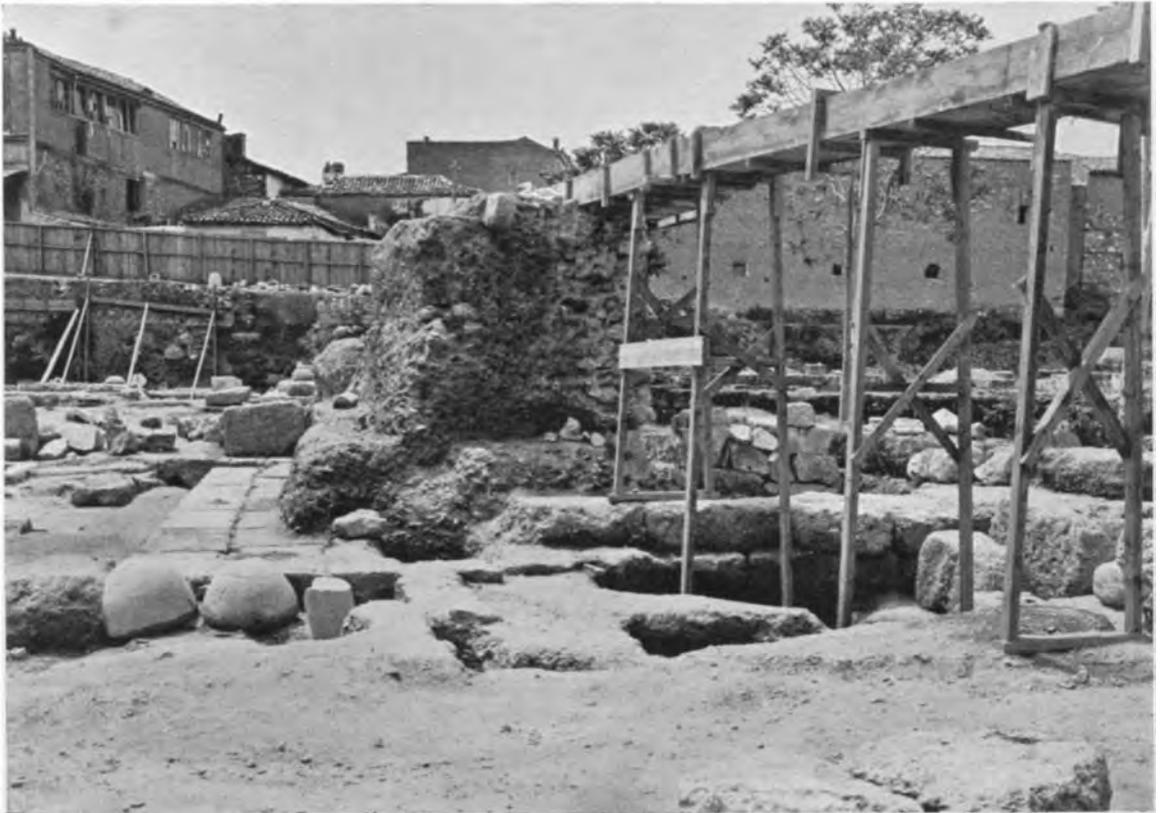
Fig. 16. North End of the Zeus Stoa

the finished level of the grade was being determined. In Roman times, at any rate, this course was visible at the north end of the stoa, where it returns for 2.10 m. to the west and then turns south against the end wall foundation. No setting line can be traced, but from the weathering it seems that the euthynteria was set back some 0.07 m. from the face of the course below it.

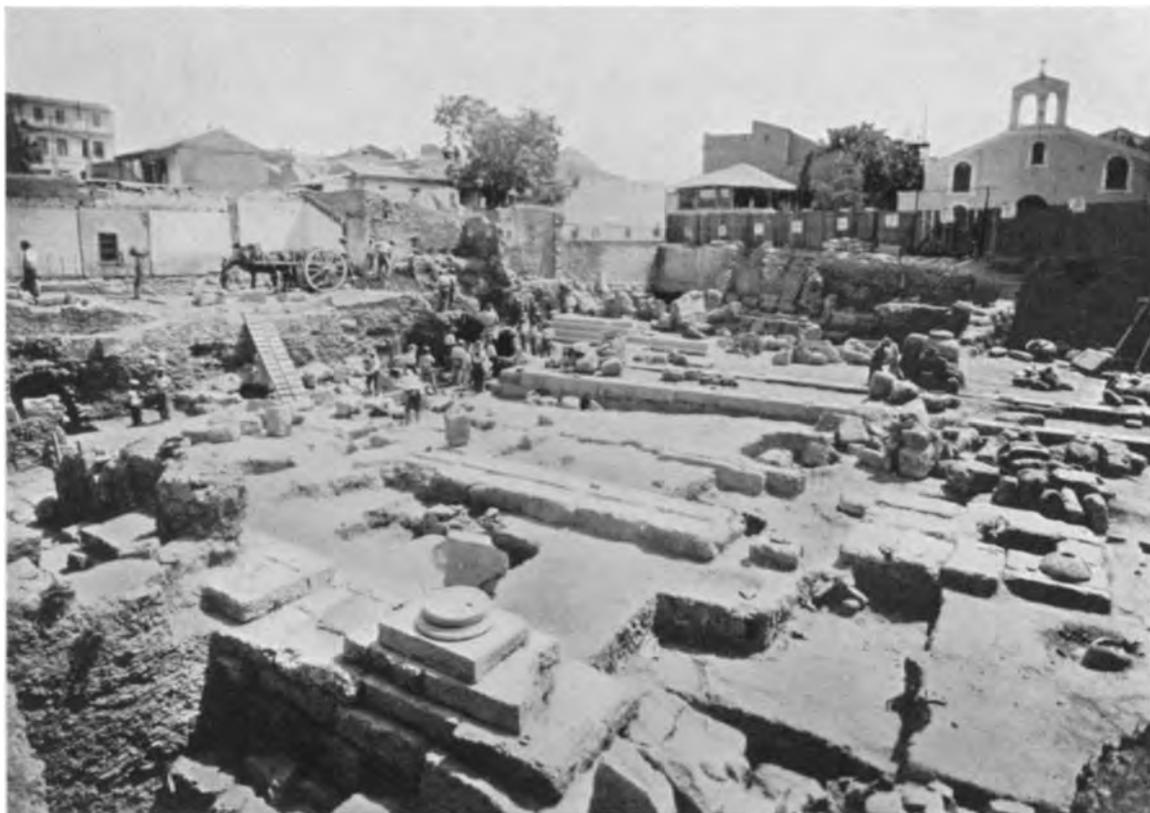
Fig. 17. Zeus Stoa. View of Base *in situ* from the West

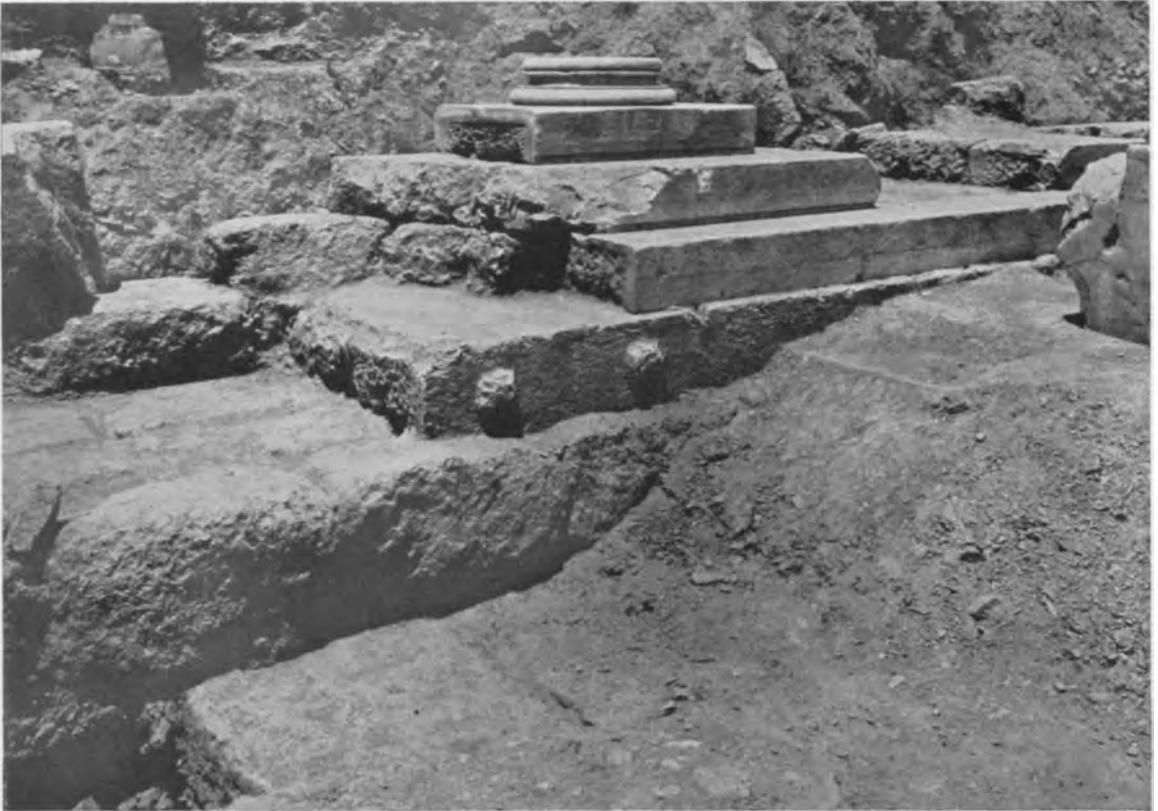
Fig. 18. Zeus Stoa. View of Base from the East

chisel and is picked above. There is no projection of one surface beyond the other but the difference in working is clearly visible (Fig. 18).

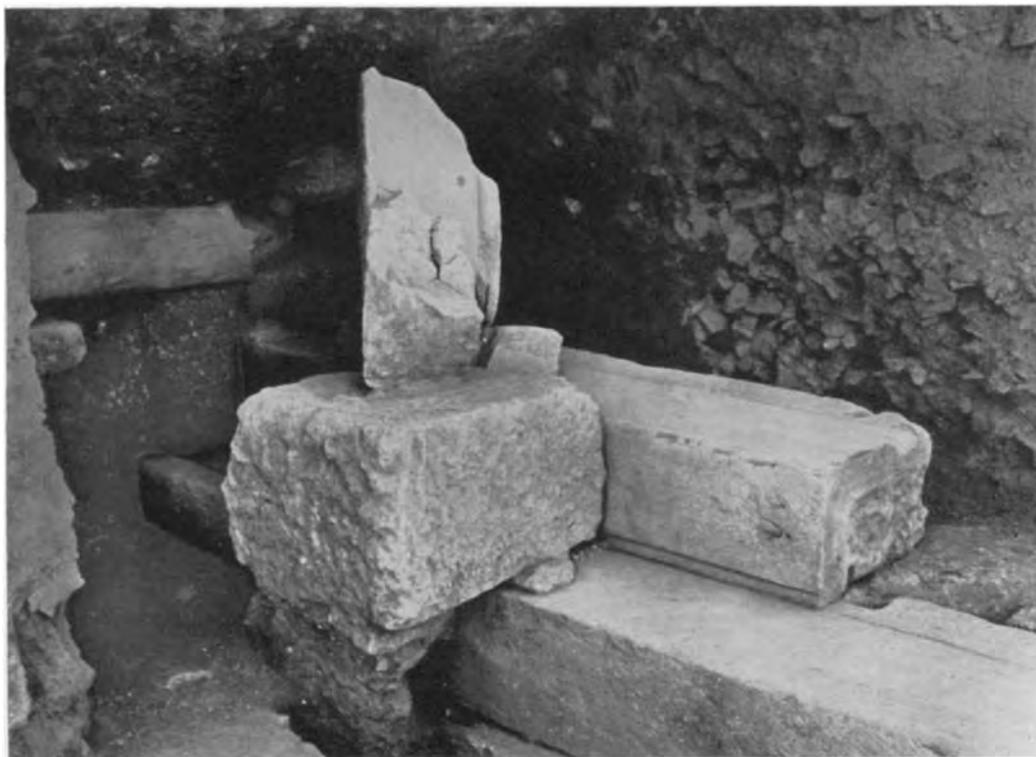
Fig. 19. South End of Zeus Stoa

It is clear from an inspection of the plan that this colonnade served as an ornamental façade for the complex of chambers to the west. If we take the length (1.29 m.) of the remaining stylobate block for the interaxial spacing of the columns, we can restore a façade of sixteen columns. Whether the break caused by the base for a monument that seems to form the southern limit of the colonnade is actually the end of the structure does not yet appear (Fig. 19).

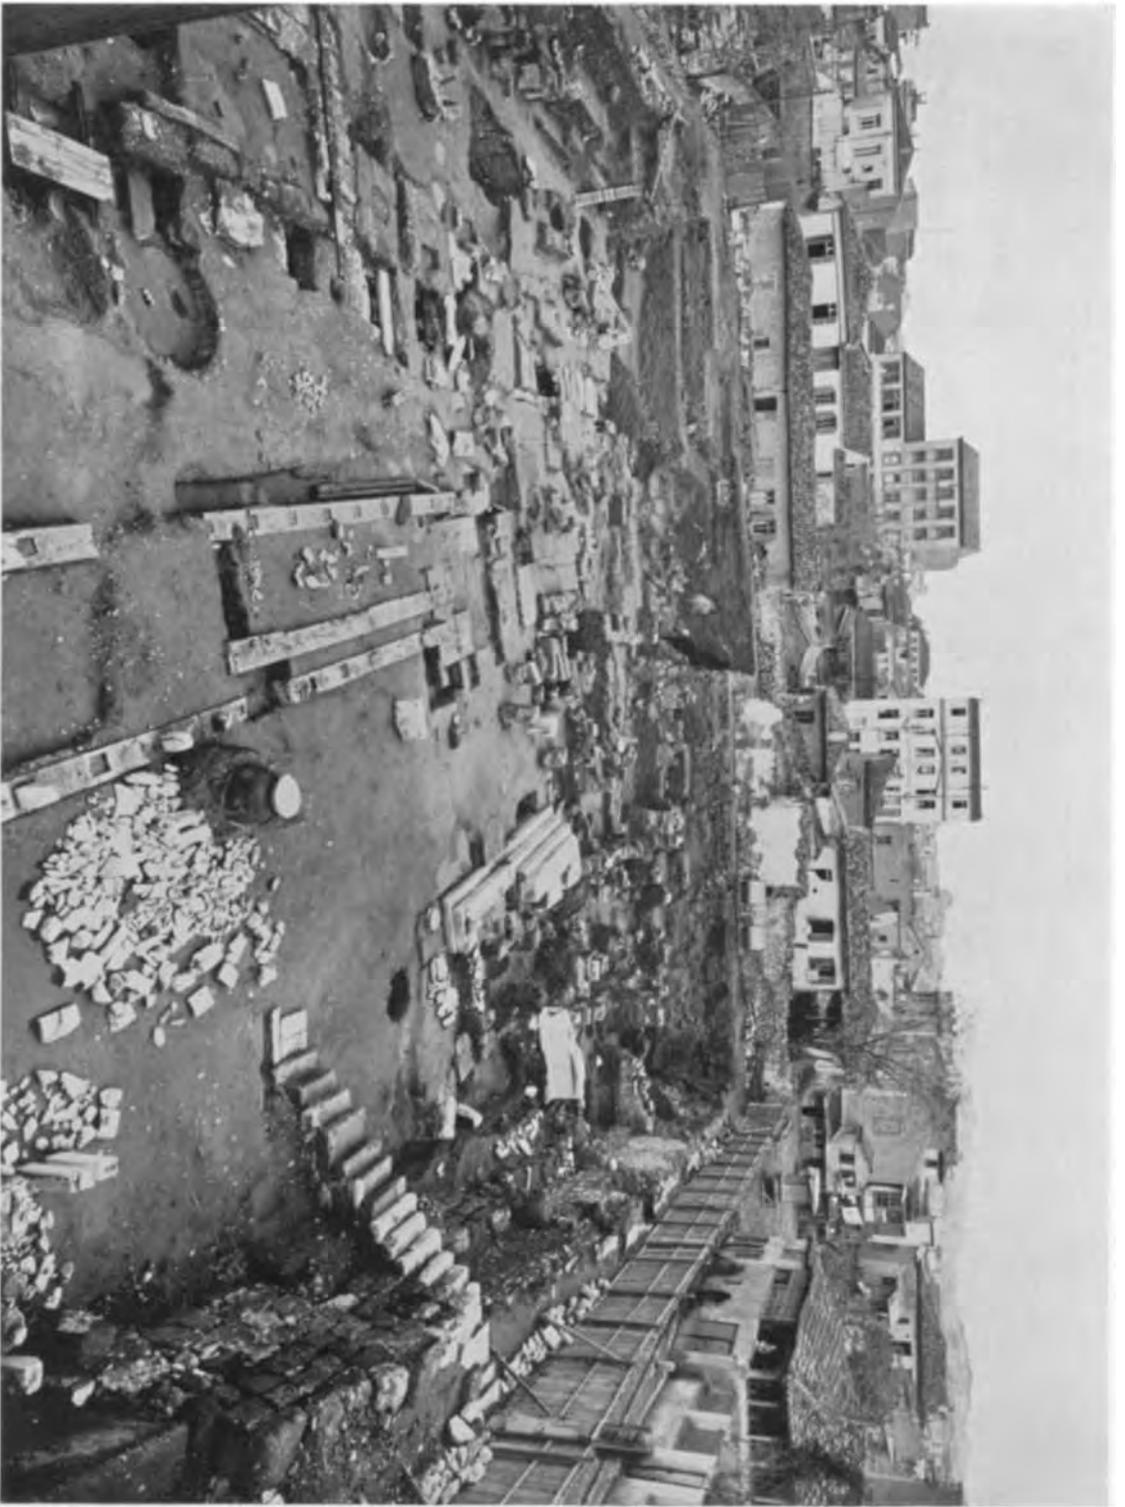
Fig. 20. View of Sector E from the South with the Fenced Area in the Centre

Midway between the Altar of the Twelve Gods (?) and the Pisistratid drain, that runs through the excavations, lies a construction the purpose of which is at the same time clear and yet most mystifying (Fig. 20). A foundation ca. 18.40 m. long and 3.68 m. wide with marks of post holes, and with the stumps of two marble posts still *in situ*, surrounds an area in which was a long narrow foundation, part of which is still preserved (Fig. 21). The blocks which form the foundation average 1.27 m. long by 0.47 m. wide. Their depth varies from 0.50 m. to 0.32 m., the deeper blocks being generally nearer the north end of the foundation, which is bedded in or on the hard fill that formed the level of the agora at this point. Only at the extreme north end of the structure did the blocks rest on masonry, and here it is only a question of their having been laid over part of an earlier foundation. The length of the blocks gives the spacing of the posts of the fence (1.27 m.), and originally there were fifteen posts on the sides and four on the ends, the corner posts being counted twice. Each post was fastened by two oblong dowels, and the upper surface of the foundation or sill was in a few cases dressed off slightly to accommodate the post, but generally the trace of the post on the masonry is very slight. The dowels measure 0.055 m. by 0.012 m. The posts, from the

traces on the foundation, were about 0.33 m. by 0.25 m. in section at the foot. The corner posts were presumably square and had the larger dimension. Both within and without the boundary of the fence the foundation is dressed down smooth for a portion of the total height of the blocks. On the outside this dressing does not maintain an even height but is deeper at the north end, extending down 0.28 m. from the top of the course. At the south end the depth is less, being only 0.18 m. The difference in level occurs about one third of the way from the north corner, on the west side.

On the east the break occurs nearer the north end and is almost exactly opposite the extension of the south side of the altar steps. On the inside of the circuit the dressing is only about 0.10 m. deep. At some period in the history of this foundation there was an alteration. The original posts were removed and were replaced by a new series with about the same spacing, although considerably more irregular. The new uprights were not dowelled to the base, but were set in holes cut in the foundation to a depth of 0.12 m. to 0.05 m. and were leaded in. Two stumps of these remain *in situ*. The enclosure was at the same time lengthened towards the south by two more uprights, making the total length about 21.00 m. The extra posts were set in separate blocks, one a re-used statue base with an inscription.

The southeast corner post of the new series still remains in place. It is of marble which is rather a poor quality of Pentelic, and it shows holes for wooden rails 0.09 m. by 0.03 m. On the east side there is evidence for two rails on the post that remains *in situ*, set about a foot apart, with the bottom rail a foot above the foundation. Neither the height nor the spacing of the rails was uniform. This can be seen on two other posts remaining *in situ*. One almost complete post, of Hymettus marble, has three rail holes preserved on each side.

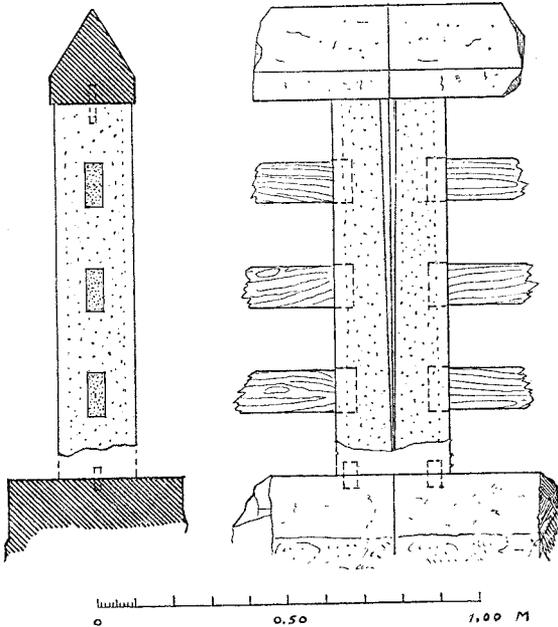
Fig. 22. Limestone Post and Capping Stone

A post lying near the foundation, made of limestone, shows very much better workmanship, and may belong to the earlier series, although its section does not correspond with that indicated on the foundation. Since the foot is broken away it is possible to restore a base of large enough section to fit the tooling on the foundation, but there is no certain evidence. A drawing of this post is given in Fig. 22. The workmanship is very good, the corners being finished smooth and the field of the four sides being picked. There is, however, no perceptible line of demarcation between the

As will be noted, the face of the post shows a V-shaped cutting which divides the upright into two jambs. An iron dowel is still preserved and a part of the capping stone, quite possibly the one that fitted this actual post, has been found. It is triangular in section, with the lower edges of the triangle chamfered off so as to give a vertical fascia about 0.07 m. high. At the end, where a joint came over the centre of the upright, is a dowel cutting, and on one of the sloping faces, presumably the one that originally was turned towards the inside of the fence, is a hook clamp.¹

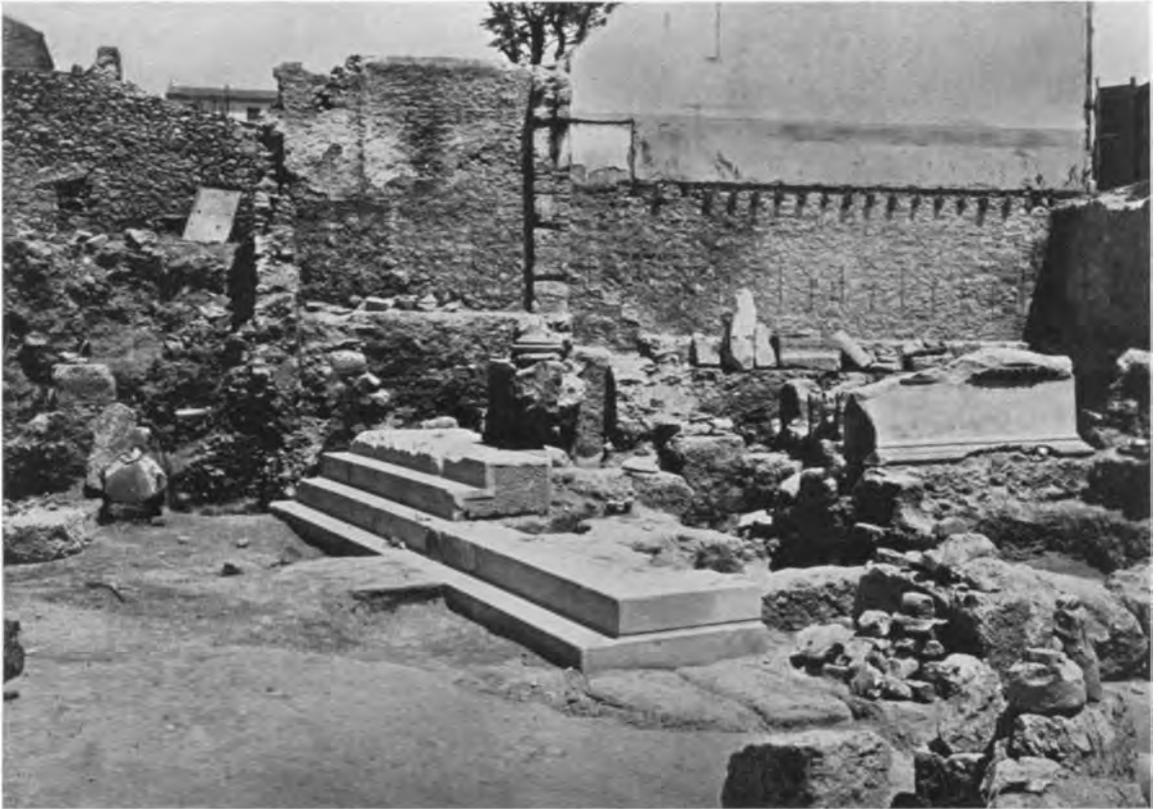
Fig. 23. View of Altar from the Southwest

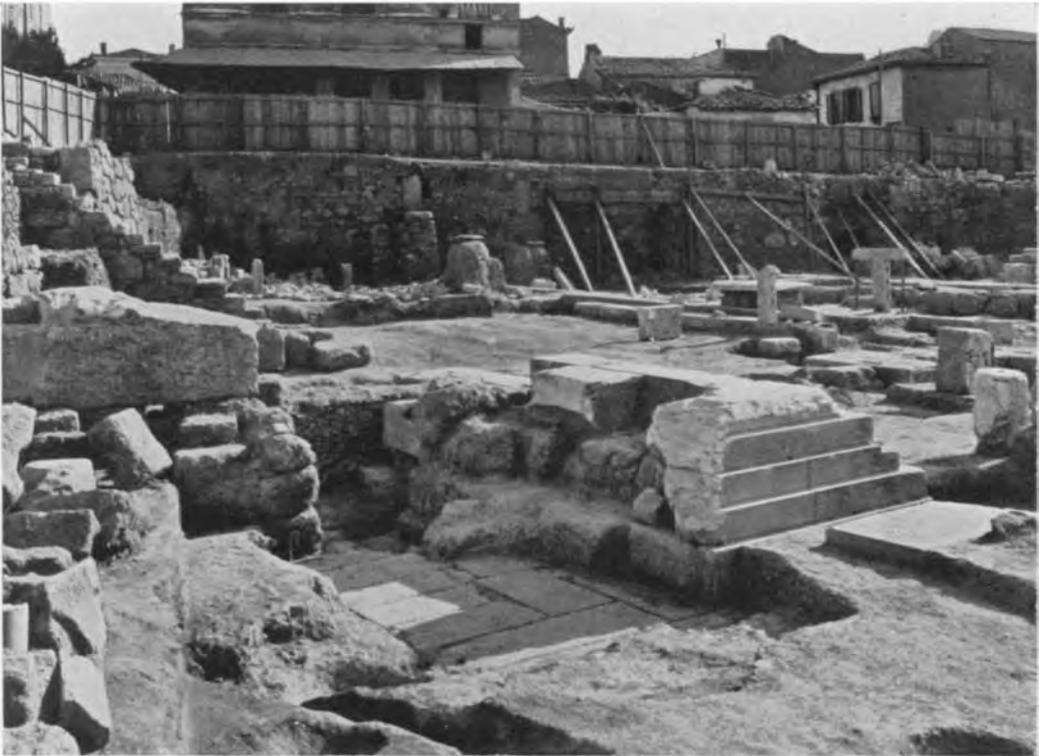
Fig. 24. View of Altar from the Northeast
