ARCHITECTURAL STUDIES

I. THE ROYAL STOA

IV. THE ZEUS STOA

VI. THE ALTAR

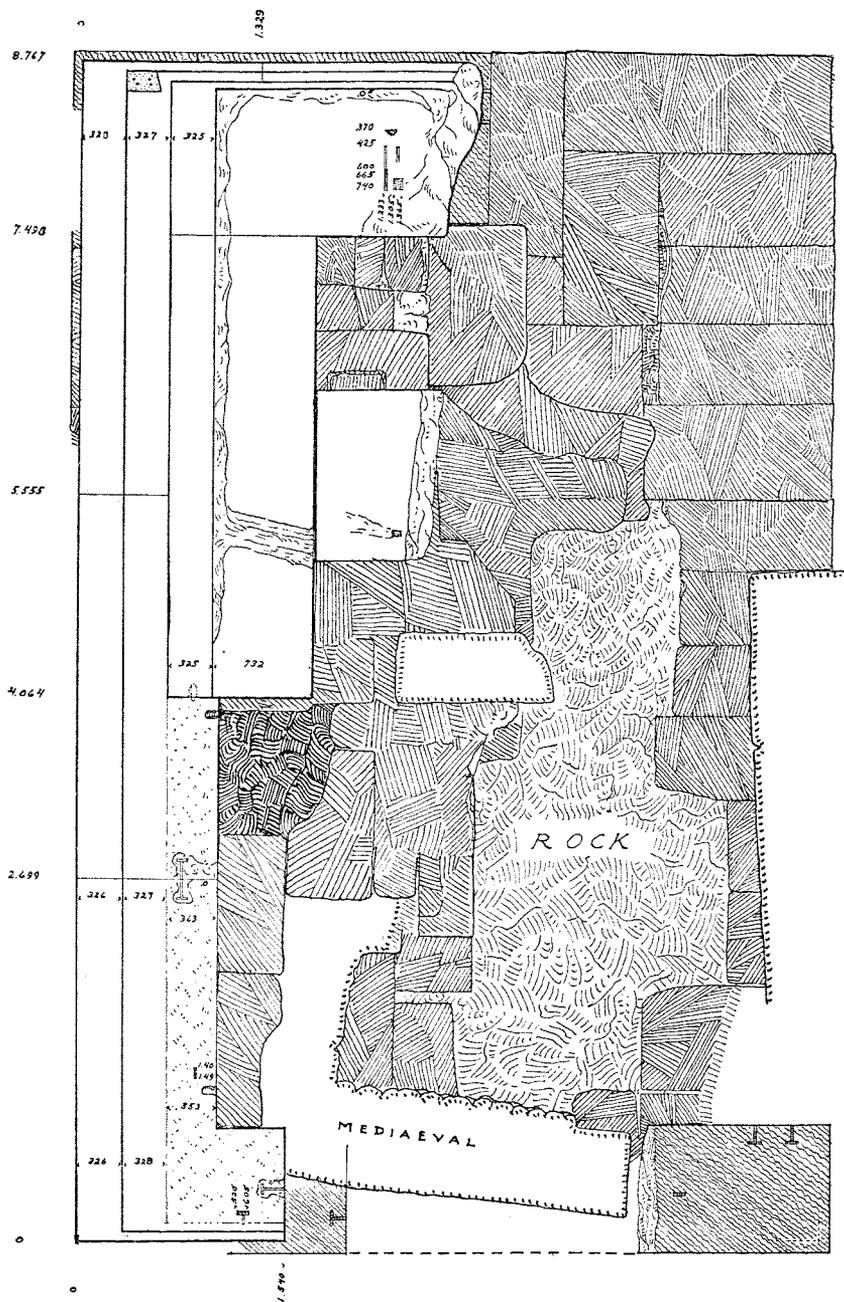
Fig. 25. Plan of Altar

remain, and make it possible to ascertain the original size of the building. It was a rectangle measuring, on the bottom step, 8.76 m. by 5.43 m. The setting lines for the southeast corner step can be seen on the course below, and the restoration of the original dimensions is certain.

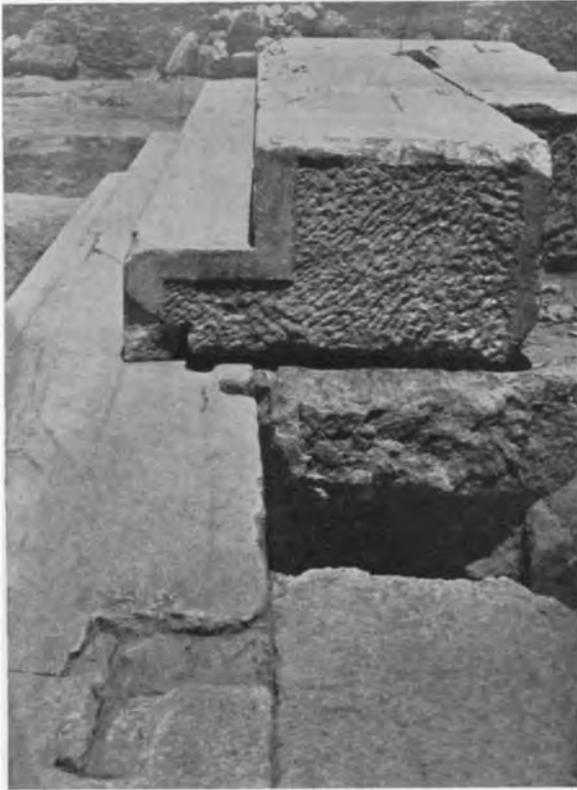
Fig. 28. Detail of Holes for Clamps and Dowels

eastern edge of the block of the lower marble course seem rather strange, and there is no corresponding mark in the poros backer adjacent to one of these holes. A patch at the northwest corner of the lower step has two sets of pin holes for fastening it in place. Apparently the repair fell out once and was replaced. One is inclined to think that some alteration was made to the structure, or even that it was moved in antiquity from some other position.

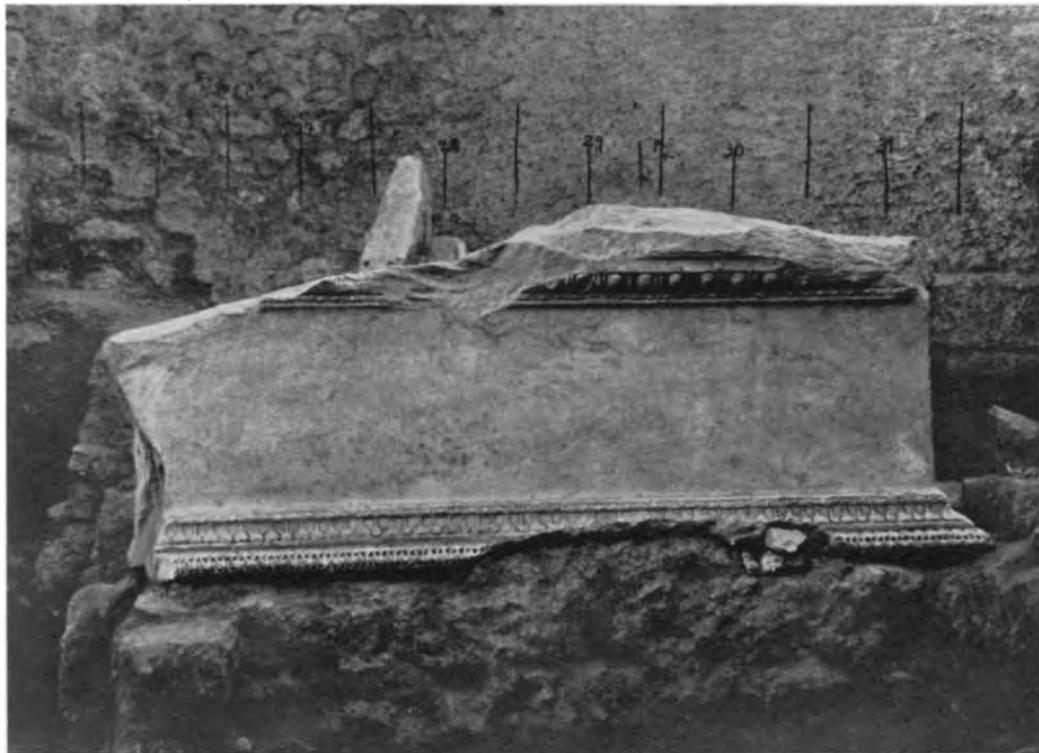
Fig. 29. Altar. Detail of Marble Orthostate

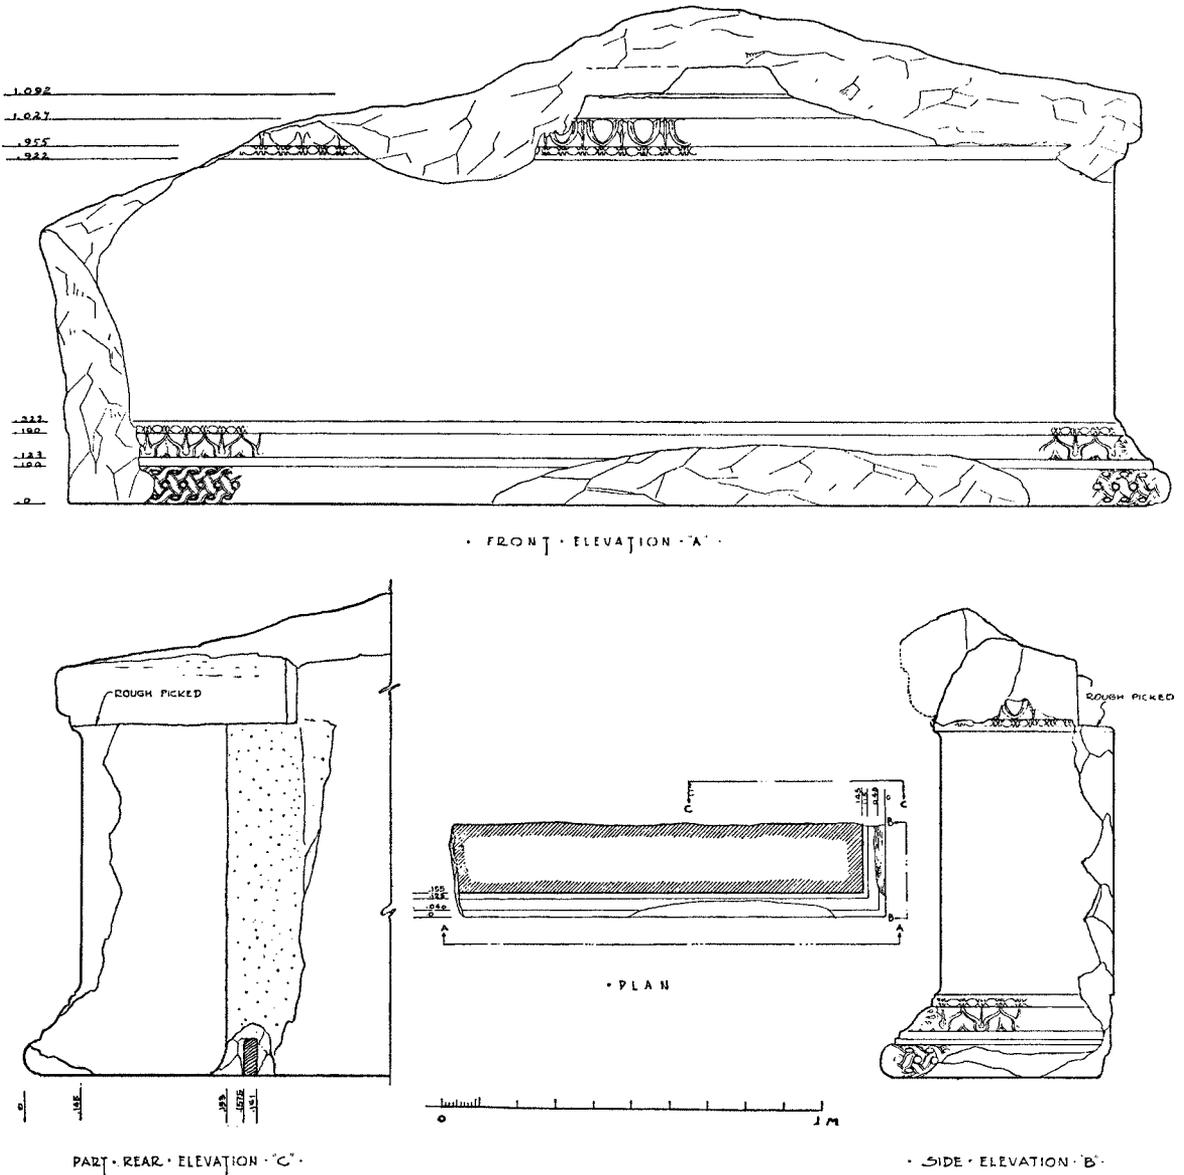
Fig. 30. Drawing of Orthostate from Altar

preserved to its full length. The present length is about 2.90 m. As will be seen from the drawing (Fig. 30), which gives the principal dimensions, it was a corner piece. The
