THE ROMAN BATH AT ISTHMIA

PRELIMINARY REPORT 1972–1992

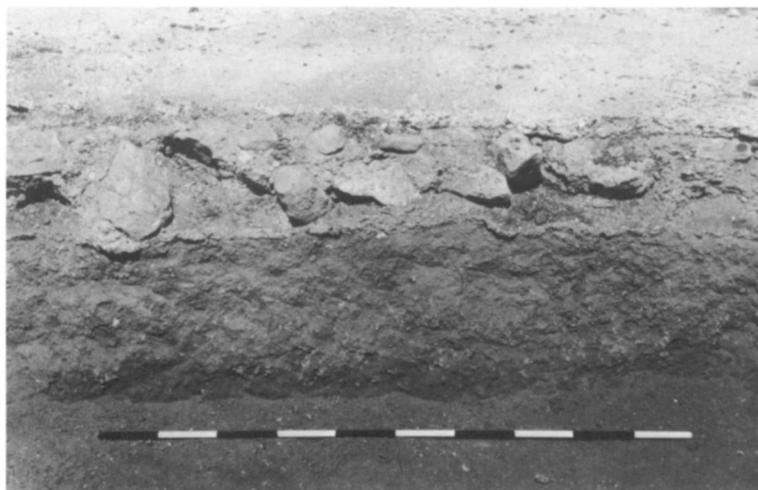
a. Mosaic bedding in Room VI

Lifting the mosaic provided considerable information about how the mosaic was originally prepared and laid (Pl. 58:a).³⁹ The foundations were first prepared by bringing in large quantities of red soil that was leveled about 0.50 m. below the projected surface of the mosaic. Above this was set a layer of hard, crystalline rocks, roughly 0.15–0.20 m. in diameter, from a source not in the immediate vicinity of the Bath. Above and around the stones a layer of mortar was poured, up to about 0.20 m. below the surface of the mosaic. This was allowed to dry, and a second layer of mortar was applied, up to about 0.10 m. below the surface of the mosaic. Once this had dried, the final layer of mortar was laid and the tesserae placed in this. Our investigation revealed vertical lines through each of the layers of mortar, showing that the layers were not laid complete at one time but rather in sections that presumably represented what could be accomplished in a single day's work. The final plan for the mosaic must have been at hand from the beginning of work on these foundations, since many of these lines correspond to divisions in the decoration of the mosaic. Marks on the surface of these layers of mortar show that the surfaces were smoothed with boards, and sections of the middle layer bore the impressions of several feet, some of them bare and others in hob-nail shoes (Pl. 58:d). There were marks on this surface that looked as though they were part of the cartoon that was presumably laid out before the mosaic was set, but these were nowhere well preserved. In several places, however, the undersides of the mosaic panels were marked by black lines that occasionally cut across the lower surface of the white tesserae; they, indeed, must have been from the cartoons that originally set out the decorative scheme.⁴⁰

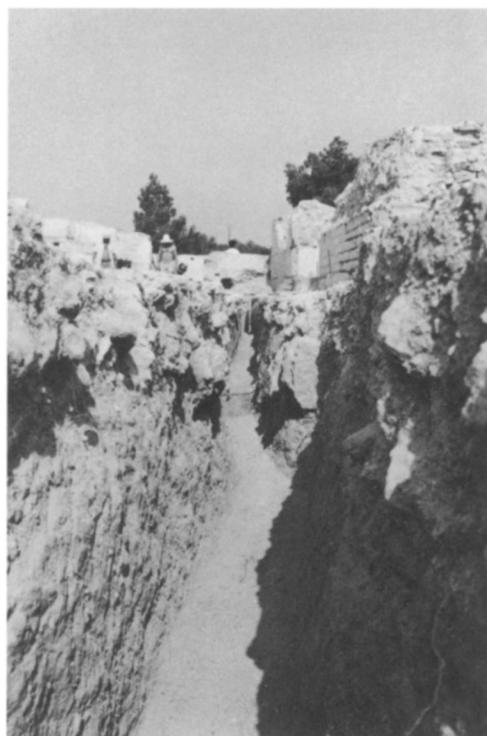
b. Long cutting through the mosaic in Room VI

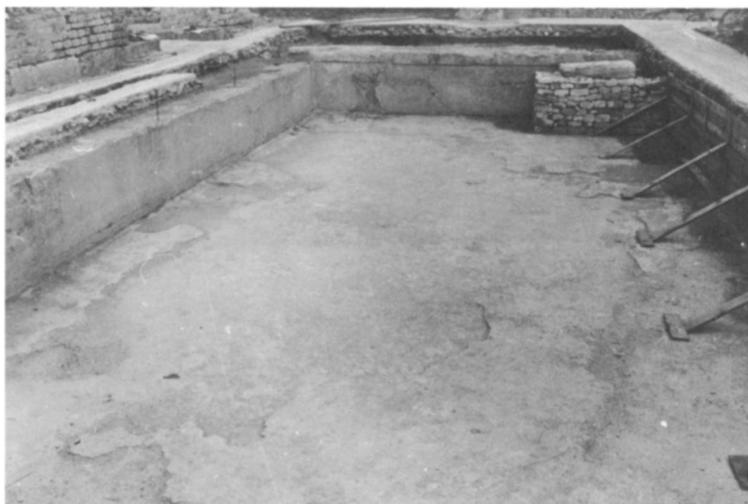
b. Northeast corner of the Greek pool, from the west

The pool is almost square (Plate 59:b shows only the northeast corner of the pool, shaded in Figure 11). The blocks of the northeast and southeast corners are preserved *in situ*, while the southwest corner is indicated by the broken cement floor; the wall blocks there were robbed away when the Roman Bath was built. Only the northwest corner must be hypothetically restored, since it lies deep under the cement floor of Room III. On the basis of the preserved evidence, the sides do not appear to be exactly the same but vary between 30.04 m. and 30.31 m. in length. The eastern wall, whose corners are best preserved, is 30.04 m. long, and this probably gives the best estimate of what the builders originally intended. Almost certainly the length of each side was meant to be one hundred Greek feet. Oscar Broneer has shown that at Isthmia a foot of *ca.* 0.320 m. was in use in the Archaic and Classical periods, while by the time of Alexander a foot of 0.302 m. was the norm.⁴⁶ The evidence from the pool suggests that the latter foot was used in its construction. As will be seen, the pool must be dated to the earlier part of the 4th century B.C., and this pushes the use of this foot back into the Classical period.

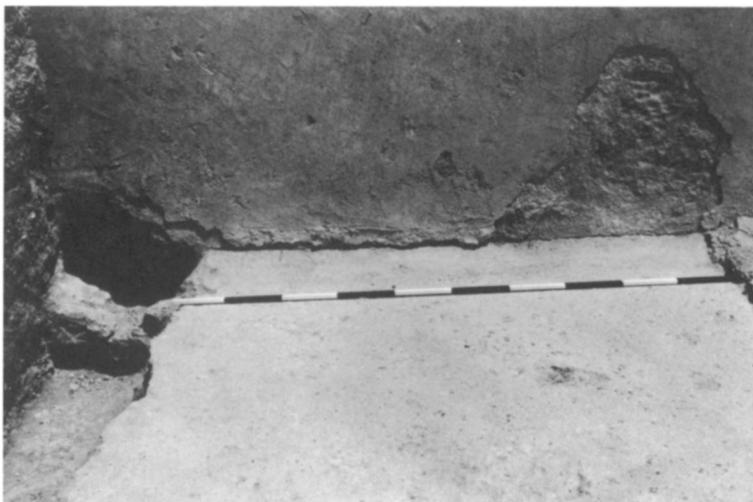
c. Drain in the Greek pool

The drains for the Greek pool are clearer in their arrangement and function. Thus, one drain (of a probable set of drains) was found along the northern side (Pl. 59:c). This was about 14.4 m. west of the northeast corner of the pool. It preserves a rough, circular cutting, *ca.* 0.12 m. in diameter on the south face and 0.18 m. on the north face, set just above the floor of the pool; it was presumably lined with some material, and fragments of decomposed bronze found at the opening suggest that it had been fitted with a bronze pipe. This drain emptied out through the north wall of the pool, originally into a large drain, 0.51–0.56 m. wide, that ran off to the north under what became Room II of the Roman Bath. This drain was blocked, presumably by the Romans, but another constructed in the same Greek technique of large blocks covered with waterproof cement is still visible 0.45–0.50 m. to the west, where it was incorporated into the drainage system of the Roman Bath. This must have been connected with a drain in the Greek pool that is now covered by an unexcavated section of the white mosaic in Room VI. We should probably imagine, then, at least two drains centered in the middle of the north wall of the pool (Fig. 11). Immediately to the north of the pool the water line branched to the west and to the east. Immediately to the west was the reservoir/drain for the Roman Bath (pp. 289–290 above). To the east the water line, built of large blocks covered with waterproof cement and *ca.* 0.50 m. wide, ran at least as far as the southwest corner of what became Room I of the Roman Bath. This water line, running parallel to the north side of the Greek pool and about 4.5 m. north of it, was utilized in Roman times as a drain for Room I (running east–west to the reservoir).

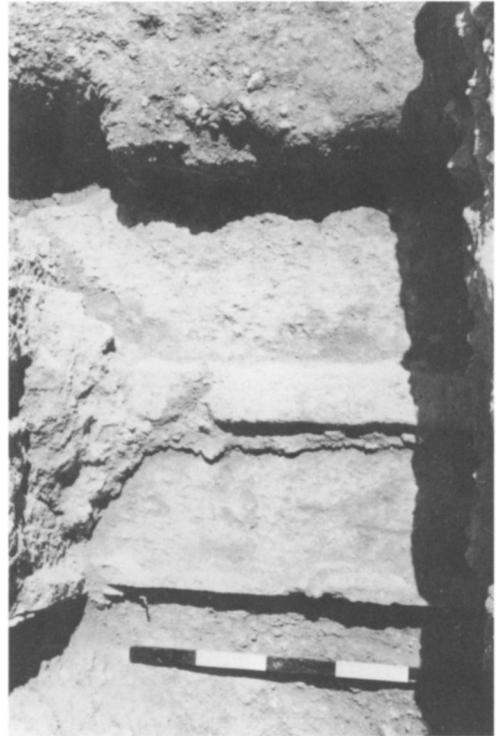
b. Southernmost excavated block of the east wall of the Greek pool showing cement filling between blocks, from the west

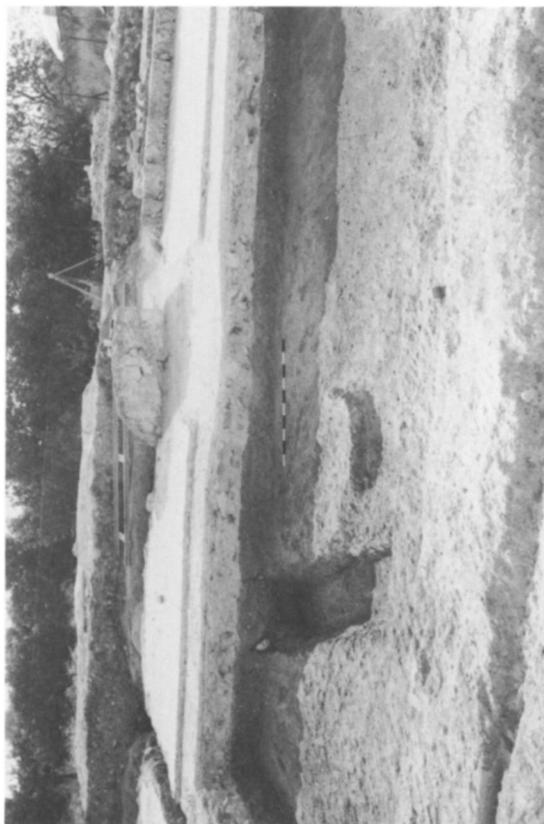
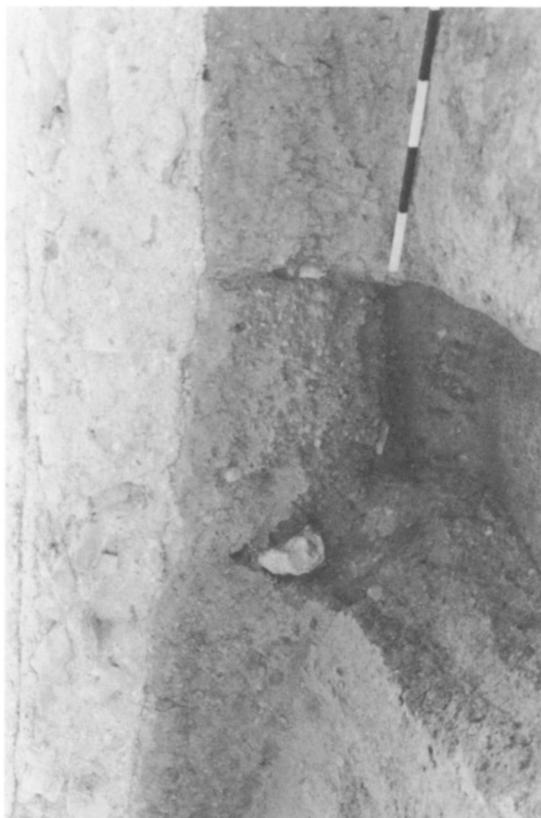
c, d. Cutting in virgin soil east of the Greek pool, from the west

at least 0.40 m. deep (Pl. 62:c, d). This cutting must have been for a water line, running roughly northeast–southwest, presumably originally lined with stones and covered with waterproof cement, although this lining was discovered *in situ* in only two places along its course. By its position, this water line must be older than both the cement floor that lay above it and the Greek pool, whose east wall cut through it. The line was filled in when the Greek pool was constructed, and the pottery found in it is the same as that discovered elsewhere in construction fill for the pool. The direction of the water line cannot be determined, since only a small section of it was explored and only the sides of the line in the virgin soil could be identified; its orientation and the general lay of the land suggest that it ran off to the northeast.
