# EXCAVATION OF A 13TH-CENTURY CHURCH NEAR VASILITSI, SOUTHERN MESSENIA

A small-scale excavation in the area of Vasilitsi, southern Messenia, revealed the remnants of a previously unrecorded 13th-century triple-aisled cross-vaulted church with a series of burials along its north wall. In addition to ceramics and a marble basin, a small hoard of Venetian *torneselli* was found. The author discusses the church's period of use and details of its architecture and construction, as well as the identity of its builders and the settlement pattern of this largely unknown area. Parallels from published histories, surface surveys, and excavations from other regions of medieval Messenia and Greece are discussed. An osteological report on the burials is presented as an appendix.

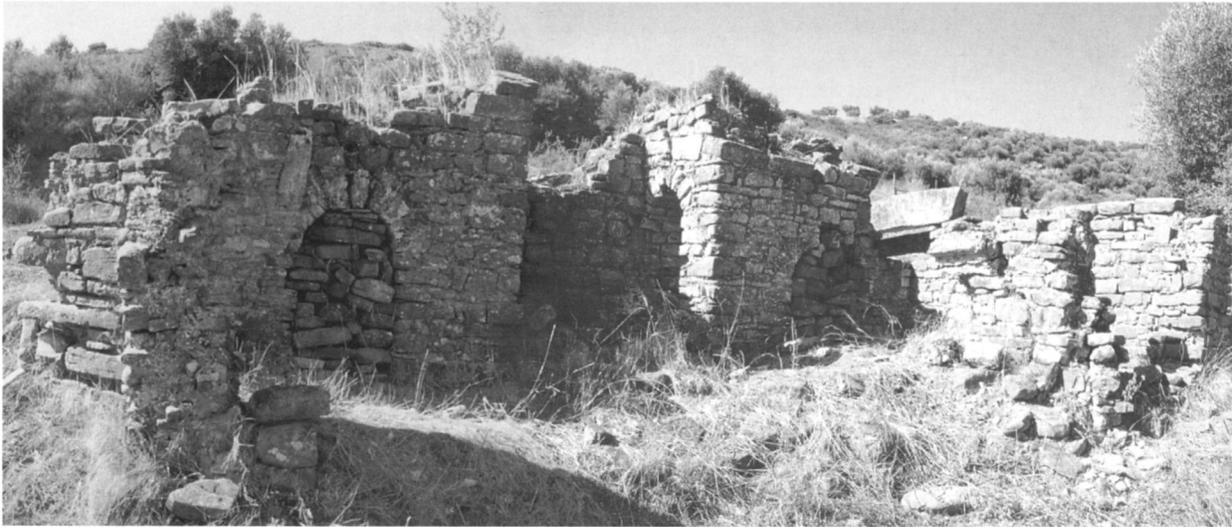
**Figure 2.** General view of the site before excavation, from the north-east. Photo N. D. Kontogiannis

When the surface vegetation was cleared, it became apparent that the downward-shifting earth had created the unevenness of the site: the surviving parts of the south side of the church remained above ground, while those on the northern and eastern sides were completely buried (Fig. 2). There was a pressing need to address the instability observed in the remaining parts of the masonry; therefore, it was decided that a limited excavation should be conducted in order to uncover the building's north part and complete its plan, and that immediate measures should be taken to consolidate the masonry.

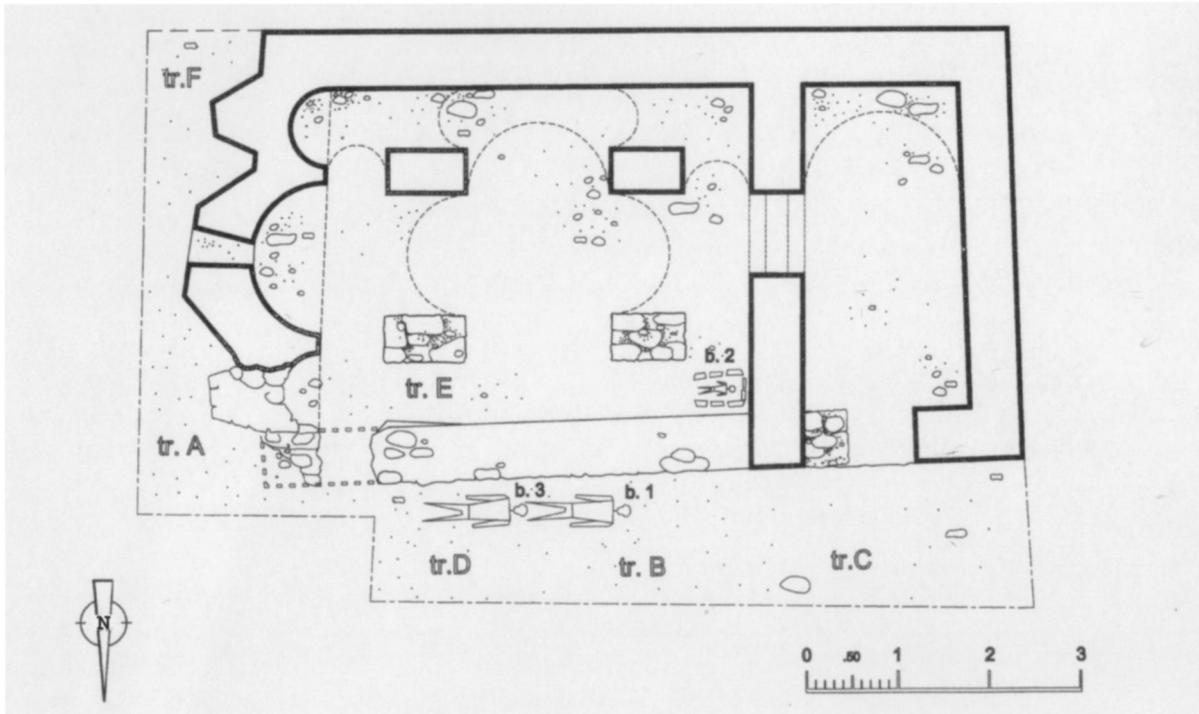
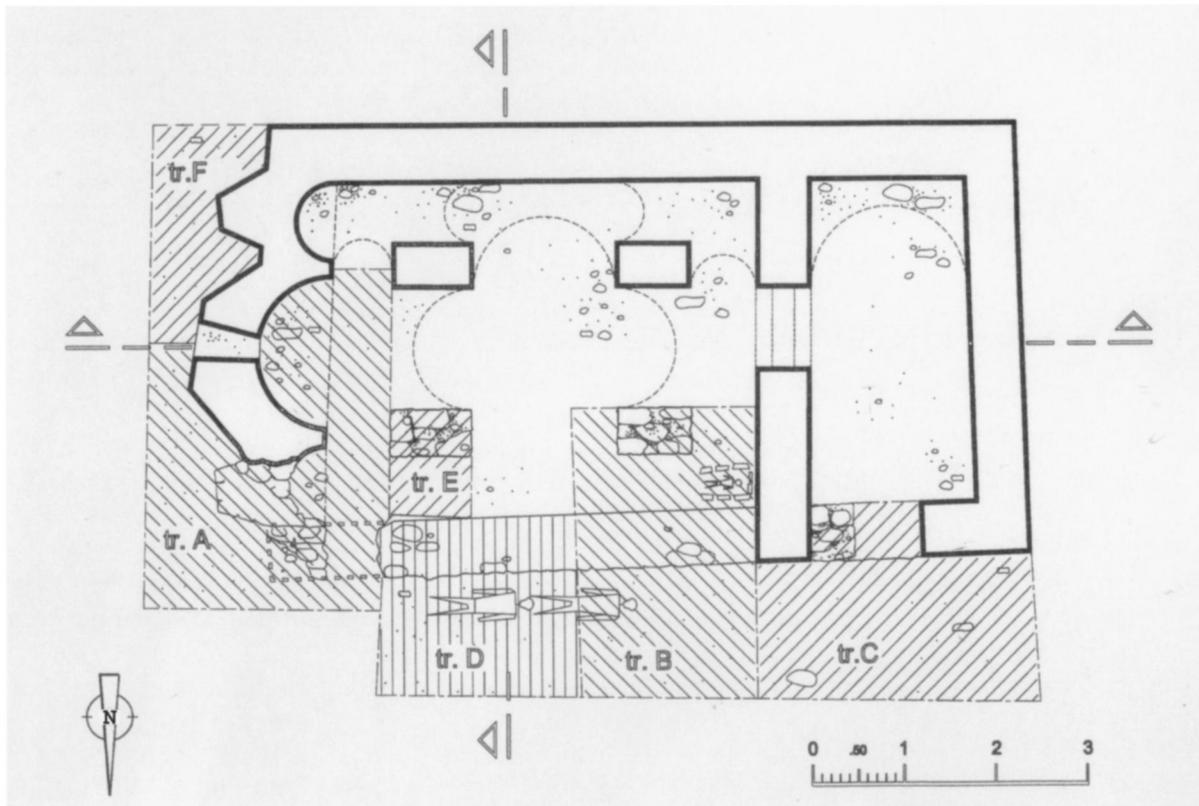
Figure 3. Plans showing the church, trenches, and three intact burials. M. Michailidis

Six trenches were dug on the north and east side of the church (Fig. 3).<sup>5</sup> In all trenches, under a thin surface layer of dark brown earth, roots, stones, and tiles, we excavated the building's destruction layer, which contained large quantities of stones that had fallen from the building's upper levels, as well as broken tiles from the roof. Some of the stones still bore traces of the lime mortar that was used in the wall construction. We also collected many fragments of the painted plaster that once coated the building's interior. There was no sign of plaster, however, on the exterior surfaces of the surviving walls. The absence of traces of fire, charred wood, and charcoal suggested that the building had collapsed from natural causes, such as erosion, earthquake, or a landslide, perhaps long after the church had been abandoned.

Trench A enclosed a large section of the church's east end, including the sanctuary (Fig. 3). It extended from the central apse and the eastern surviving pier northward, covering the part of the church that lay buried in this direction. The trench was rectangular, with overall dimensions of 3.50 (L.)  $\times$  2.60 m (W.). The earth that covered this area slanted northward, resulting in elevation differences in the trench. The highest part lay inside the building, at a depth of ca. 1.73 m from the leveling point, with the lowest (northern) part of the trench outside the building, at a depth of ca. 2.38 m.

Masonry belonging to the *prothesis* was unearthed in the area north of the central apse (Fig. 3). The lower parts of this smaller apse survive on the south and east sides; on the north side, only the foundation remains. The *prothesis* was semicircular on the interior, with the lower stones of the

The discovery of a third projecting apse was important because it helped to clarify the plan of the church (Figs. 3, 4); it also provided useful indications as to the external—still unearthened—side of the southern apse. The excavation of the southern *diakonikon* apse (trench F) was planned in order to observe the formal and structural details that would in turn help us reconstruct the lost upper part of the northern *prothesis* apse. No trace of the church's north wall was found in trench A. The wall's eastern end, which should connect to the *prothesis* conch, must have been completely destroyed. It is possible, however, based on the size of the north conch, to reconstruct its position in the plan (Fig. 3).

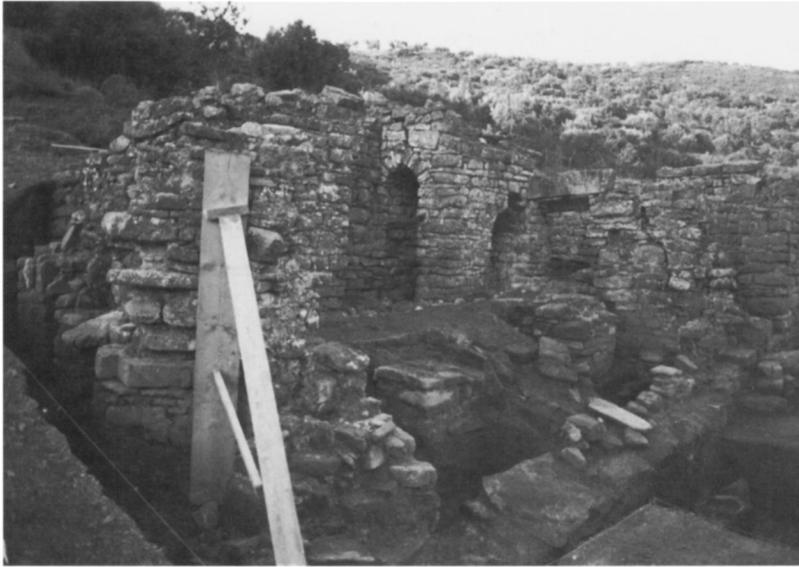
**Figure 5.** General view after excavation, from the northeast. Photo N. D. Kontogiannis

Underneath the destruction layer, the foundation layer of the church was excavated just above the soft natural bedrock. Signs of the original flooring of the building were noted in two trenches (A and B). The excavation fulfilled its goal of revealing the entire north side of the church. The eastern side was freed from earth and the remains of all three apses of the sanctuary were recovered, together with the lower part of two northern piers (Figs. 5, 6).

The church is built exclusively with roughly hewn stone slabs set in courses with lime mortar as bonding material (Fig. 5). Structurally important features, such as the arches and lintels, are constructed with finely hewn stones. The alternating courses of brick and stone appearing on the surviving part of the east wall with the apses of the *bema* and *diakonikon* constitute an exception (Figs. 5, 6). The different construction may well have been an attempt to distinguish the most important part of the church. No other form of decoration has been observed on the exterior. The interior surfaces of the church were covered with a plaster coating made of white mortar. The traces of colored plaster preserved on numerous stones indicate that this plaster surface bore some form of painted decoration; no sign of murals was seen, however, and it is possible that the church never had them.

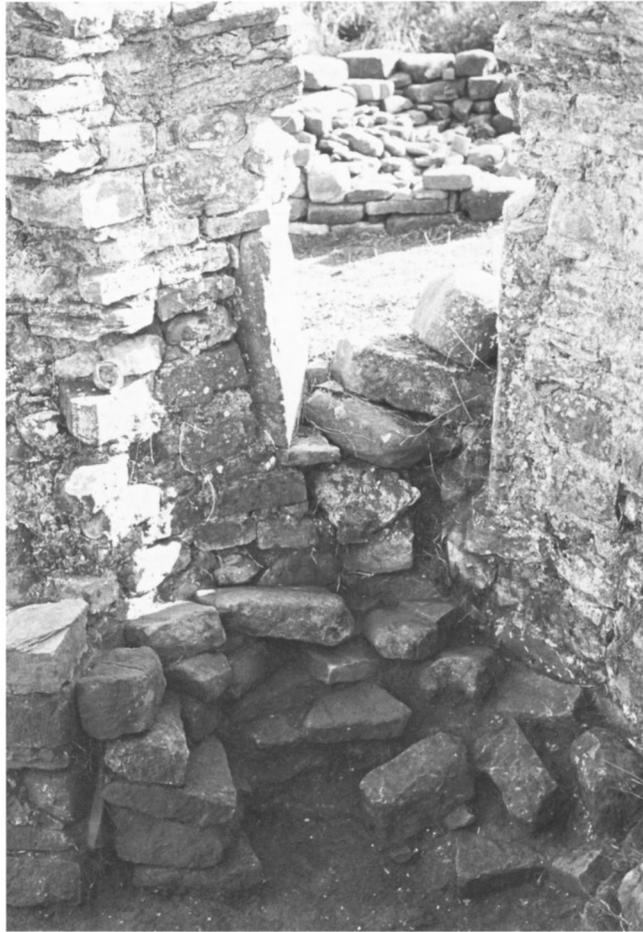
Figure 7. Central apse with the remains of the altar. Photo N. D. Kontogiannis

a low shelf was revealed (p.H. ca. 0.40 m). The shelf, constructed of stone slabs and little or no mortar, was not structurally bonded to the apse wall (Fig. 7). The discovery of plaster behind it indicated that the shelf was added after the initial construction and decoration of the church. It can be interpreted as the built-in altar of the church, a typical feature in small ecclesiastical structures. A similar feature also survives in the *diakonikon*.

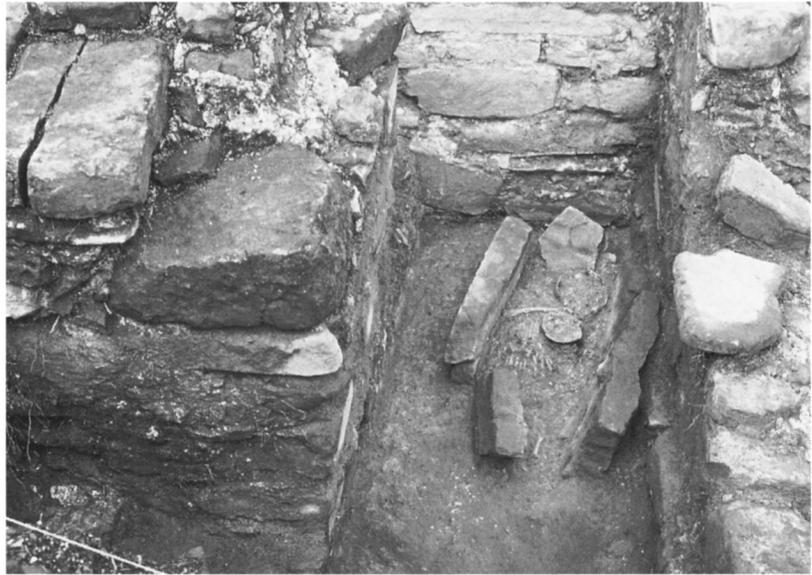
Figure 8. Trench B, burial 2, from the east. Photo N. D. Kontogiannis

In the northwestern corner of the *naos*, between the north wall and the transverse wall, the excavation uncovered a child's burial in a stone-lined and slab-covered cist grave (burial 2, Figs. 3, 8).<sup>6</sup> The slabs that covered the burial were found at a depth of ca. 2.28 m, at a level immediately under that of the mortar floor noted in the eastern part of the trench. Under the cover slabs, an oblong formation of stones set vertically to the ground was unearthed. The tomb, with external dimensions of  $0.90 \times 0.43$  m, was parallel to and almost in contact with the north wall. Apart from the skeleton, it included earth, masses of lime mortar, and a few pieces of charcoal.

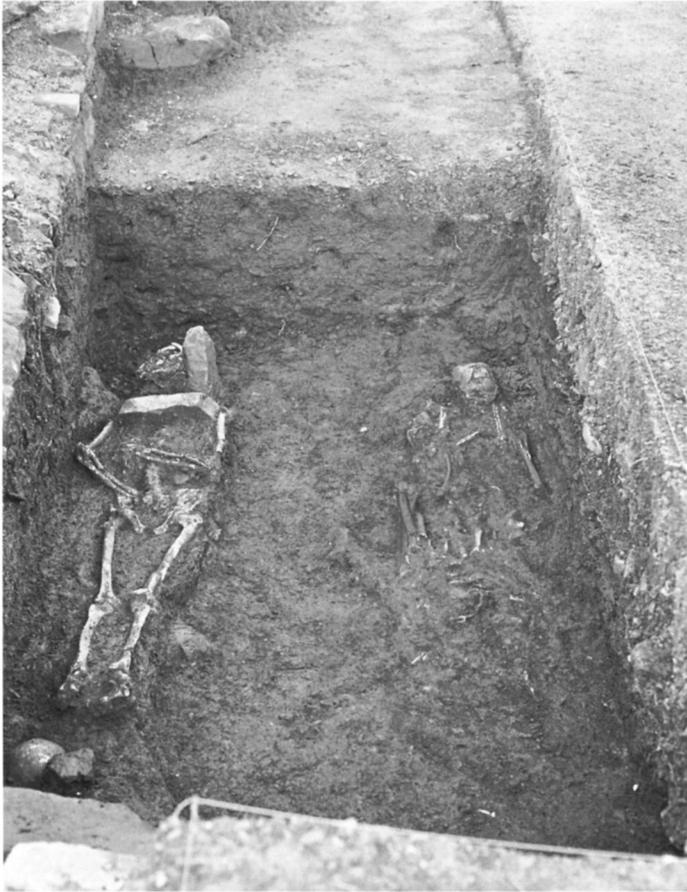
Figure 9. Trenches B and D, with intact burials 1 (*left*) and 4, from the east. Photo N. D. Kontogiannis

The excavation in the area outside the north wall was reduced to a space of 1.15 × 1.05 m. At a depth of ca. 3.07 m, a human skull began to appear, and further excavation within the limits of trench B revealed the upper torso (head and shoulders) of an undisturbed adult burial (burial 1).<sup>7</sup> The skeleton lay buried along the north wall; its head, pointing toward the west, was supported by two slabs that had been set vertically on the ground with a right angle between them (Figs. 9, left; 12). The excavation stopped at a depth of ca. 3.25 m. There were no other finds apart from numerous bones, which did not originate from burial 1 but from other, obviously disturbed, earlier burials.

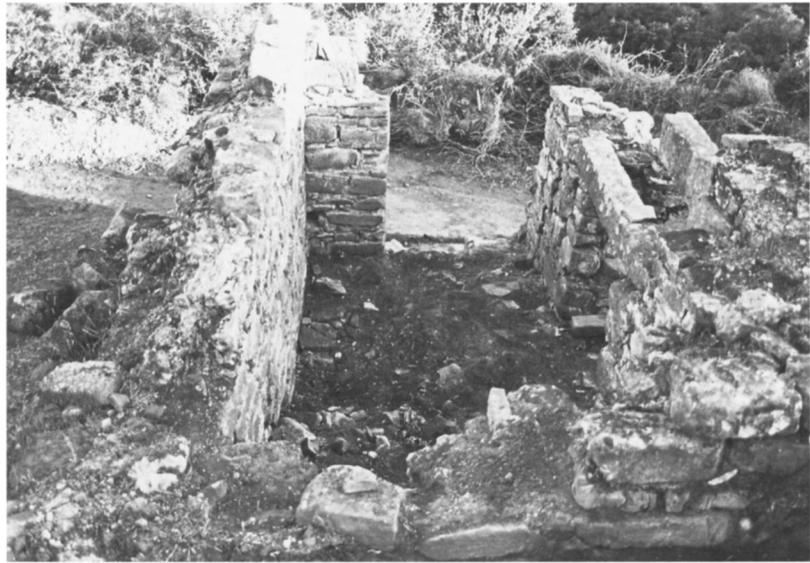
Figure 10. Narthex, from the south.  
Photo N. D. Kontogiannis

As expected, the excavation revealed the threshold of the narthex portal at the building's north wall. The opening has a width of 0.72 m and a thickness equal to the thickness of the wall at this point, ca. 0.56 m (Fig. 10). The doorstep, formed by a single worked stone, was found at a depth of ca. 2 m. A series of slabs was found outside the doorway, in contact with the north wall of the narthex. These either belonged to a pavement or formed built steps that led to the door. Their precise function, however, could not be determined because of the poor quality of the construction. After clearing and recording, the slabs were partly removed to establish the depth of the foundation of the narthex wall. Bedrock was recovered at a depth of 2.60 m in the western part of the trench.

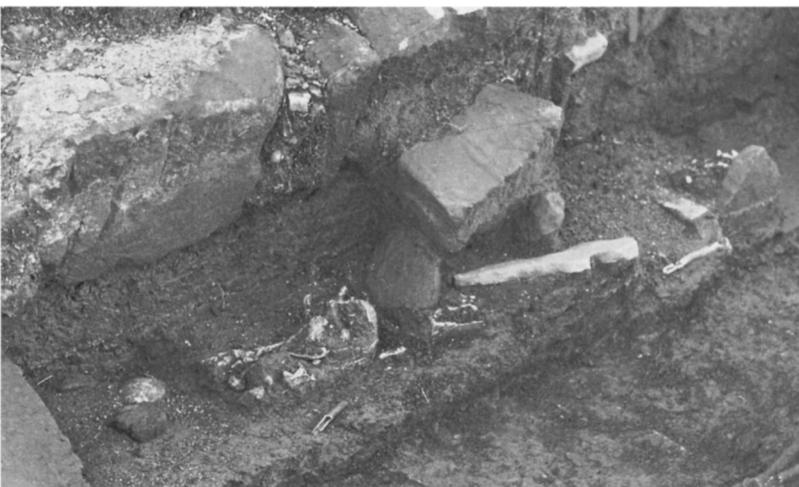
**Figure 12.** Trenches B and D, burial 1. Reburied skull and long bones of an earlier burial over the lower part of the skeleton. Photo N. D. Kontogiannis

The work in trench D completely unearthed burial 1 (Figs. 11, 12). The skeleton was placed in an extended position with the forearms crossed over the chest. The bones appeared at a depth of ca. 3.25 m. The area occupied by the skeleton was 1.60 m long and 0.42 m wide. Around the hands of the individual were sherds from a small, unglazed cooking pot (15, Fig. 19, below). Moreover, a skull and long bones—probably coming from an earlier, disturbed burial—lay over the feet of the skeleton. The placement of these bones was not the accidental result of erosion or earth movements, but a precise and conscious act by the people who performed burial 1. There was also a slab set vertically to the north wall that kept the second skull in its place. This must be a reburial of an earlier skeleton, which occurred at the same time as burial 1.

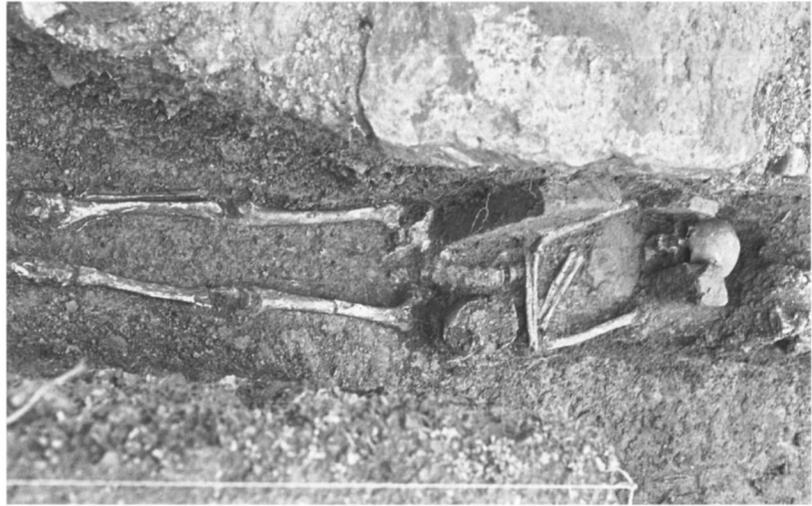
**Figure 13. Trench D, burial 3.** Photo N. D. Kontogiannis

East of burial 1, at the same axis and virtually in contact with its lower bones, another similar undisturbed burial was found, also parallel to the north wall (burial 3, Figs. 11, 13).<sup>8</sup> The bones appeared a little deeper than those of burial 1, at a depth of ca. 3.35 m, set directly above bedrock. The skeleton occupied an area 1.63 m long and 0.30 m wide. Bedrock was unearthed at a depth of 3.65 m (lowest point).

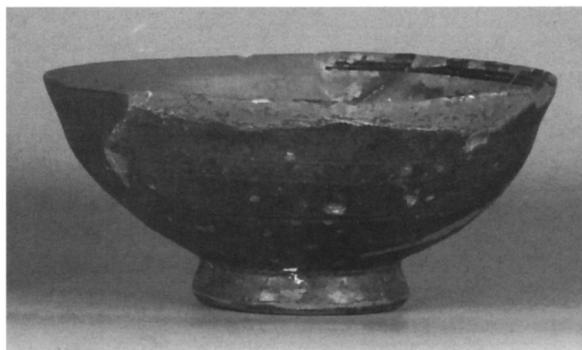
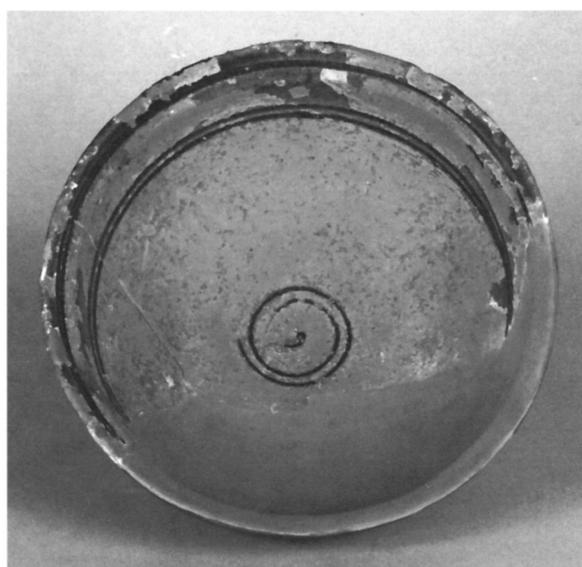
**Figure 17. Restored and completed late sgraffito bowl (11) found in trench D.** Photos G. Maravelias; drawing M. Georgoutsou

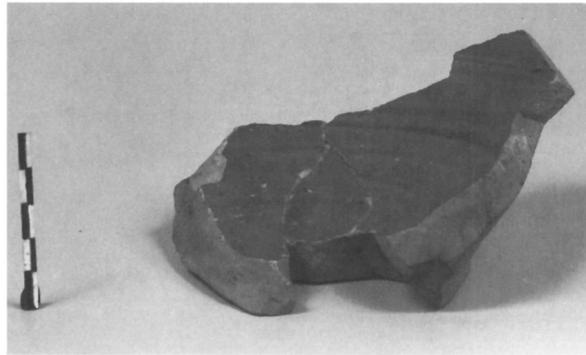
**Figure 18. Plain glazed ware: open(?) vessel (13) and closed(?) vessel (14) found in trench A. Photos G. Maravelias; drawings M. Georgoutsou**

13 Open(?) vessel Fig. 18

14 Closed(?) vessel Fig. 18

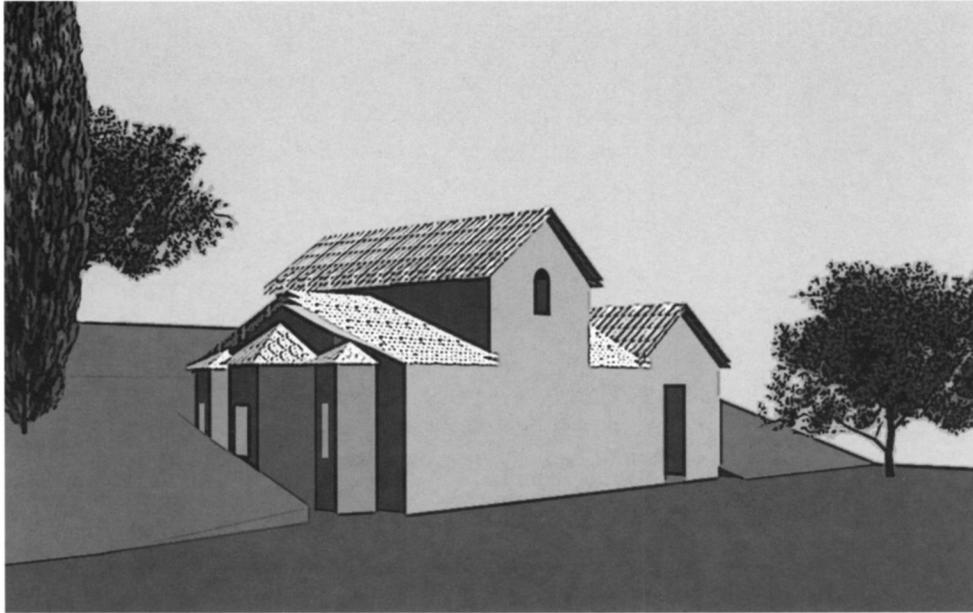
There are no other extant openings in the *naos*, apart from the door that leads to the narthex. It is possible that the walls of the higher transverse vault contained windows or simple light slits that did not survive (as reconstructed in Fig. 23).

As shown in the proposed reconstruction of the vaulting of the *naos* with the three longitudinal barrel vaults and a higher transept (Fig. 23), the building is an example of a cross-vaulted church, and, more precisely, belonging to the quite uncommon triple-aisled group.<sup>16</sup> According to the catalogue compiled by Küpper,<sup>17</sup> there are eight other known examples of this type in Greece, of which only four are dated to the 13th century.<sup>18</sup> Of these four churches, two are found in Epiros (Ayios Dimitrios Tourkopaloukou at Kupseli<sup>19</sup> and Ayios Ioannis at Kostaniani<sup>20</sup>). A third example is located in Attica (Ayios Nikolaos at Kalamos,<sup>21</sup> mid-13th century), while the last is less than 30 km from the church at Vasilitsi (Ayios Vasileios at Paniperi),<sup>22</sup> and dates to the beginning of the 13th century (Figs. 1, 24).

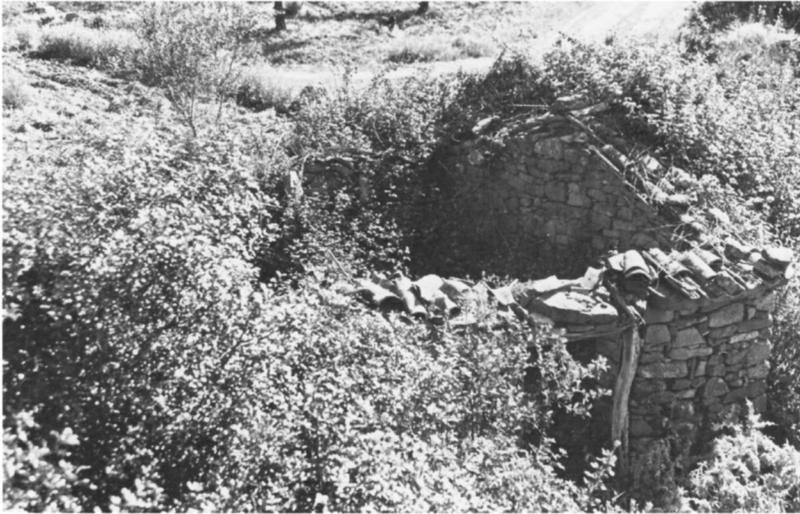
**Figure 25. Remains of a rural house northeast of the area of excavation.**  
Photo N. D. Kontogiannis

The excavated church presently stands isolated in a semiabandoned agricultural area mainly planted with olive trees. The nearest modern settlement, the village of Vasilitsi, lies at a distance of more than 10 km (Fig. 1). Nevertheless, while traveling the modern roads that lead from Vasilitsi to Selitza, one occasionally encounters isolated, abandoned houses, lying in ruins amid the olive trees, such as the remains of two small houses ca. 200 m northeast of the excavation (Fig. 25). Both are single-roomed and

single-storied, stone-built, timber-roofed constructions that, unfortunately, offer no hint as to their chronology. They belong to the common type of Greek rural longhouse known as *monospito*,<sup>34</sup> and were probably used by the families of the farmers or shepherds who worked in the surrounding lands. The use of stone rather than mudbrick may indicate that these were permanent installations, not temporary constructions for the harvest period. Farmers no longer need to live in the area; modern transportation enables them to reach their lands easily from the village of Vasilitsi.
