# A ROMAN ROAD SOUTHEAST OF THE FORUM AT CORINTH

## TECHNOLOGY AND URBAN DEVELOPMENT

A wide, unpaved, north–south Roman road was established in the Panayia Field at Ancient Corinth in the last years of the 1st century B.C. Over the next six centuries, numerous civic and private construction activities altered its spatial organization, function as a transportation artery, and use for water and waste management. Changes included the installation and maintenance of sidewalks, curbs, drains, terracotta pipelines, and porches at doorways. The terracotta pipelines are presented here typologically in chronological sequence. The road elucidates early–colony land division at Corinth, urbanization into the 4th century A.D., and subsequent deurbanization in the 6th century, when maintenance of the road ended.

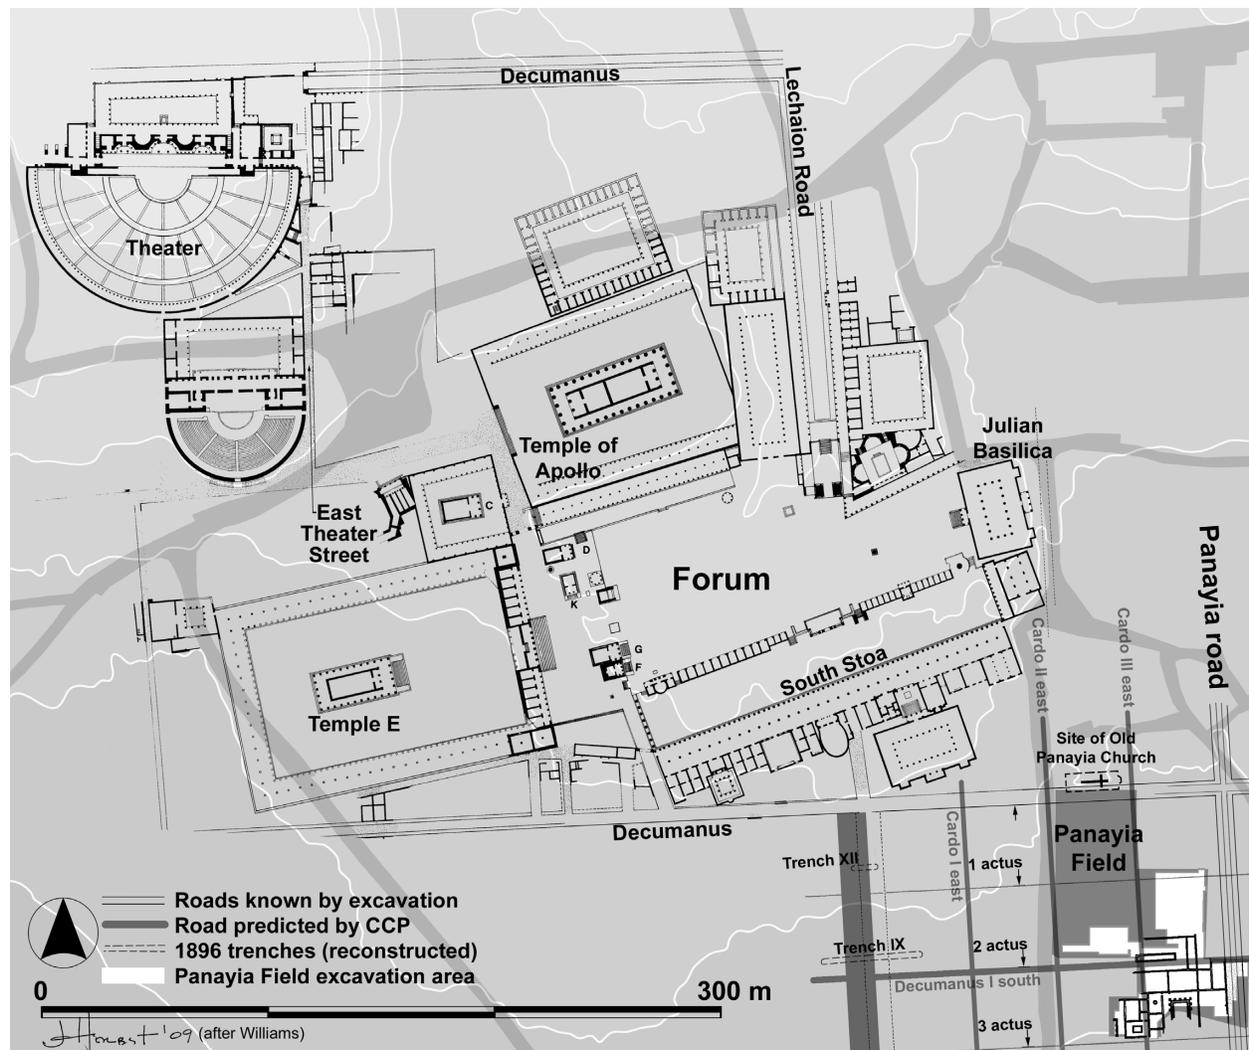
Figure 1. The Roman forum and the Panayia Field. Scale 1:3333. J. A. Herbst

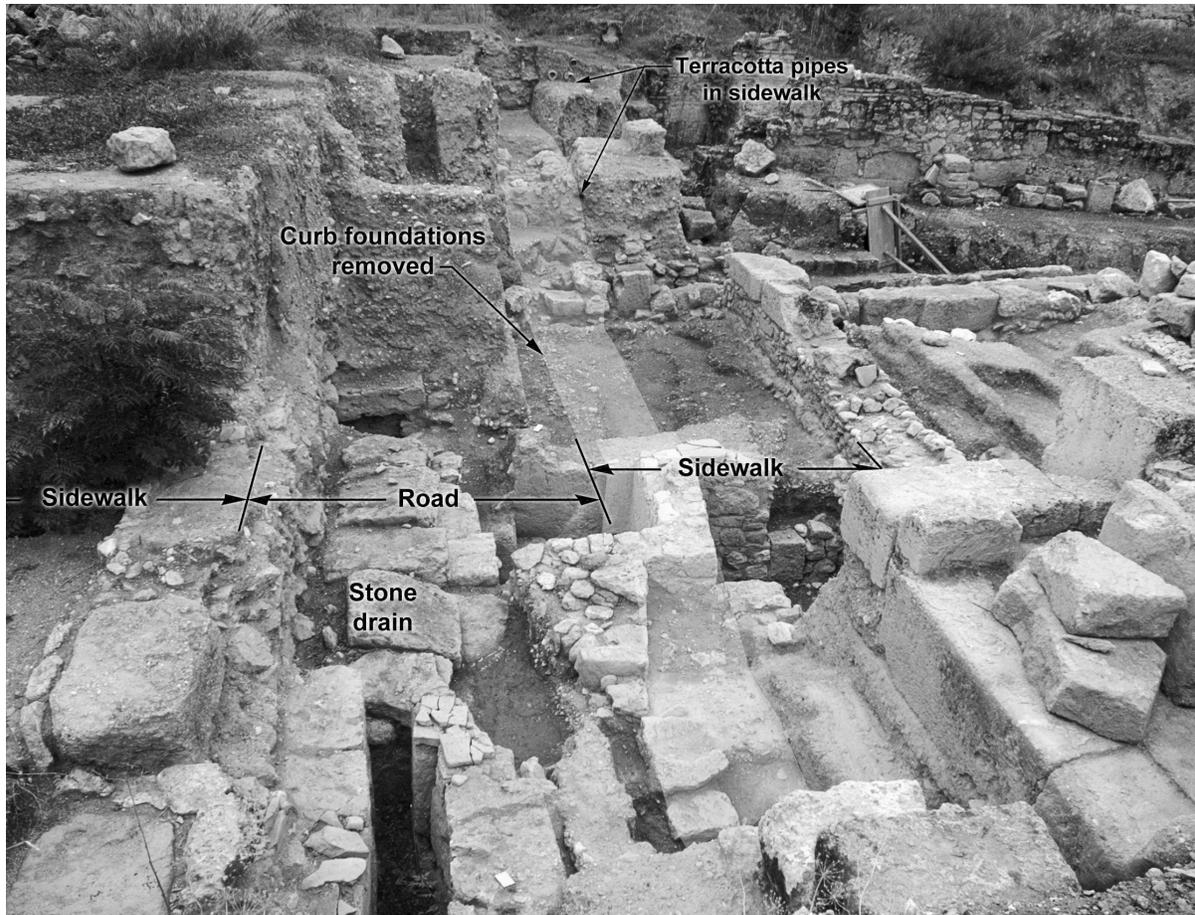
Figure 2. The Panayia road from the south. Photo courtesy Corinth Excavations

additional geophysical survey detected a further 90-m stretch of the road some 91 m south of the Panayia Field.<sup>3</sup> When initially laid out, the road was 7.4 m wide, or 25 Roman feet, but in the latter half of the 2nd century curbs were added, creating broad sidewalks on each side.<sup>4</sup> In this period, the sidewalks each measured 2.77 m and 2.47 m wide, or about 9 Roman feet, and the road itself measured approximately 2.15 m, or 7 Roman feet (Fig. 2).

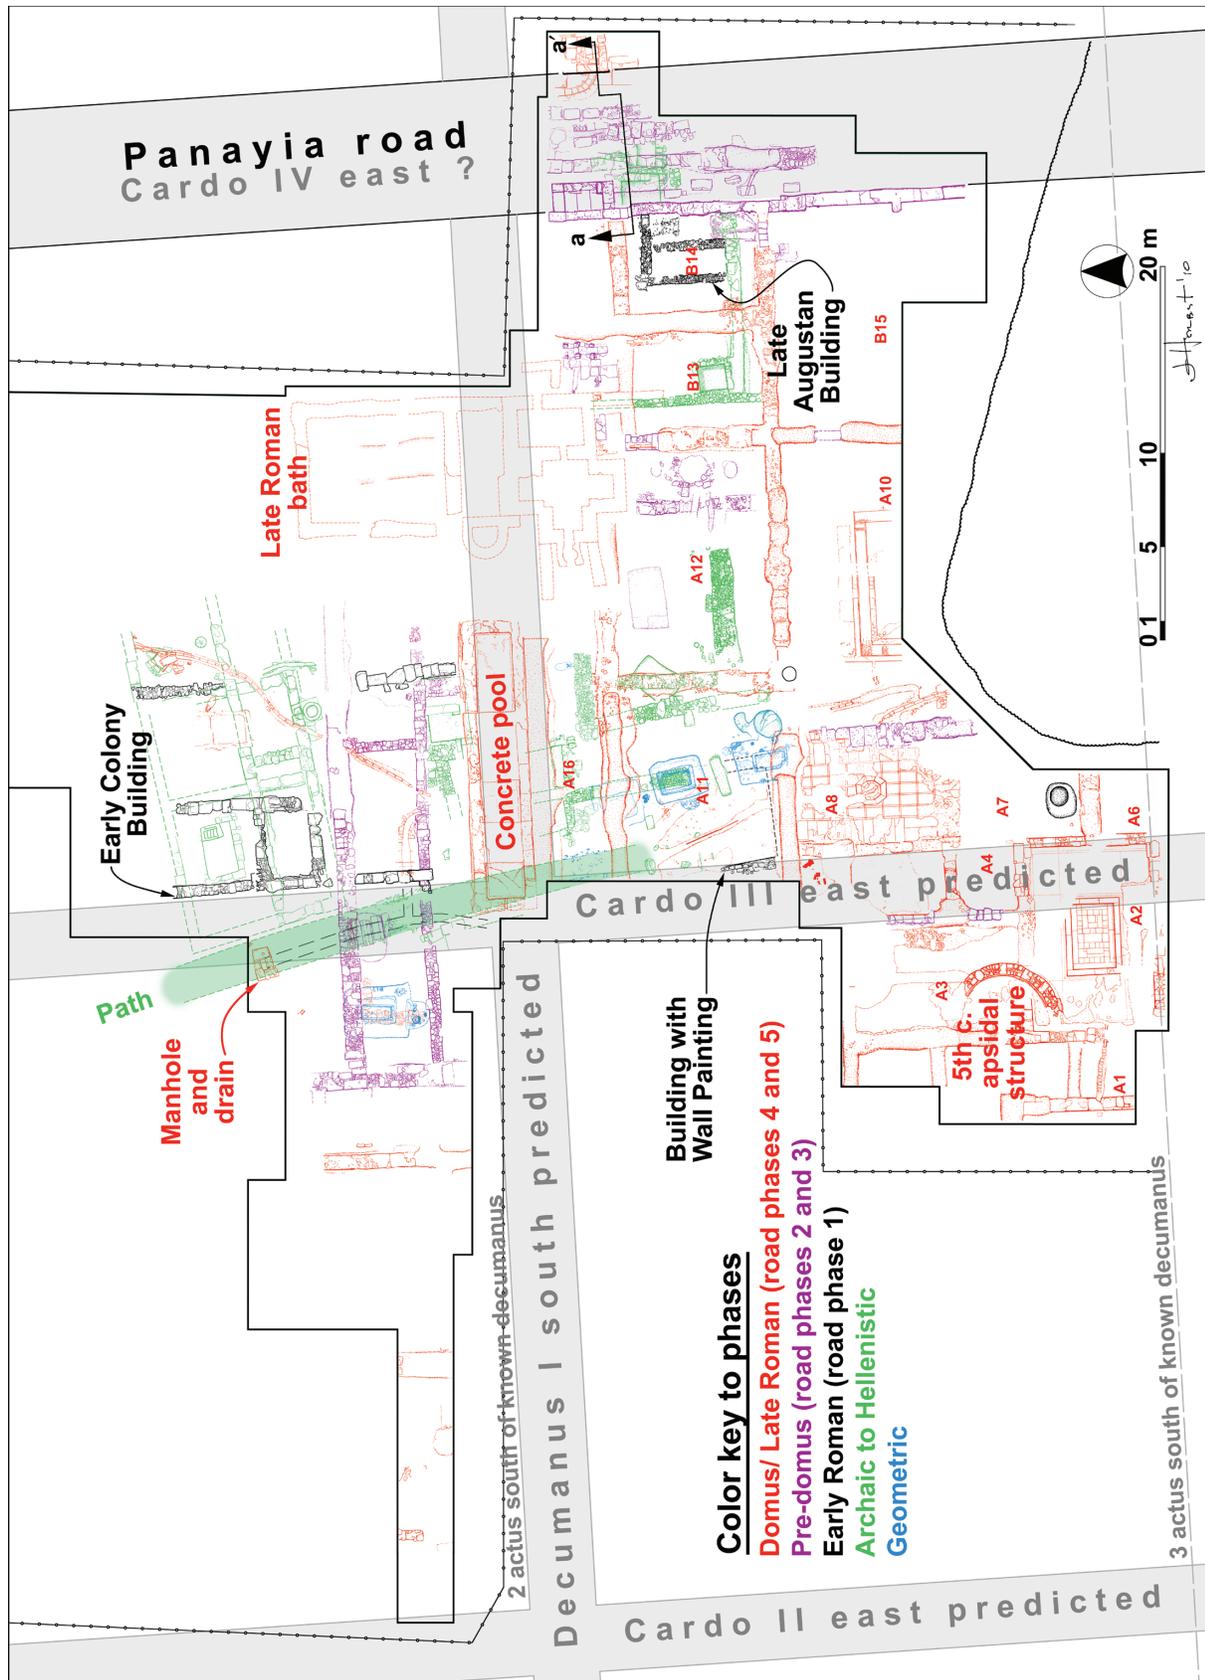
Figure 3. State plan of the Panayia Field showing Geometric through Roman phases. Scale 1:400. J. A. Herbst

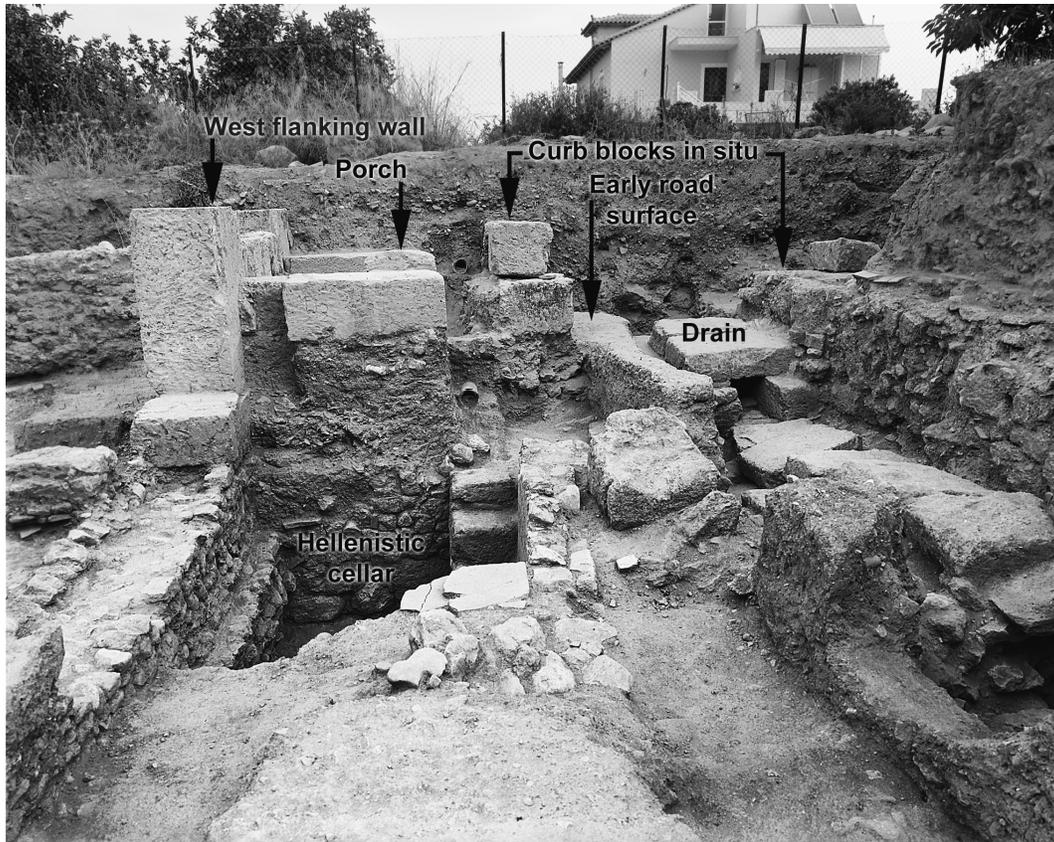
Figure 5. Early road surfaces preserved between the later structures, the stone channel, and the western curb wall. View from the south.

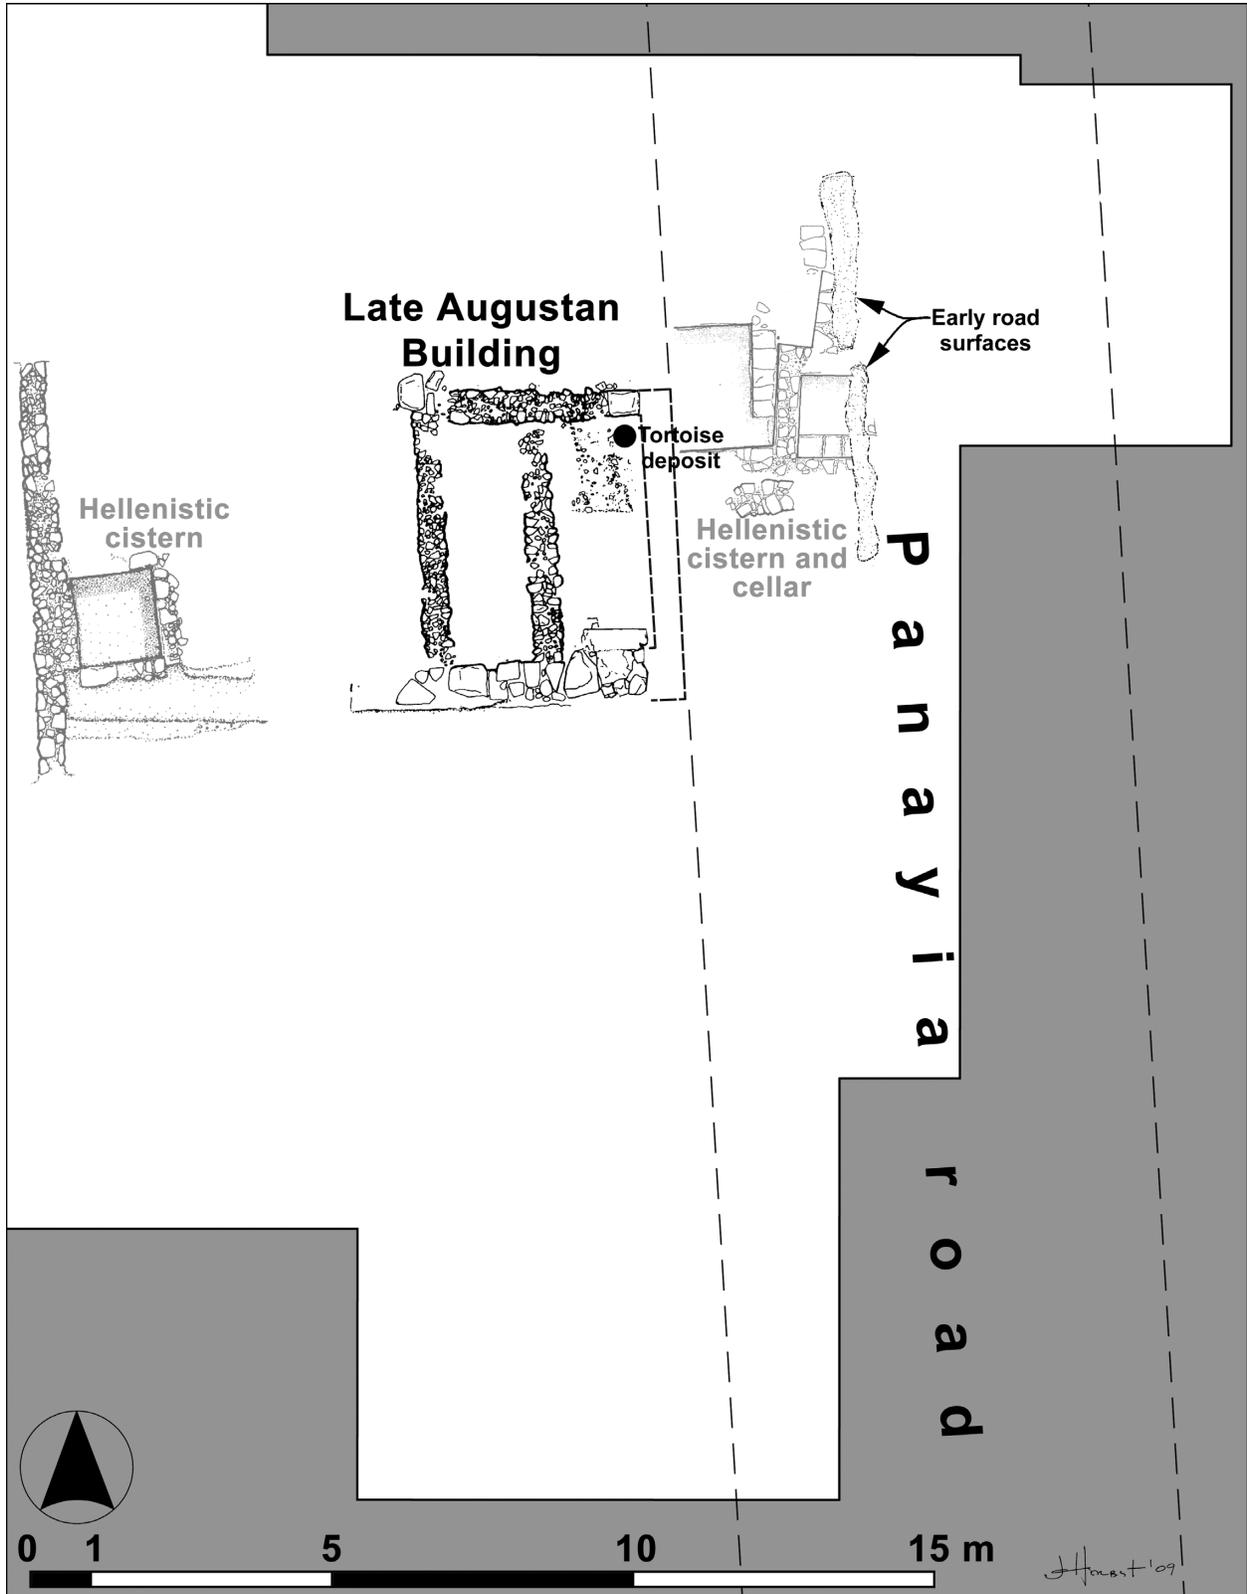
Figure 6. State plan of phase 1 of the road. Scale 1:125. J. A. Herbst

A third building, dubbed the Late Augustan Building, was unearthed directly adjacent to the road on its west side (Figs. 3, 6, 7); this building provides important chronological evidence for the road. Excavation revealed two rooms enclosed by three Roman walls, each preserved in a single course of cobble foundations that abutted the north face of an earlier Hellenistic east-west wall of heavier boulders. Presumably, a fourth wall formed the eastern side of the building, but it did not survive later construction activity in the area. The floors of the building or other deposits from the time of its habitation were likewise completely removed by later activities, and thus it is not possible to propose a function for the building. However, excavation recovered a significant ritual foundation deposit from the construction phase of the building. After setting the cobble foundations, several objects were placed within a shallow depression dug against the walls of the northeast corner of the east room and backfilled. Within the deposit (lot 2001-33), excavators unearthed a coin (coin 2001-136, Fig. 8) and a lamp (lamp 2001-1, Fig. 9) buried under a tortoise (Fig. 10). The lamp provides a Late Augustan terminus post quem for the construction.<sup>13</sup> Shortly thereafter the walls were dismantled to make room for construction in the next phase of the road.

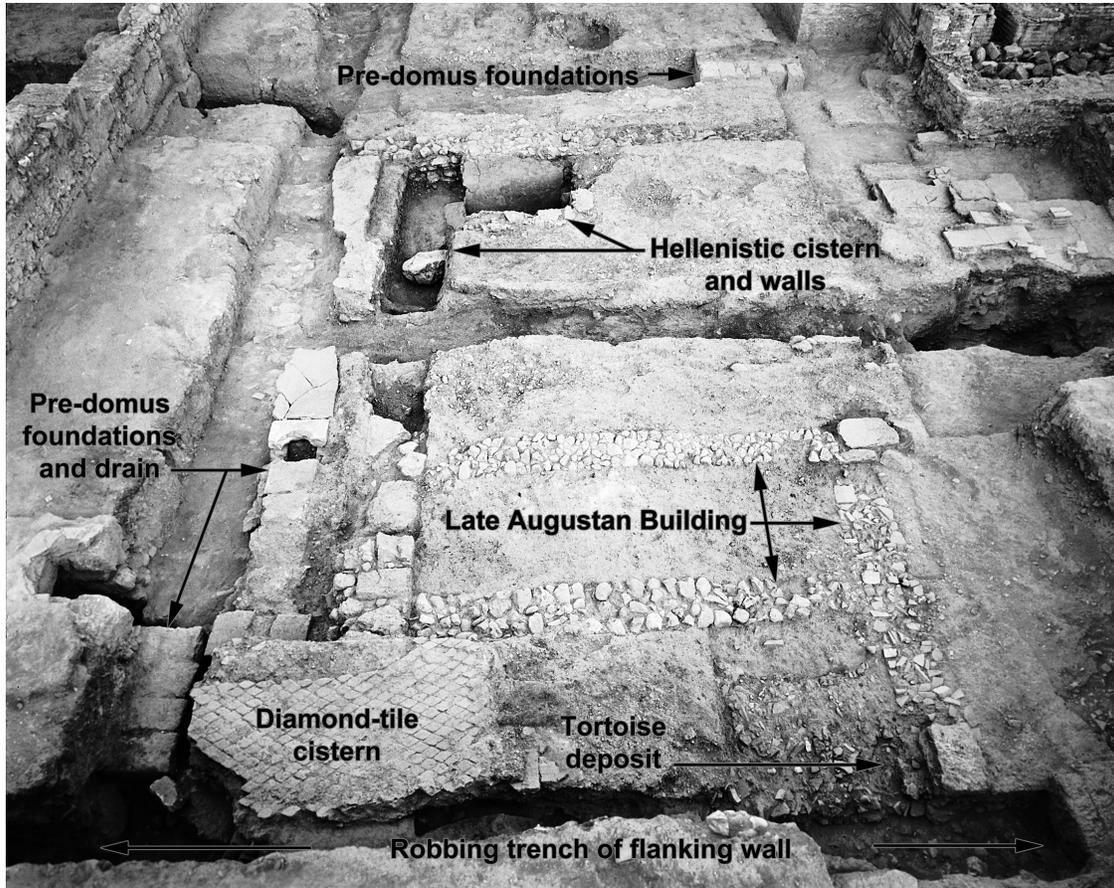
Figure 7. Hellenistic and Roman structures west of the road, including the Late Augustan Building and the tortoise foundation deposit. View from the east. Photo I. Ioannidou and L. Bartzoti

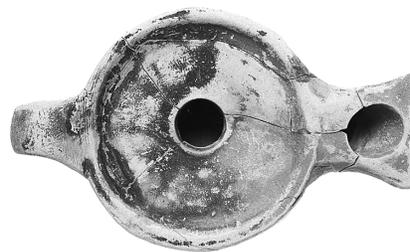
Figure 8. Corinth coin 2001-136, Greek Imperial Anonymous type A dating to 44/40 B.C. Scale 1:1. Photos I. Ioannidou and L. Bartzoti

13. The lamp is Broneer type XVI with glazed buff fabric, similar to lamp 1981-11 from manhole 1981-3, which dates to the Late Augustan era; see Slane 2005, p. 40, fig. 9:5. Special thanks to Kathleen Slane for identifying this lamp. The coin is a Greek Imperial Anonymous type A dating to 44/40 B.C. It was identified by Orestes Zervos and further explained to us by Michael Ierardi.

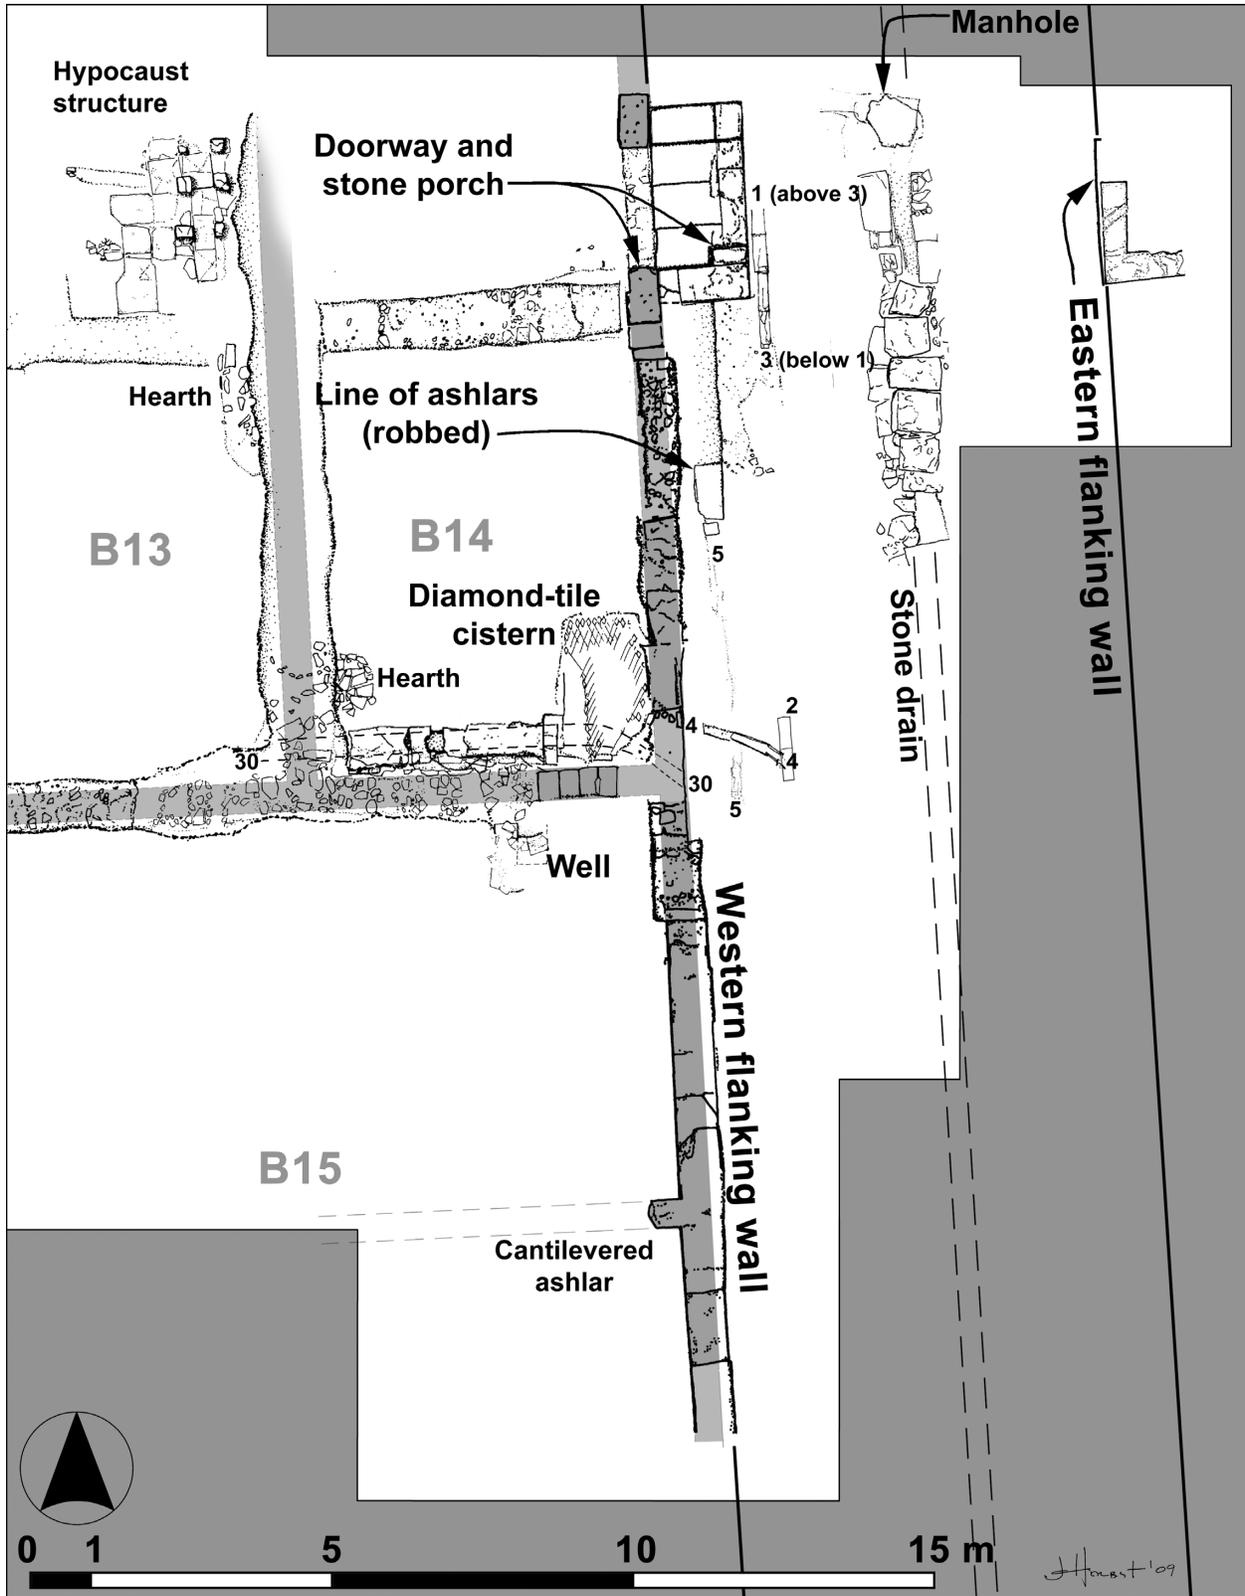
Figure 11. State plan of phase 2 of the road. Scale 1:125. J. A. Herbst

8. There are 27 ceramic pipelines, 1 robbed line, and 3 built drains. These lines are numbered on the phase plans, Figs. 11, 17, 18, and 20.

Both of the walls flanking the road were heavily constructed, deeply founded, and sizable enough for the load-bearing requirements of a multi-story structure. The walls were built using 0.90-m-wide cobble foundations set into a trench, with a toichobate course of 0.76-m-wide ashlar surmounted by upper courses of random ashlar that range in width between 0.50 and 0.60 m (Fig. 4: strata 2, 3; Figs. 11–13). The construction trenches

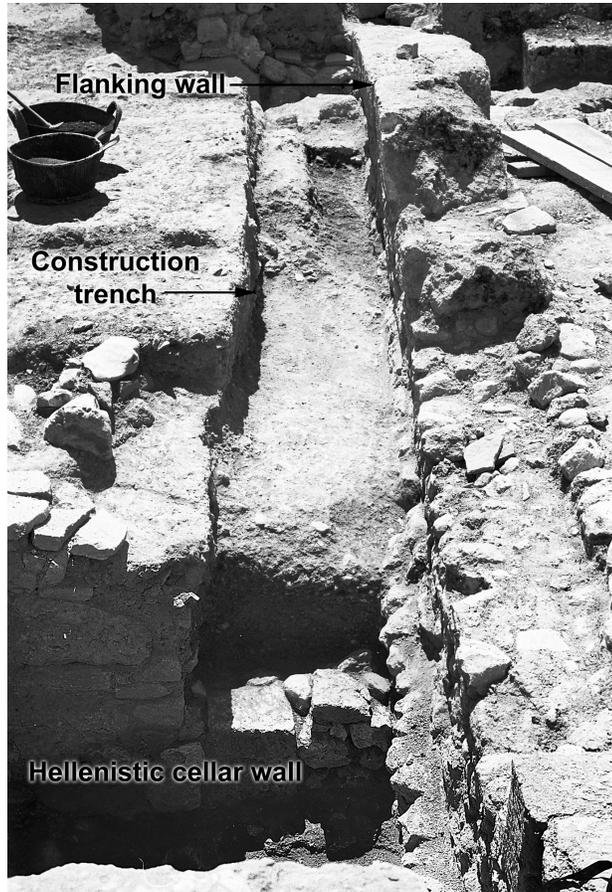
Figure 12 (*left*). Western flanking wall and its construction trench, which cut through the Hellenistic wall at lower left. View from the north. Photo courtesy Corinth Excavations

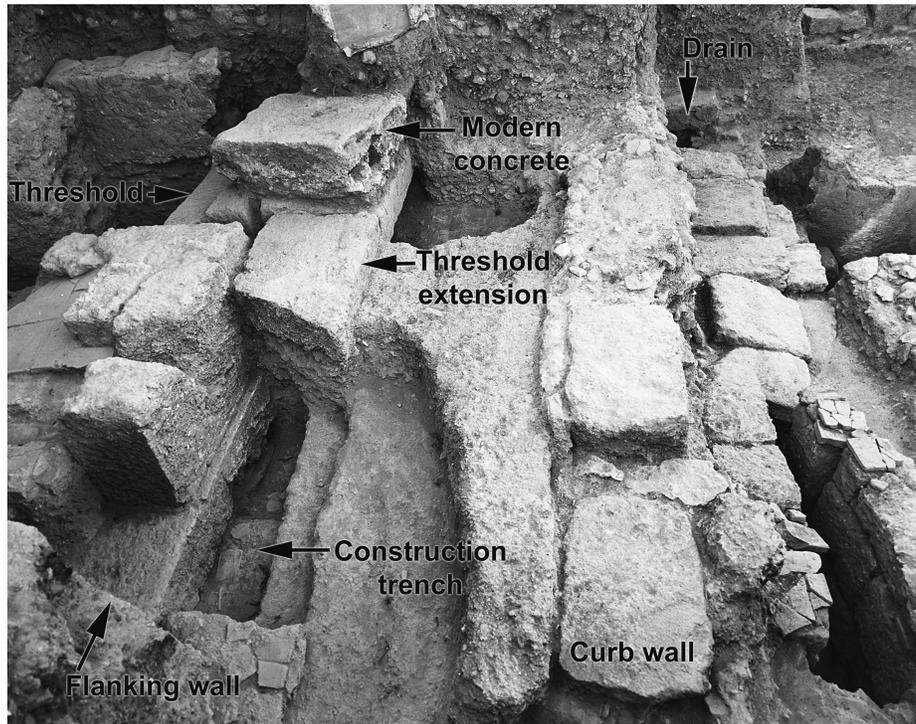
Figure 13 (*below*). Eastern sidewalk showing flanking wall. Other visible features include the threshold extension of phase 4 and the curb wall of phase 3. The phase 2 stone drain is in the roadbed at right. View from the north. Photo I. Ioannidou and L. Bartzoti

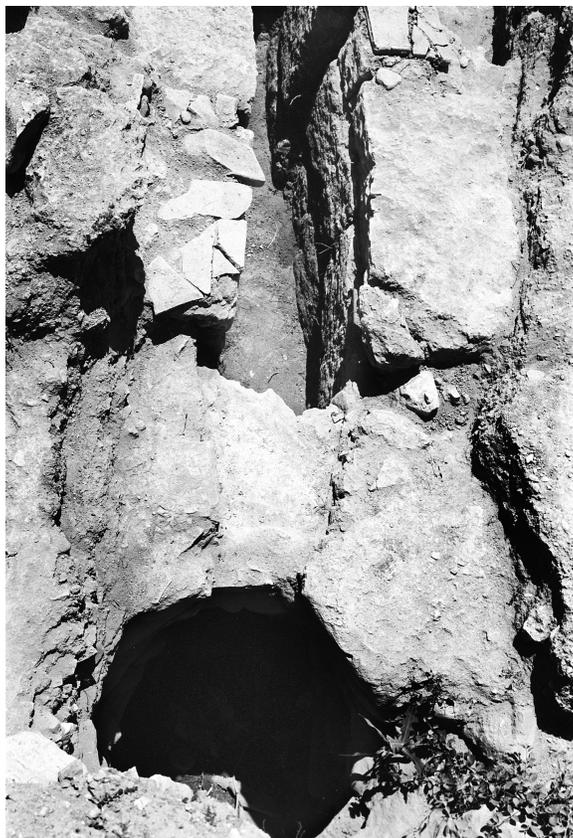
Figure 14. Manhole for the stone drain of the road. View from the north. Photo courtesy Corinth Excavations

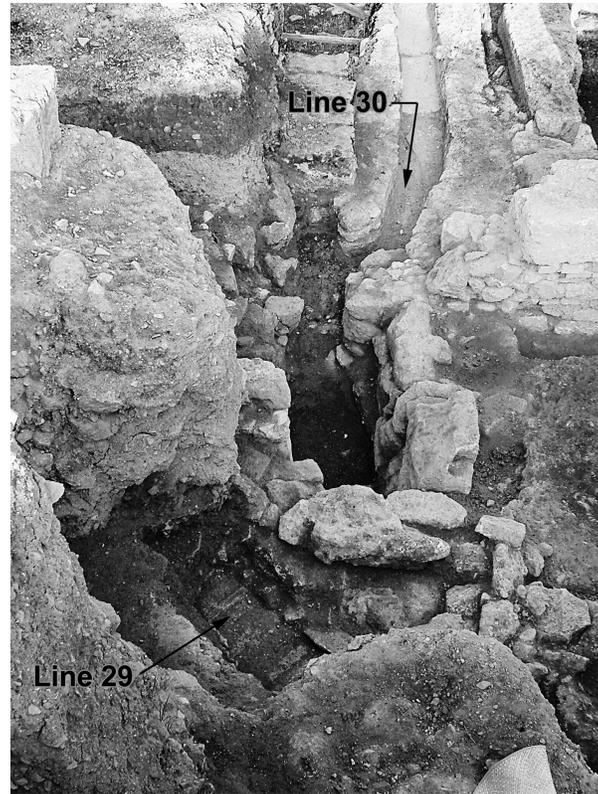
Figure 15. A series of drains (lines 29, 30) cut through the western flanking wall to empty into the stone drain. View from the east. Photo J. Palinkas

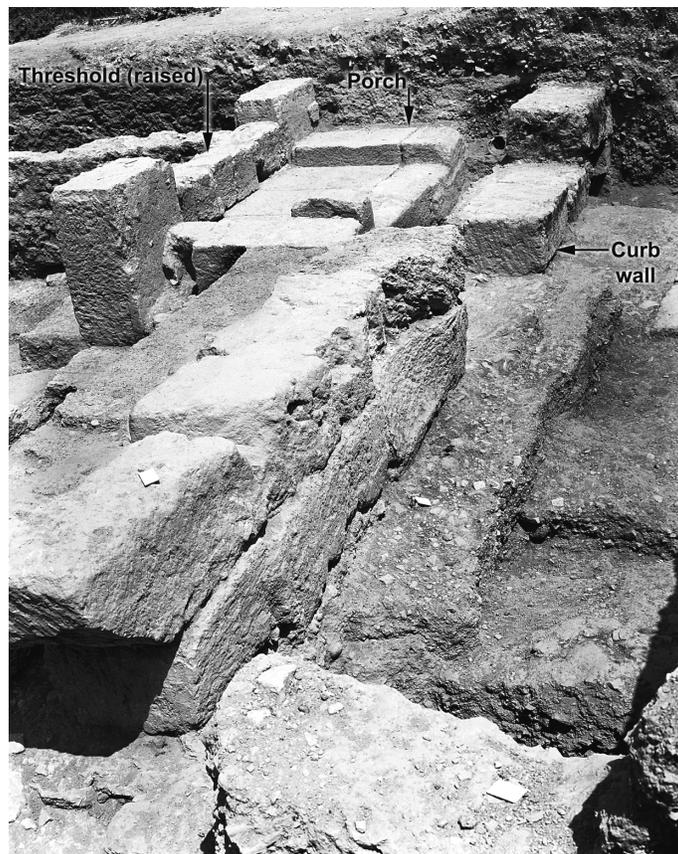
Figure 16. First-century limestone porch and the western curb wall. View from the southeast. Photo I. Ioannidou and L. Bartzoti

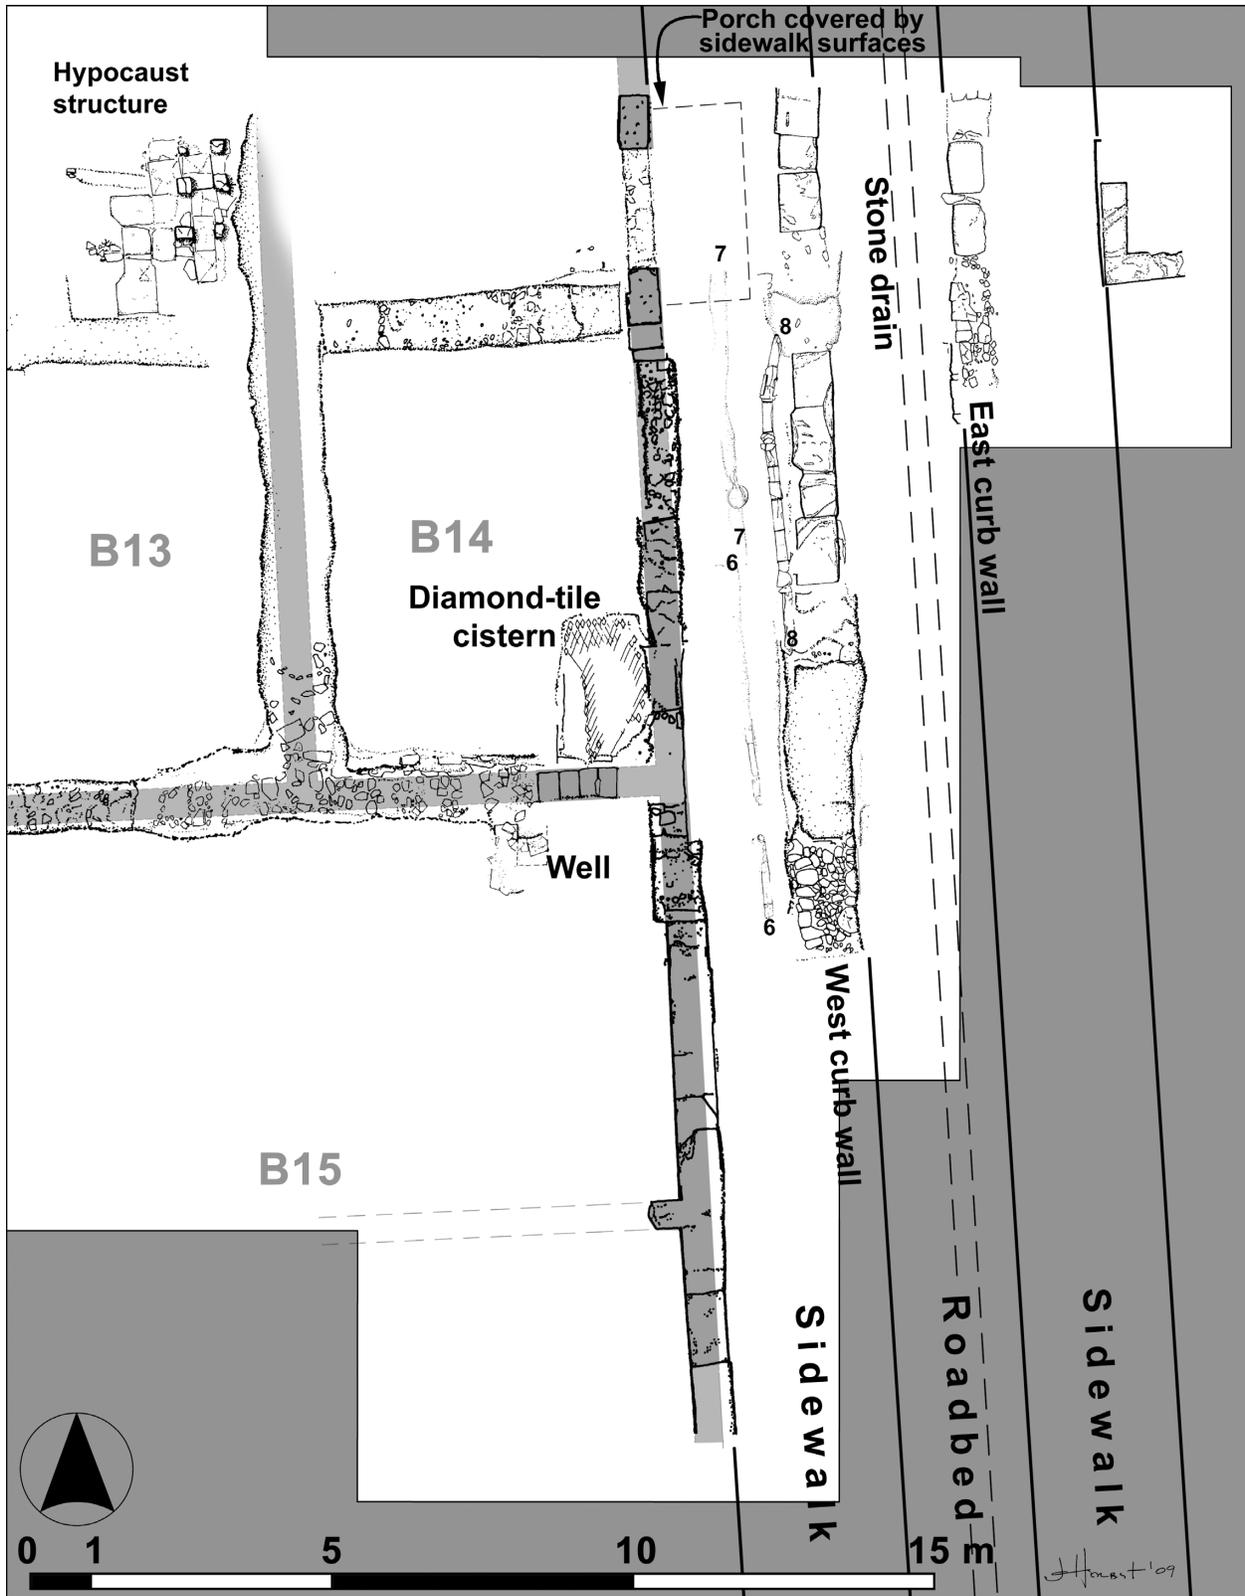
Figure 17. State plan of phase 3 of the road. Scale 1:125. J. A. Herbst

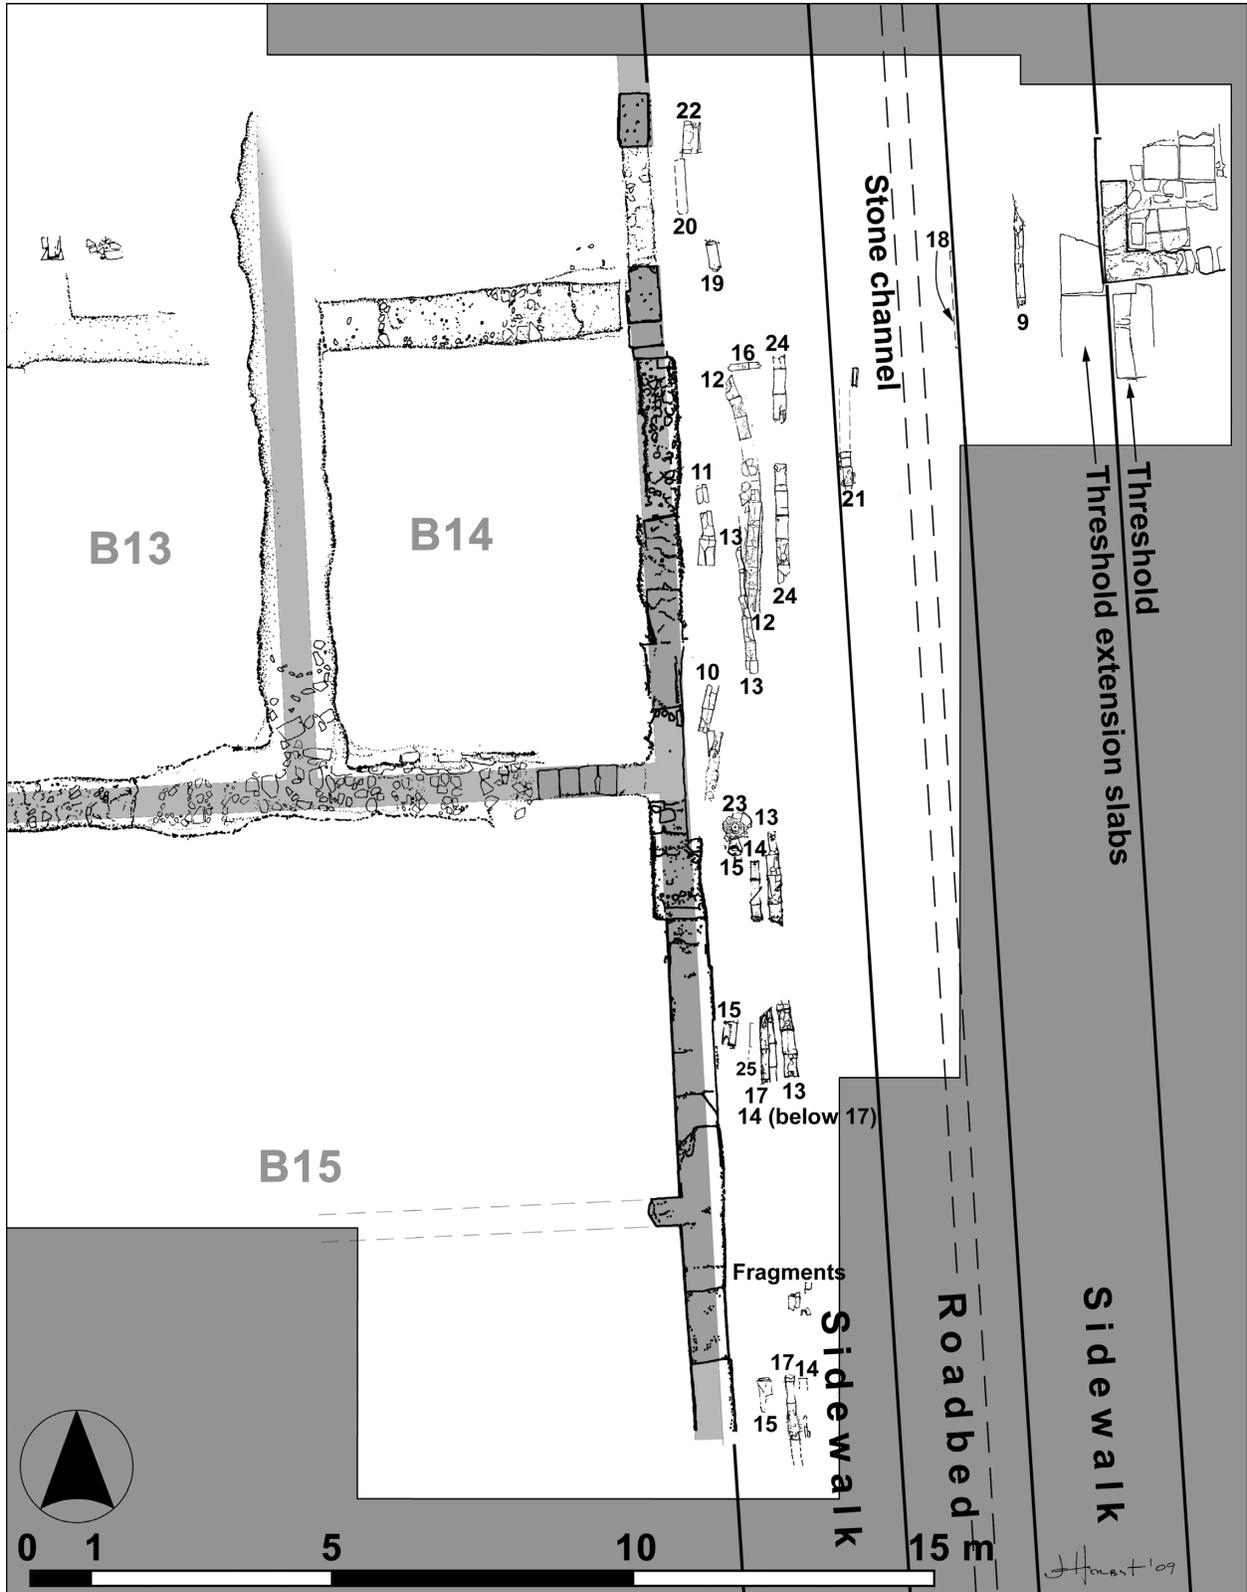
Figure 18. State plan of phase 4 of the road. Scale 1:125. J. A. Herbst

Phase 4 coincides with the broad reconstruction within the insula west of the road, which introduced a large Roman domus. East of the domus and adjacent to the road, several separate spaces continued in use (Fig. 3: B13–B15; Fig. 18).<sup>32</sup> Although later removal of the walls and subsequent overbuilding have left the domus in fragmentary condition, it was, without doubt, richly assembled and ornately decorated. Included within its walls

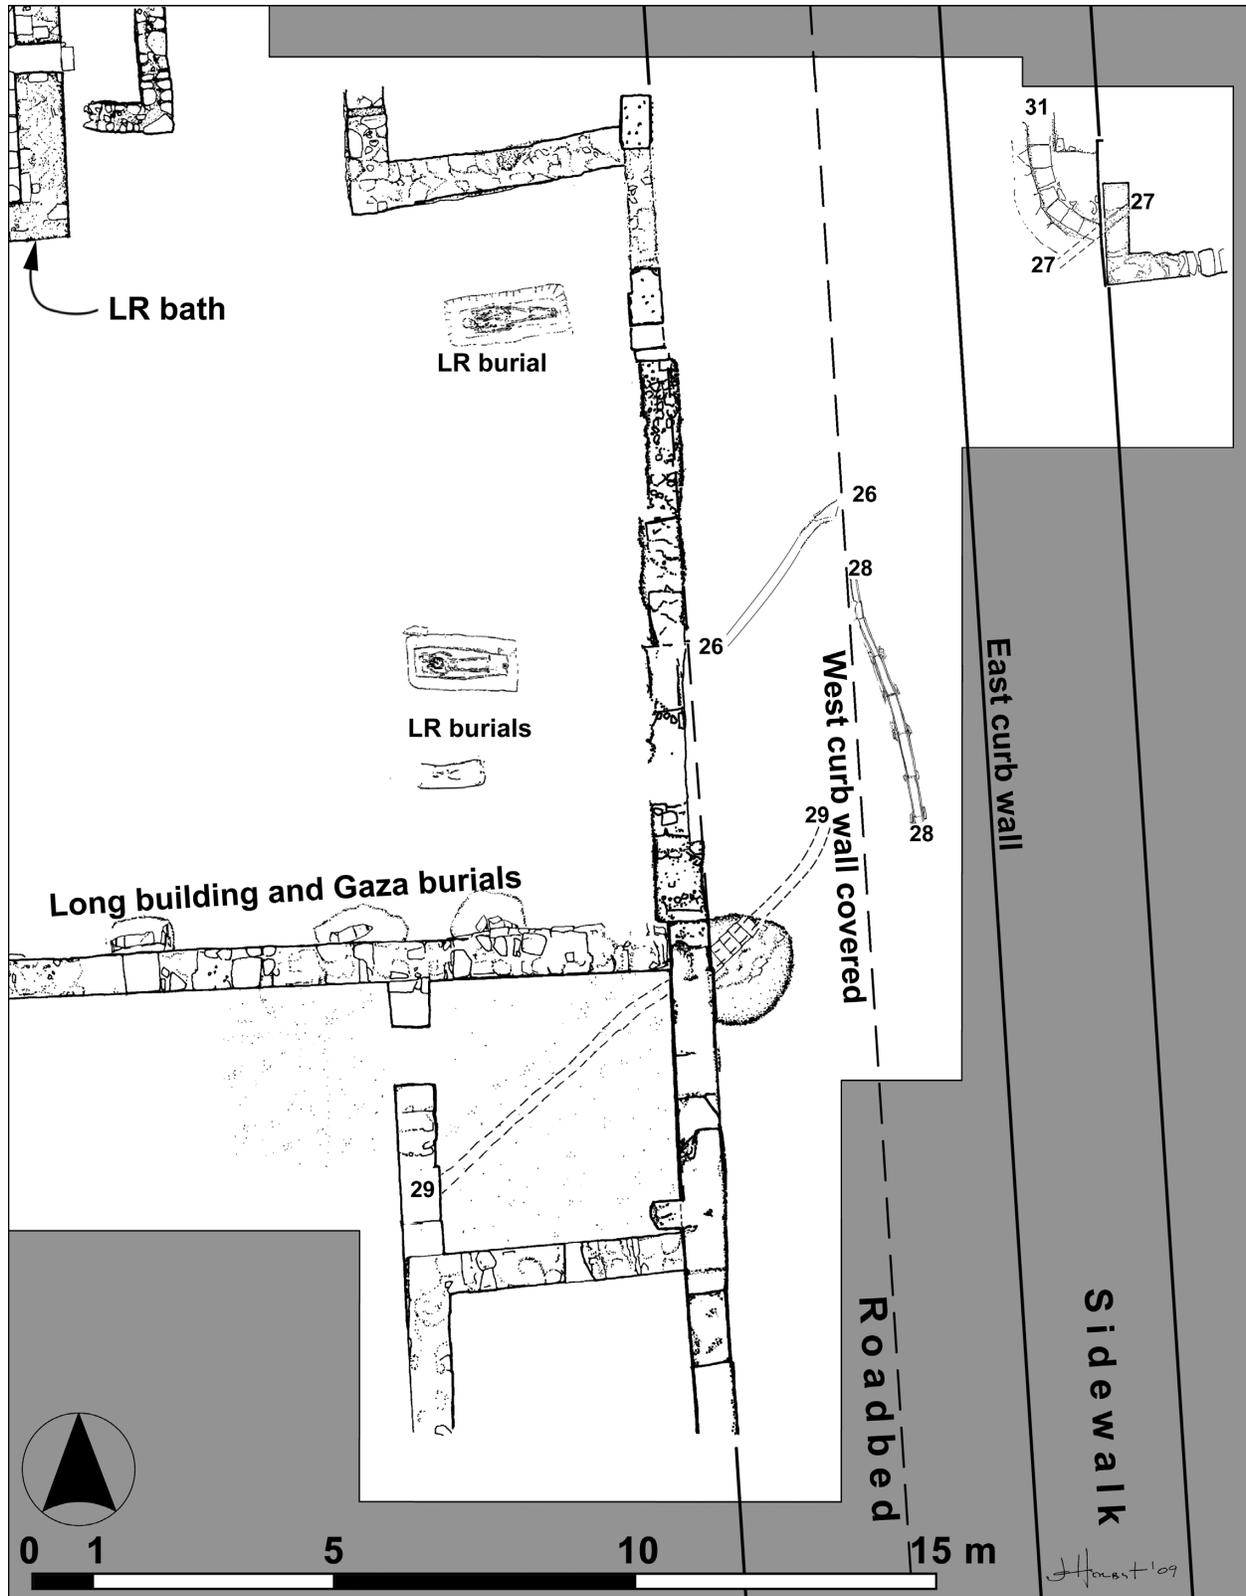
Figure 20. State plan of phase 5 of the road. Scale 1:125. J. A. Herbst

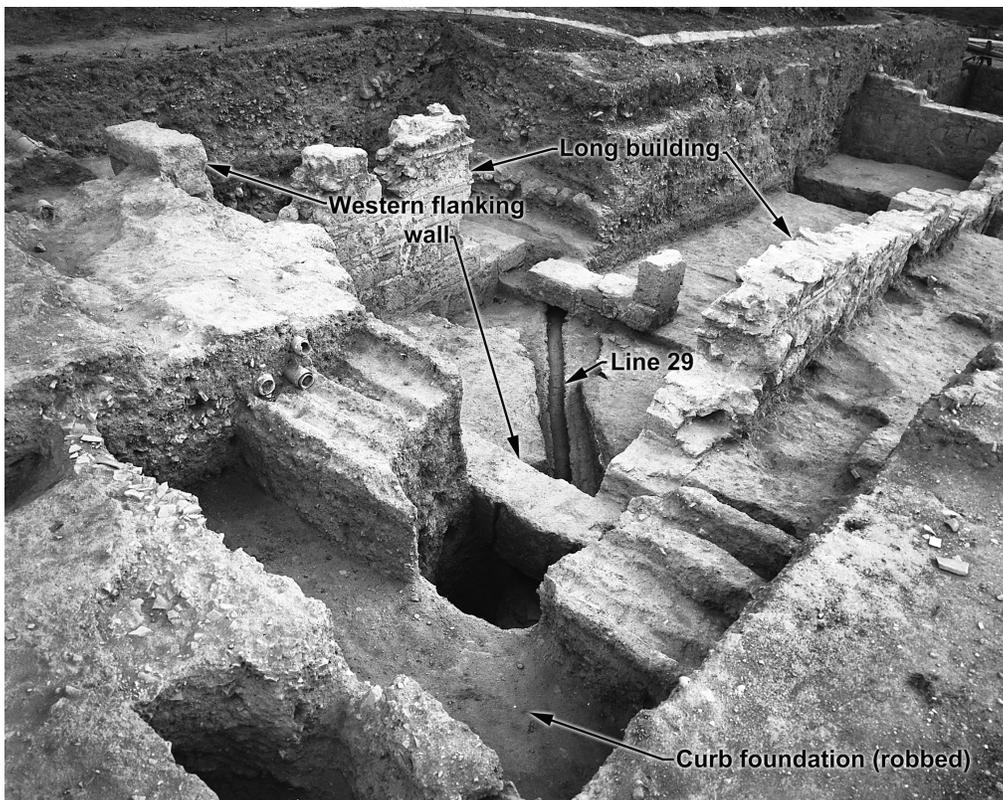
Figure 21. West sidewalk looking toward the long building and line 29. View from the northeast. Photo I. Ioannidou and L. Bartzoti

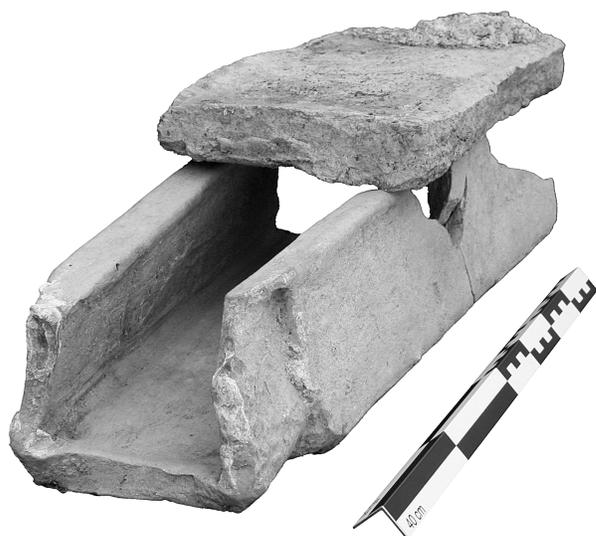
Two types of pipe—square pi-shaped and round—were installed in the road in the Panayia Field, each offering various benefits that suggest their suitability for use as supply- or drain-lines. Round, wheel-made pipes were the predominant type, accounting for 24 lines, while only three examples were found of inverted pi-shaped channels with cover tiles. Round pipes, which had considerably less exposed joint per segment, created a tighter and cleaner system. Because they formed a closed system, round pipes were more difficult to open and maintain when clogged. Pi-shaped lines with removable cover tiles allowed for easier maintenance without compromising the integrity of the conduit (Fig. 22). However, the pi-shaped lines were more prone to leaking and considerably more permeable to dirt, roots, and other intrusions. Each segment had considerably more joined surface area and pieces that were sealed with lime mortar. Consequently, the advantages and disadvantages of each form suggest their function: the round pipes were more suitable for conducting clean, constantly flowing

water, which was free of clog-causing substances, and the pi-shaped channels were more appropriate for carrying waste or fluids that increased the likelihood of clogging and maintenance.

Typical construction practices and features emerged from the body of material gathered from the pipelines. All the lines were composed of terracotta segments joined by lime mortar. Terracotta pipe was the more economical and healthy alternative to lead, according to Vitruvius (8.6.10), who also advised that the joints of terracotta pipes be sealed with a mixture of quicklime and oil (8.6.8).<sup>55</sup> Hard, white lime mortar is preserved on the male and female ends of a great number of examples noted below. Both round and pi-shaped types employed a joining system in which a narrowed male flange fit into a female opening (Fig. 23).<sup>56</sup> Because constricting the male end would reduce the flow, the female end of the round pipes was sometimes widened to counteract this effect. The widening of the female end was often manifest as a step or stop, but just as often the female end was simply wider.
