# A ROMAN ROAD SOUTHEAST OF THE FORUM AT CORINTH

## TECHNOLOGY AND URBAN DEVELOPMENT

A wide, unpaved, north–south Roman road was established in the Panayia Field at Ancient Corinth in the last years of the 1st century B.C. Over the next six centuries, numerous civic and private construction activities altered its spatial organization, function as a transportation artery, and use for water and waste management. Changes included the installation and maintenance of sidewalks, curbs, drains, terracotta pipelines, and porches at doorways. The terracotta pipelines are presented here typologically in chronological sequence. The road elucidates early–colony land division at Corinth, urbanization into the 4th century A.D., and subsequent deurbanization in the 6th century, when maintenance of the road ended.

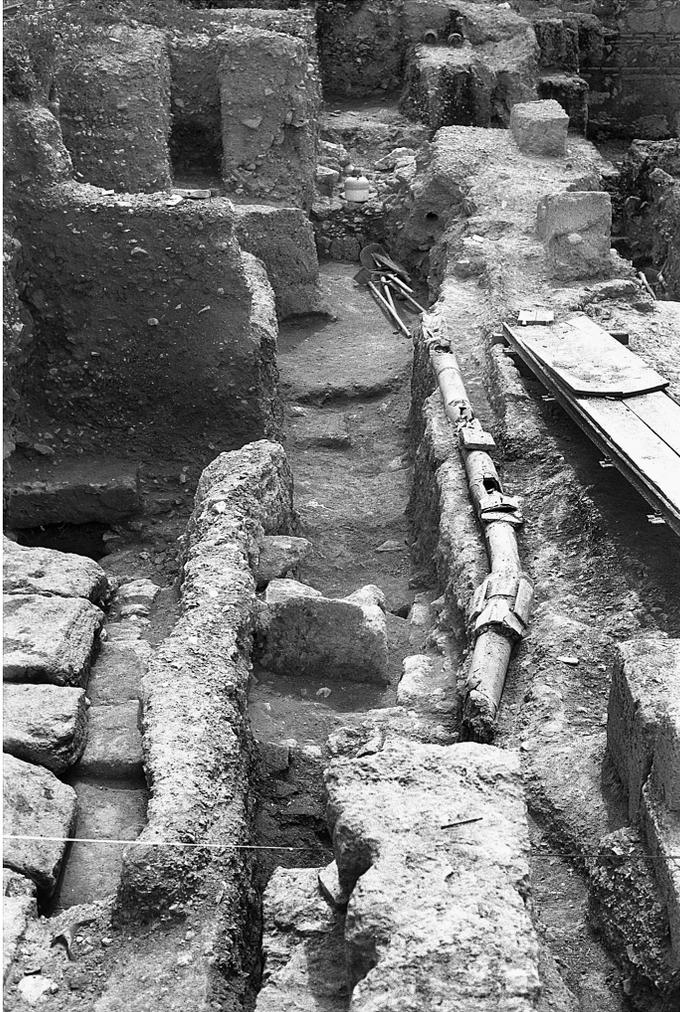
Figure 24. Line 8 showing holes broken in the pipe, which was then covered with tiles. View from the north. Photo J. Palinkas

These various issues meant that pipeline maintenance was a constant activity on Corinth's roads. To clean out the pipes, holes were broken into the tops of segments, the blockage was removed, and the hole was covered with a ceramic fragment and mortar (lines 3, 8, 11, 12, 20; Fig. 24). Another way to repair a water pipe was to remove clogged or damaged segments and replace them with new segments. There seemed to be little concern for matching replacement segments to the fabric or dimensions to the original line. Two lines include narrow- and wide-diameter segments (lines 10, 11) mixed in a single line, while other examples include segments from multiple typological groups (lines 6, 20). Occasionally, pipelines were partially or entirely removed from the road, perhaps because they were deemed beyond repair or because a newer, more efficient water pipeline was installed (lines 5–7, 23). It is clear that repairs were done as needed, with the primary focus on improving the function of the pipes, and not on aesthetics or form.

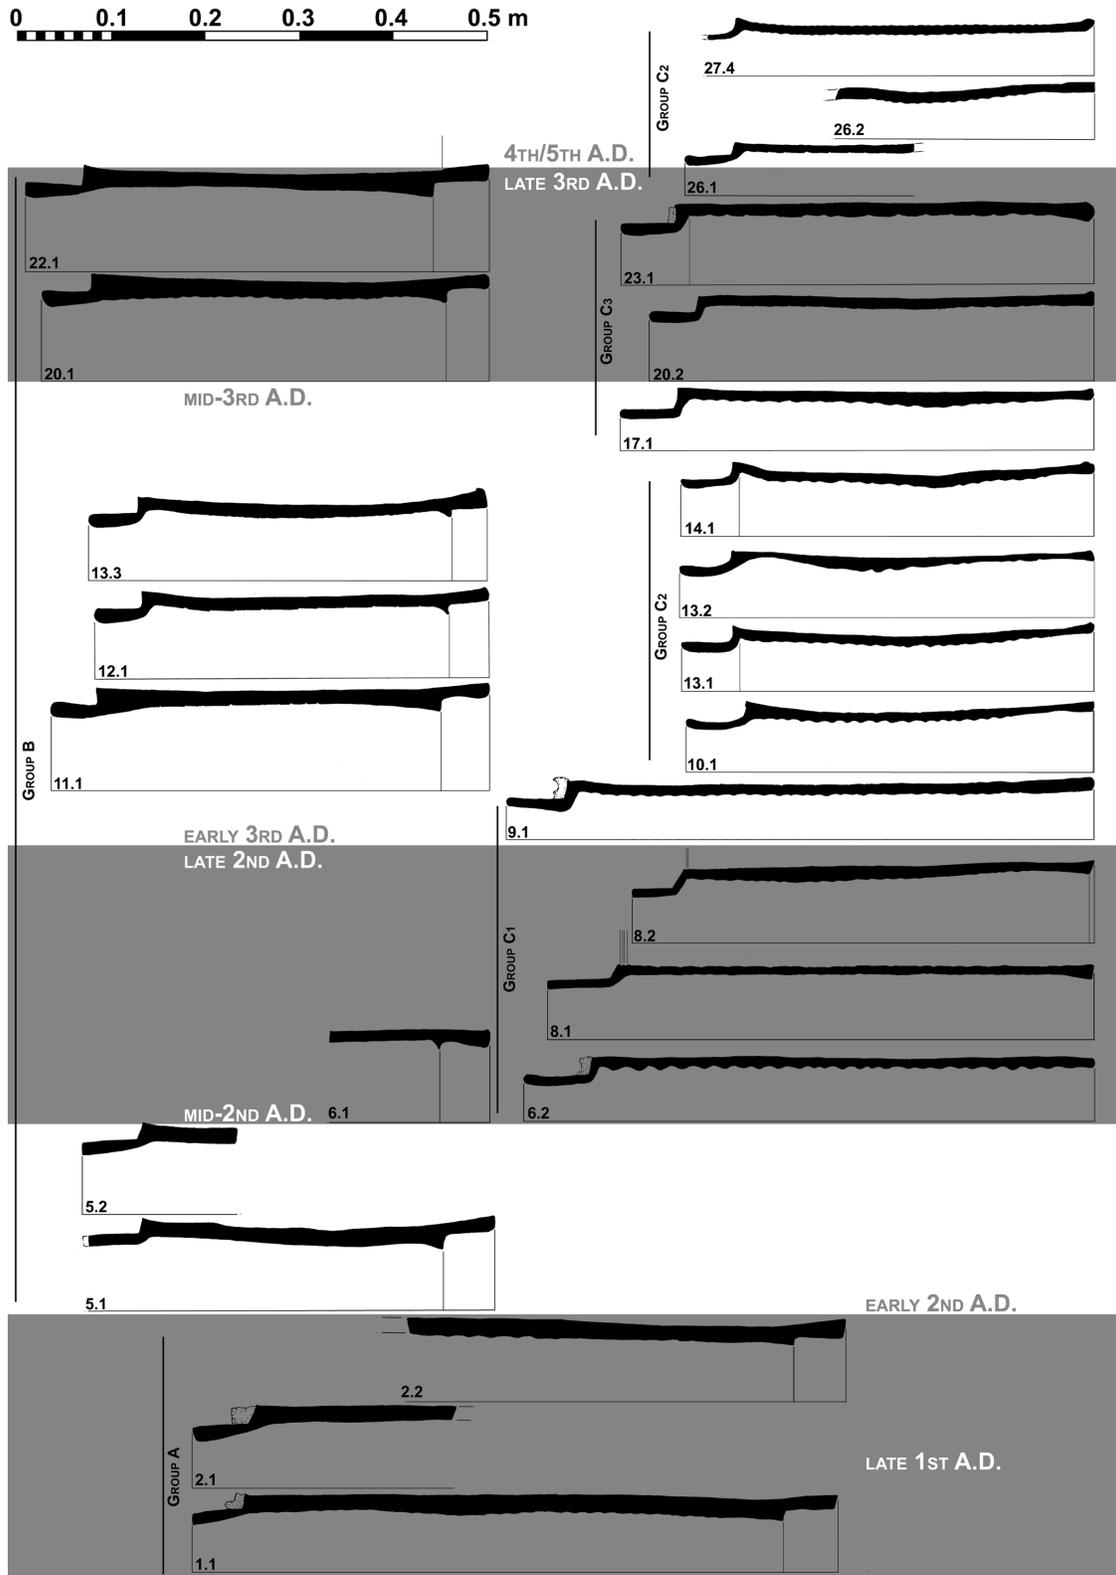
Figure 25. Timeline showing typological groups of the round pipelines from the Panayia road. J. A. Herbst

Pipes in group B have a chronological range from the early 2nd century to at least the late 3rd century. They are short-segmented, thick-walled, large-diameter pipes. Most have a stop at the female end. The bodies of this pipe group are consistently concave and shaped like an hourglass. The diameter ranges from 0.170 to 0.250 m, while the length varies from 0.395 to 0.493 m; the segments weigh between 4.9 (est.) and 8.8 (est.) kg. Early-2nd-century pipes of this group have sloping rather than square shoulders. Later shoulders are perpendicular to the body of the pipe. Another possibly diagnostic feature occurring from the mid-2nd century to the mid-3rd century is that the stop is pinched up on the interior of the pipe, as in segments 6.1, 12.1, and 13.3, rather than built up out of the body as in the other examples. Group B pipes come from lines 5, 11, 12, 22, and some segments from lines 6, 10, 13, 15, and 20. Fabric types 2b, 2c, and 2d are represented in this group.
